This report contains the results of consent monitoring and environmental effects of the New Zealand Aluminium Smelter for the year ending 31 December 2011.

This report summarises NZAS' environmental performance during 2011 and includes results, summaries and comments on discharge permit monitoring. It includes data from some reports forwarded to Environment Southland during the year with additional sections including discharges to air, dispersion conditions, liquid discharges etc. to cover NZAS' discharges to, and effects on, the environment.

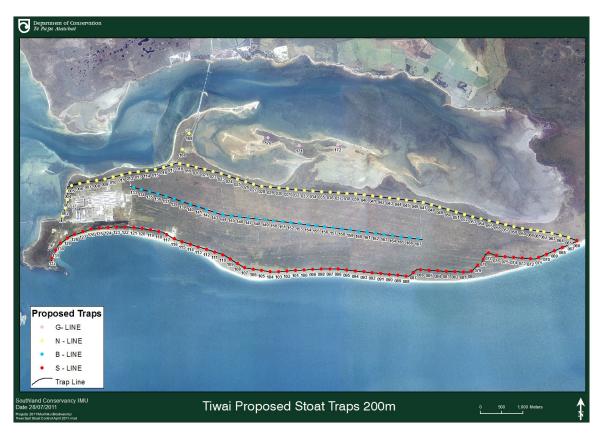
Stoat trapping is one such example. Working with DOC and NZAS's pest management contractor, the entire Peninsula is now ringed with stoat traps set 200m apart. The picture below shows the number and location of the traps.

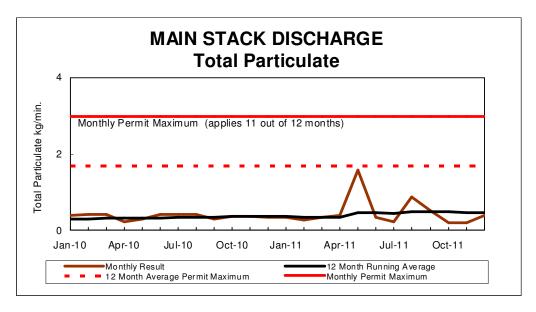
The following graph shows both the average monthly and 12 monthly running average main stack total particulate discharge during 2010 and 2011.

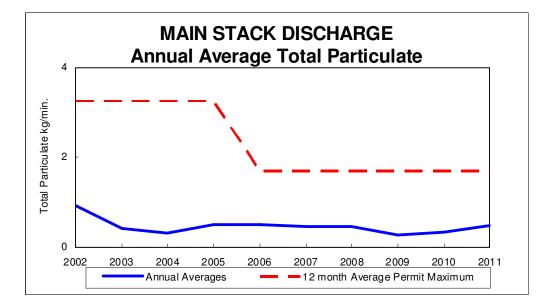
The following graph shows the annual average main stack total particulate discharge.

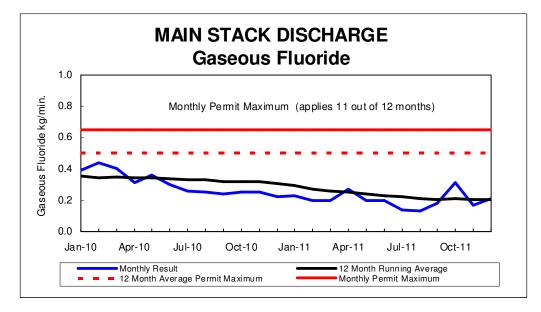
Permit: 12 month running average not to exceed 0.5 kg/min.

The following graph shows both the average monthly and 12 monthly running average main stack gaseous fluoride discharge during 2010 and 2011.

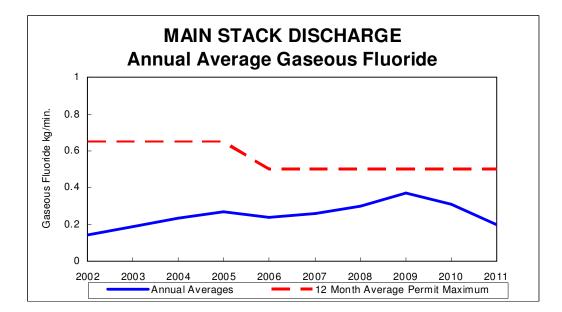
The following graph shows the annual average main stack gaseous fluoride discharge.

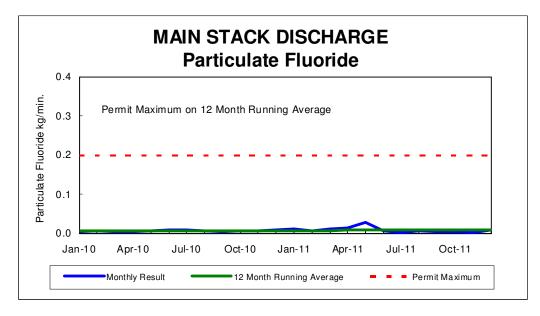
Permit: 12 month running average not to exceed 0.2 kg/min.

The following graph shows both the average monthly and the 12 monthly running average main stack particulate fluoride discharge during 2010 and 2011.

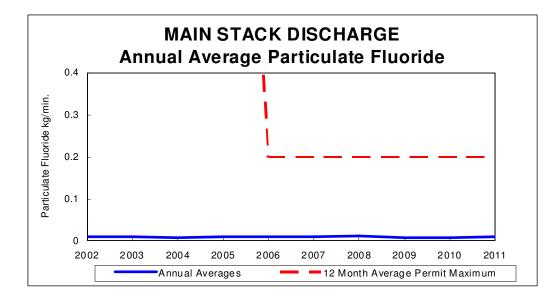
The following graph shows the annual average main stack particulate fluoride discharge.

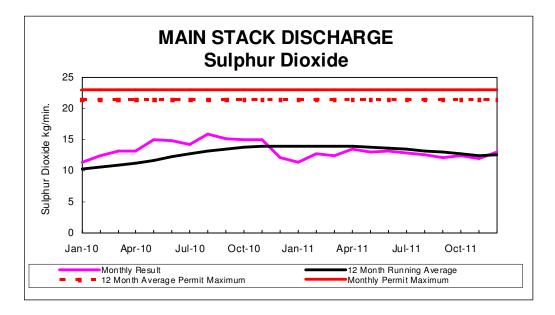
The following graph shows both the average monthly and 12 monthly running average main stack sulphur dioxide discharge during 2010 and 2011.

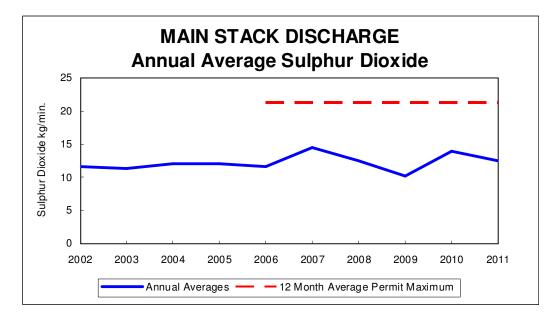
The following graph shows the annual average main stack sulphur dioxide discharge.

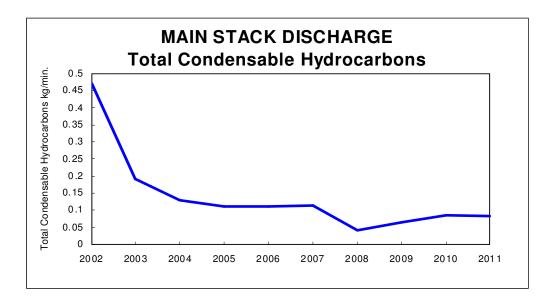
The annual analysis for total condensable hydrocarbons and 16 USEPA priority PAH was carried out during September 2011. The following graph shows the annual Total Condensable Hydrocarbons discharges.

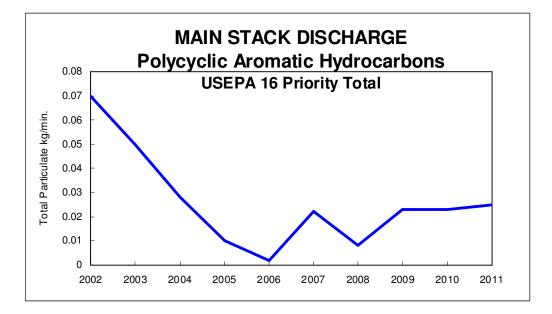
The following graph shows the annual result for 16 Priority USEPA polycyclic hydrocarbons.

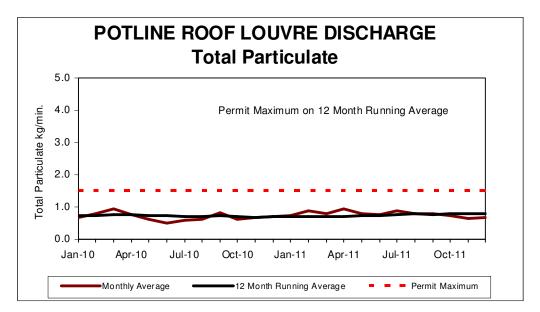
The following graph shows both the average monthly and 12 month running average Potline roof louvre total particulate discharge during 2010 and 2011.

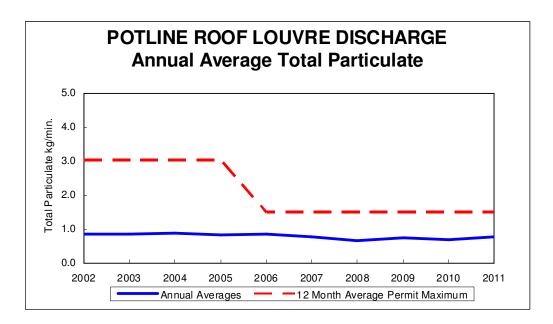
The following graph shows the annual average Potline roof louvre total particulate discharge.

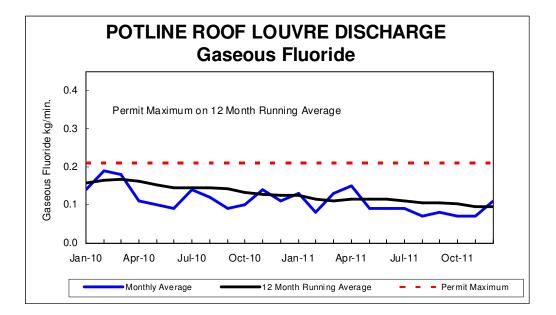
The following graph shows both the average monthly and 12 month running average Potline roof louvre gaseous fluoride discharge during 2010 and 2011.

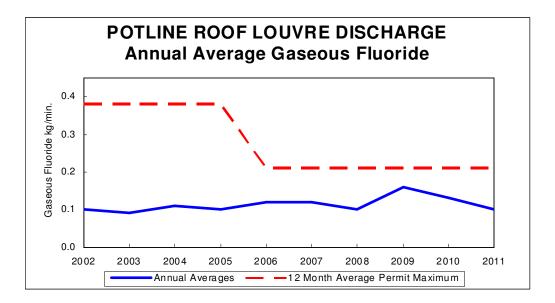
The following graph shows the annual average Potline roof louvre gaseous fluoride discharge.

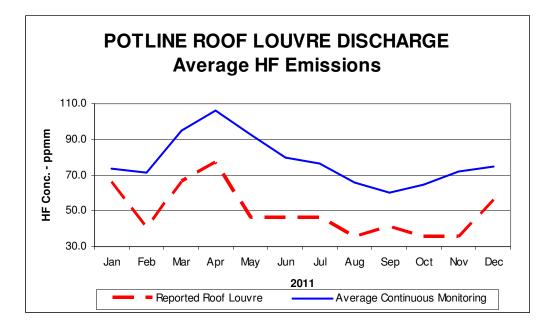
The following graph shows the reported Potline Roof Louvre gaseous fluoride emissions in comparison to the Boreal continuous monitoring results.

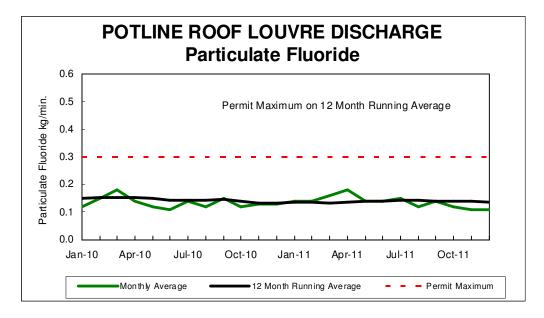
The following graph shows both the average monthly and 12 month running Potline roof louvre particulate fluoride discharge during 2010 and 2011.

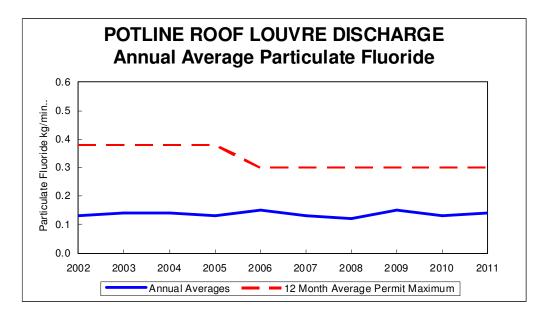
The following graph shows the annual average data for Potline roof louvre particulate fluoride discharge.

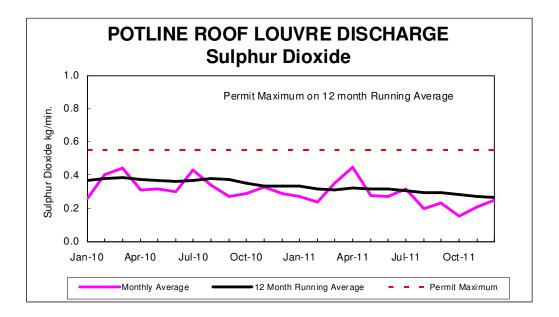
The following graph shows both the average monthly and 12 month running Potline roof louvre sulphur dioxide discharge during 2010 and 2011.

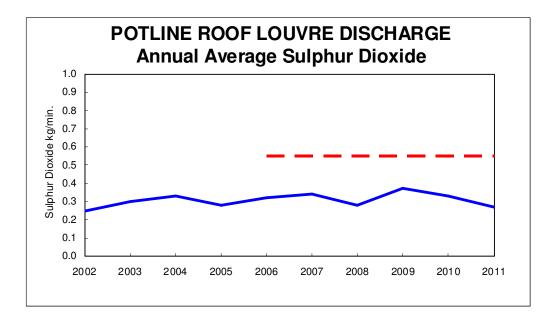
The following graph shows the annual average Potline roof louvre sulphur dioxide discharge.

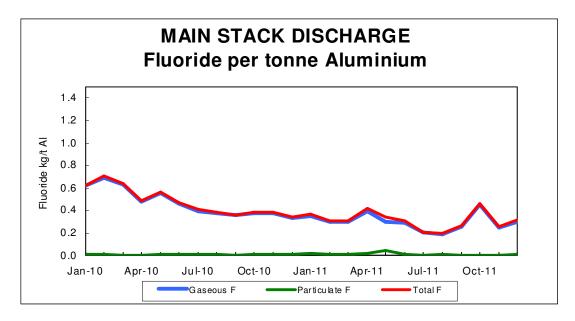
The following graph shows the monthly main stack fluoride per tonne aluminium discharge during 2010 and 2011.

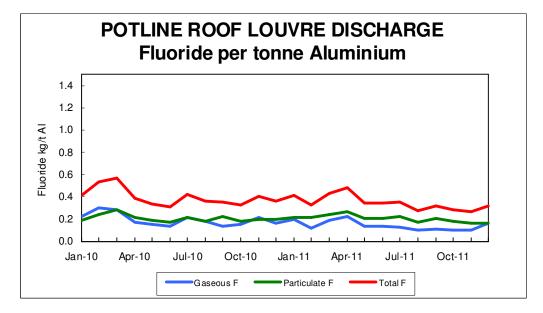
The following graph shows the average monthly Potline roof louvre fluoride per tonne aluminium discharge during 2010 and 2011.

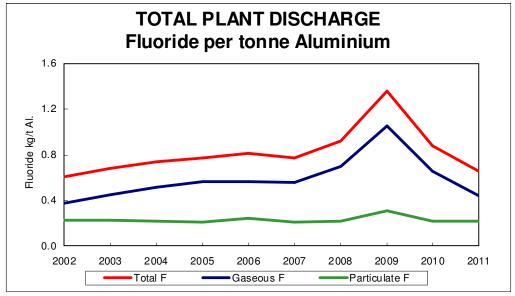
The following graph shows the average total plant fluoride per tonne aluminium for the last 10 years.

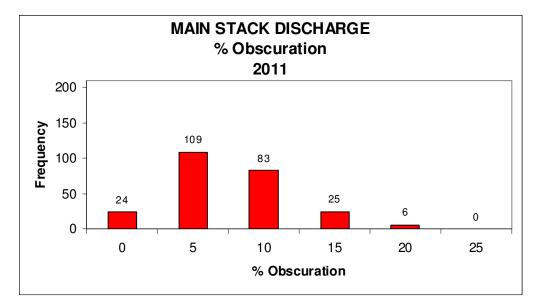
Main Stack smoke discharges were determined by visual observations using the standard Ringleman chart. The following graph summarises the observations recorded during 2011.

During 2011 there was a decrease in the frequency of observations in the 10 to 15% range and no observations greater than 20%.

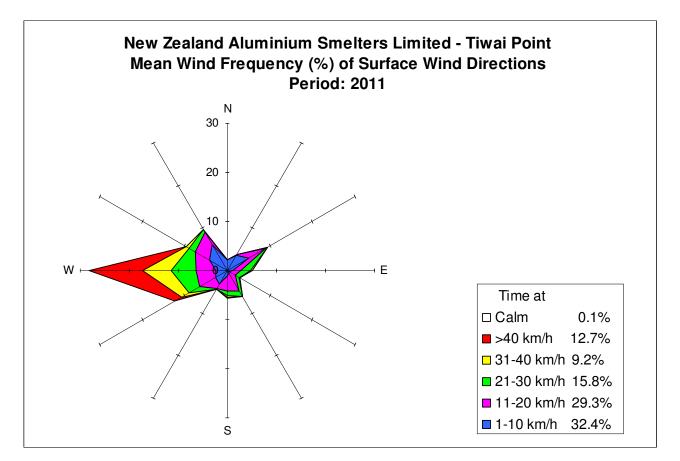
The mean wind frequency diagram on the following page shows that the 2011 wind pattern was dominated by westerly, north-westerly and north-easterly winds. Dispersion conditions are similar to previous years.

Total rainfall for the year is 1122 mm. The five year average is 1029mm. The long term average is 1107mm of rainfall.

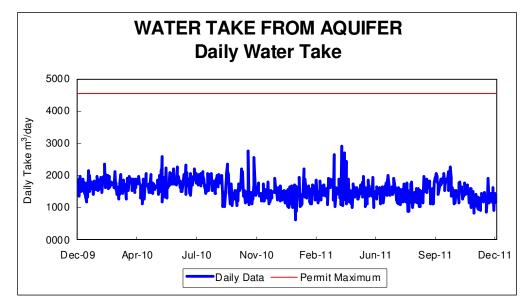
The total volume of water taken from the aquifer is recorded daily and is displayed in the graph below.

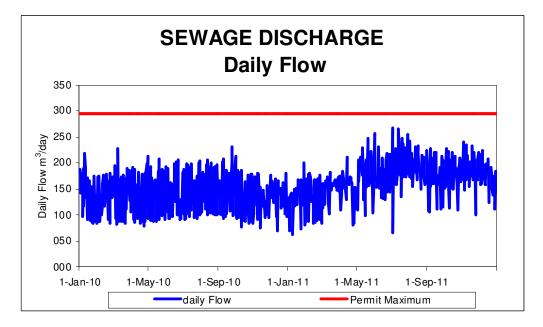
The following graph shows the daily sewage discharge flow during 2010 and 2011. The permit limit for daily flow is  $295 \text{ m}^3/\text{day}$ .

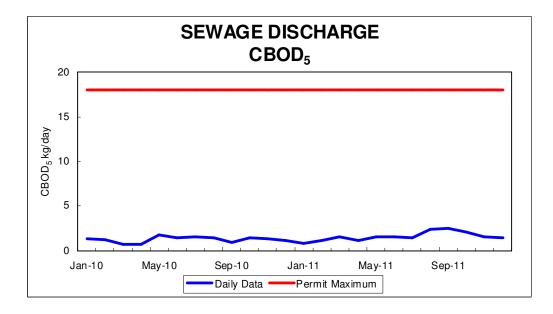
The following graph shows the monthly carbonaceous biochemical oxygen demand (CBOD<sub>5</sub>) discharge from the sewage treatment plant during 2010 and 2011. The permit limit for CBOD<sub>5</sub> is 18kg/day.

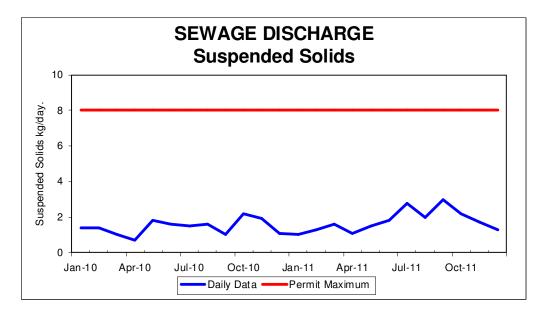
The following graph shows the monthly suspended solids discharge from the sewage treatment plant during 2010 and 2011. The permit limit for suspended solids is 8 kg/day.

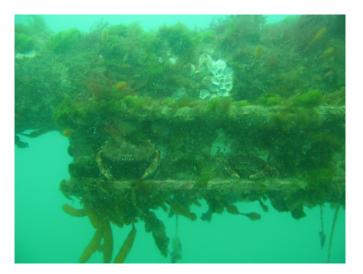
The Cathode Outfall Discharge Structure including the diffuser was inspected on 9<sup>th</sup> December 2011. The structure on inspection was found to be in good condition upright on the seafloor as intended. Growth on the structure was found to be less than other years. It was noticed that Paddle Crabs were feeding on and around the structure which may contribute to the lesser amount of growth.

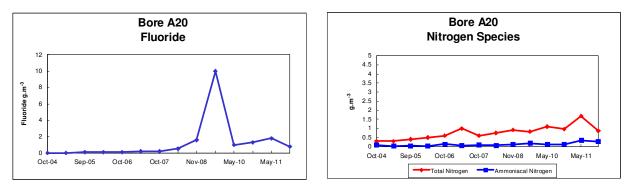
Fluoride, Ammoniacal nitrogen and total nitrogen have stabilised in upstream bore A20 during 2011.

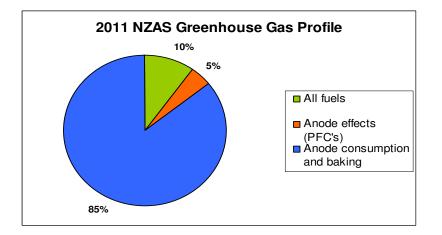
The total calculated  $CO_2$  equivalents are emitted from carbon consumption (anodes), perfluorocarbons generation (PFCs) and fuel usage.
