New Zealand Aluminium Smelters Limited

**Interdepartmental
Committee
Annual Report
2013**

*Report to Environment Southland and the Interdepartmental Committee
on consent monitoring and environmental effects of the
Tiwai Aluminium Smelter for the year ending 31 December 2013*

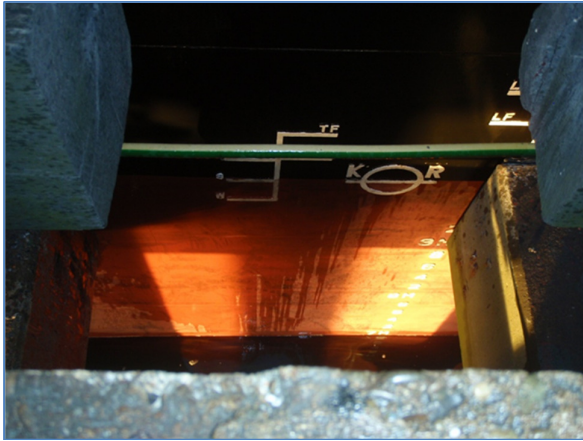
Hydraulic Oil Spill from Ship Unloader at Wharf – 26 March 2013

Due to the failure of a hose fitting, approximately 5 litres of hydraulic oil was released from the ship unloader into the sea when discharging alumina. Oil was also spilt on the wharf, ship unloader, the ship's deck and side. Approximately 40 litres was lost in this incident.

Another type of hose fitting was fitted to prevent this from happening again as it was identified that the original fitting was not best choice for the task.

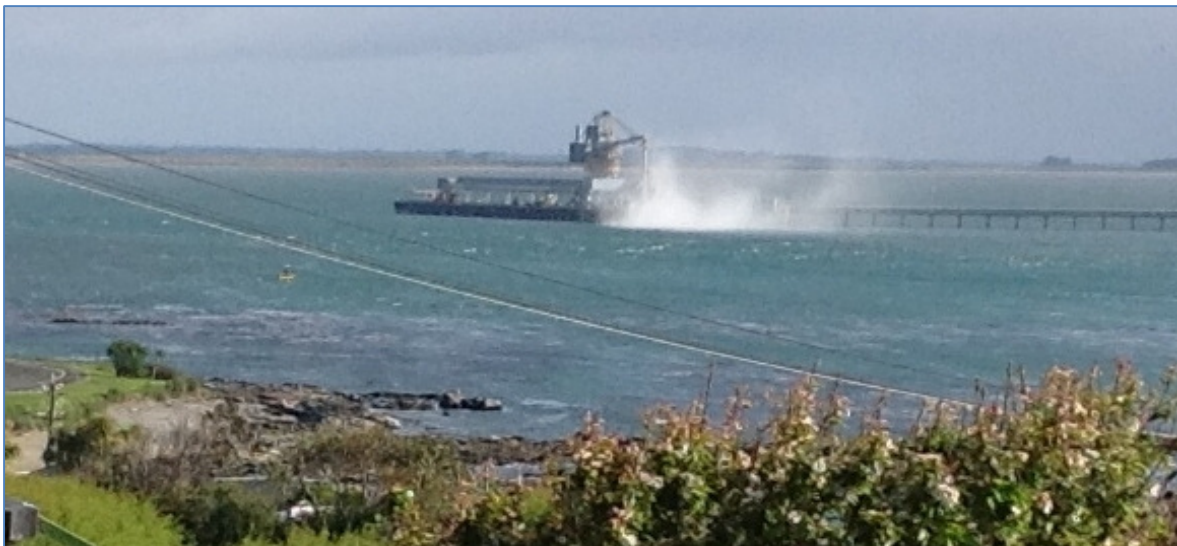
Alumina Spill at Wharf – 1 November 2013

Approximately 110kg of alumina was discharged into the sea and air when a hatch was removed to repair a scraper chain on the alumina conveyor belt. The belt had not been cleaned prior to maintainers opening up the hatch for repair. Modifications to the design of the hatch was been carried out to reduce the risk of alumina spilling when working on the hatch. Checks put in place to ensure the hatch has been cleaned prior to maintaining the equipment.

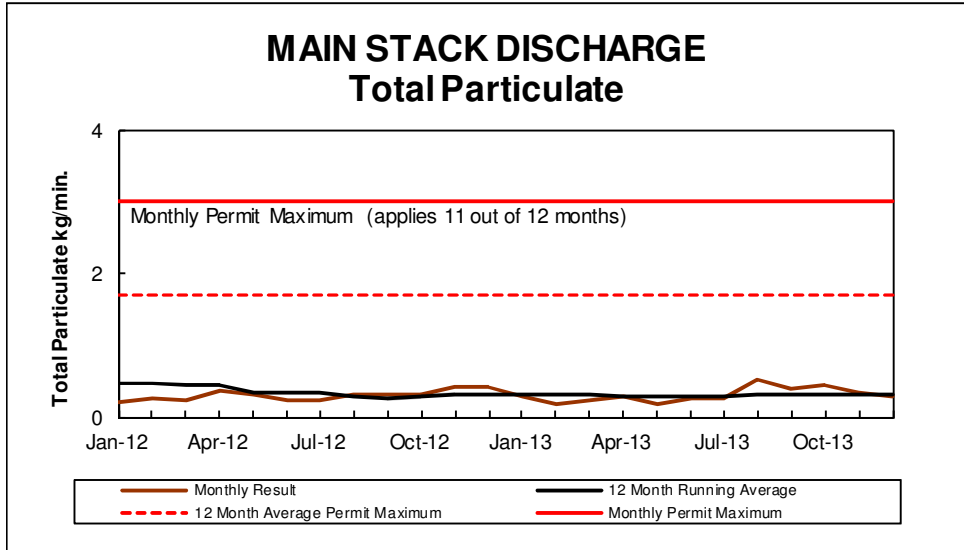
The following graph shows both the average monthly and 12 monthly running average main stack total particulate discharge during 2012 and 2013.

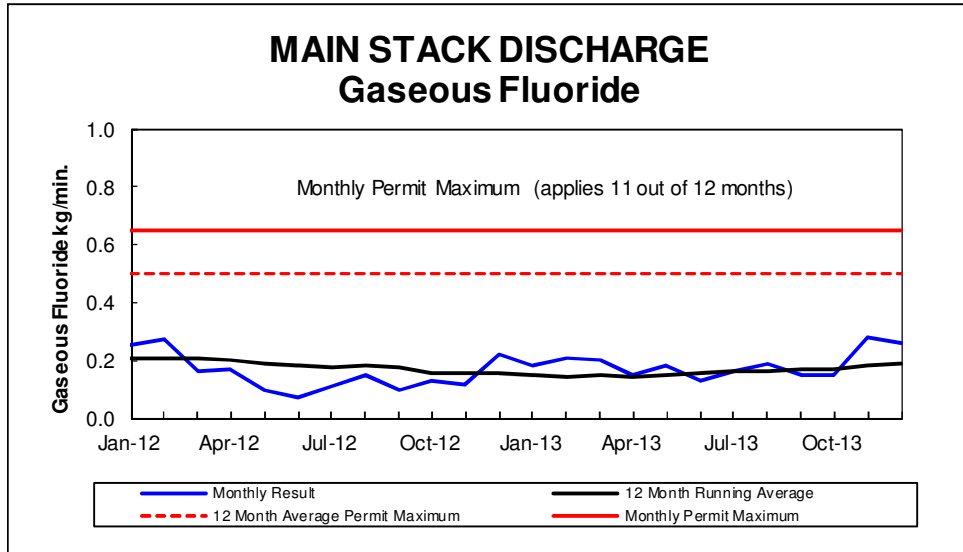
The following graph shows both the average monthly and 12 monthly running average main stack gaseous fluoride discharge during 2012 and 2013.

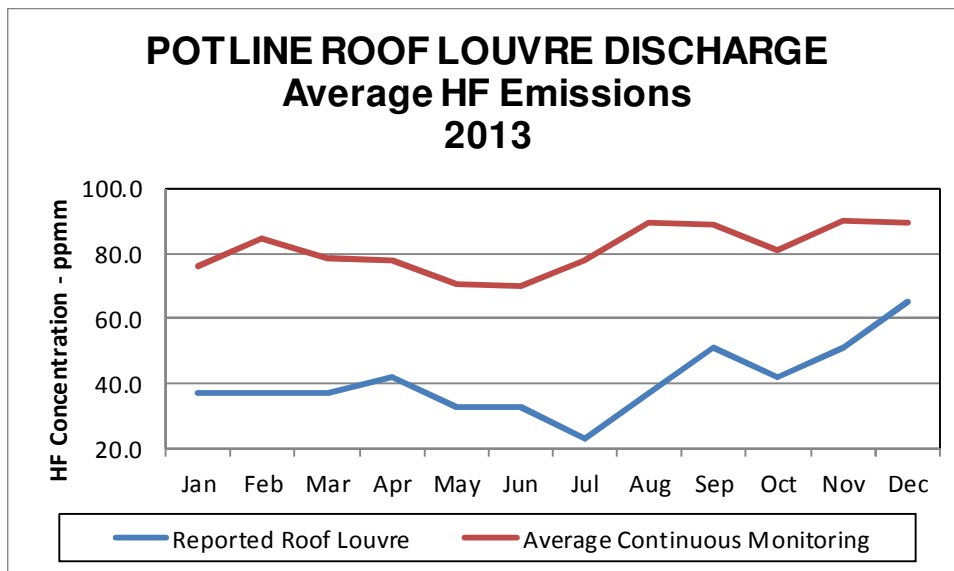
The following graph shows the reported Potline Roof Louvre gaseous fluoride emissions in comparison to the Boreal continuous monitoring results.

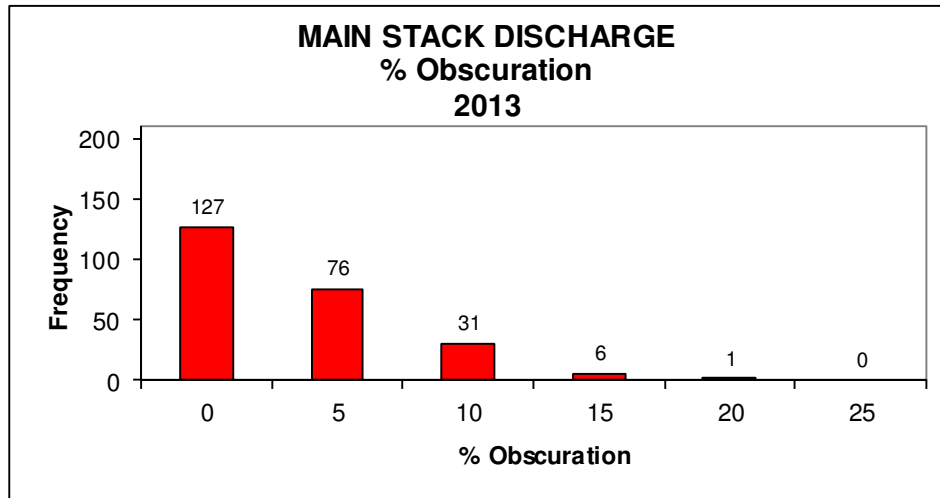
Main Stack smoke discharges were determined by visual observations using the standard Ringleman chart. The following graph summarises the observations recorded during 2013.

During 2013 there was a decrease in the frequency of observations in the 1 to 5% range, a slight increase in the 10% range and no observations greater than 20%. The majority of the observations were 0%.

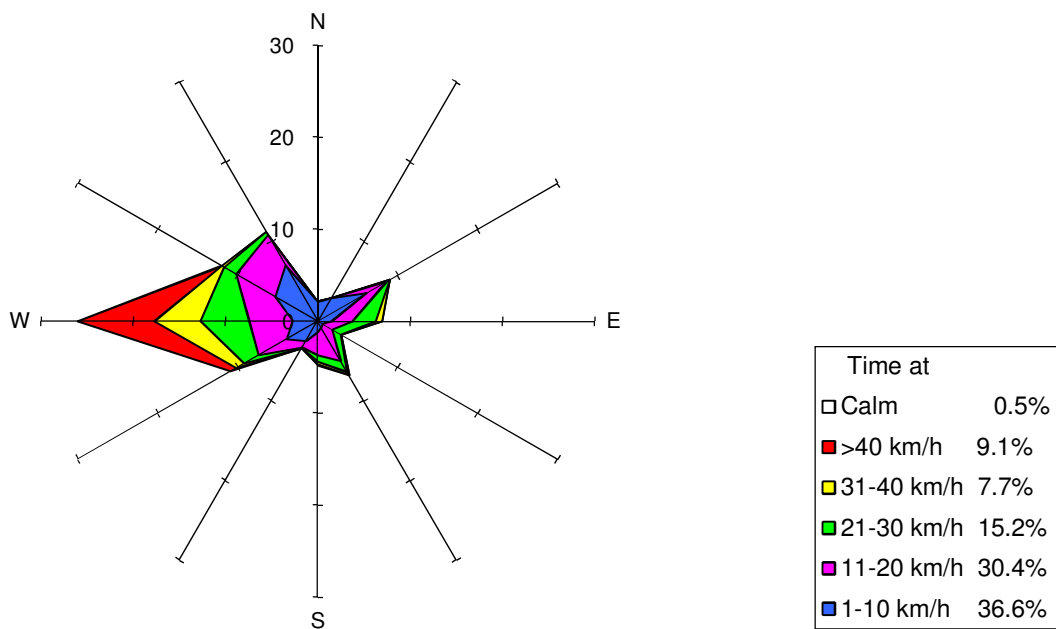
New Zealand Aluminium Smelters Limited - Tiwai Point
Mean Wind Frequency (%) of Surface Wind Directions
Period: 2013

The mean wind frequency diagram on the following page shows that the 2013 wind pattern was dominated by westerly, north-westerly and north-easterly winds. Dispersion conditions are similar to previous years.

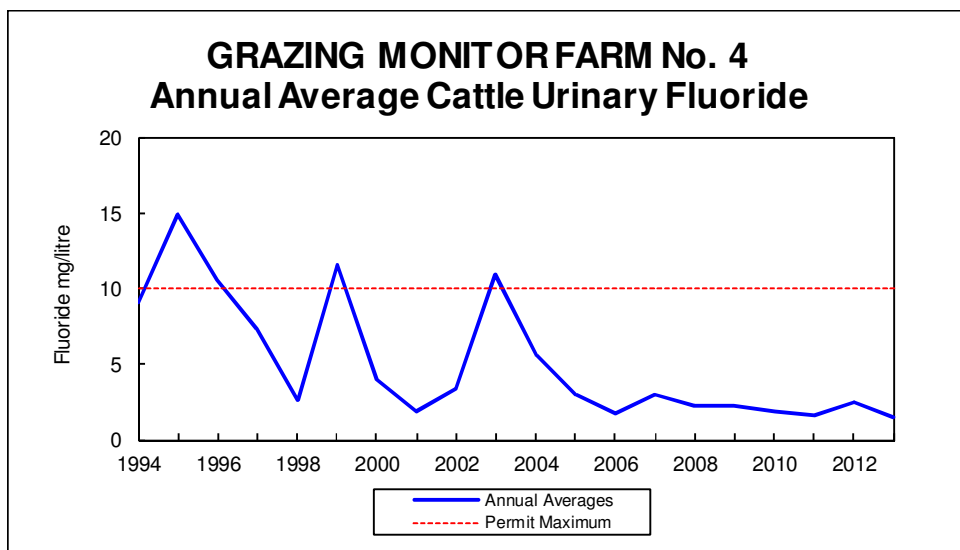
The following graph shows the annual average fluoride concentration in cattle urine.

The annual average urinary fluoride concentration measured during 2013 was 1 mg/L similar to the average measured during 2012. It should be noted that this farm is now a dairy farm and not all the stock remains on the farm over the winter.

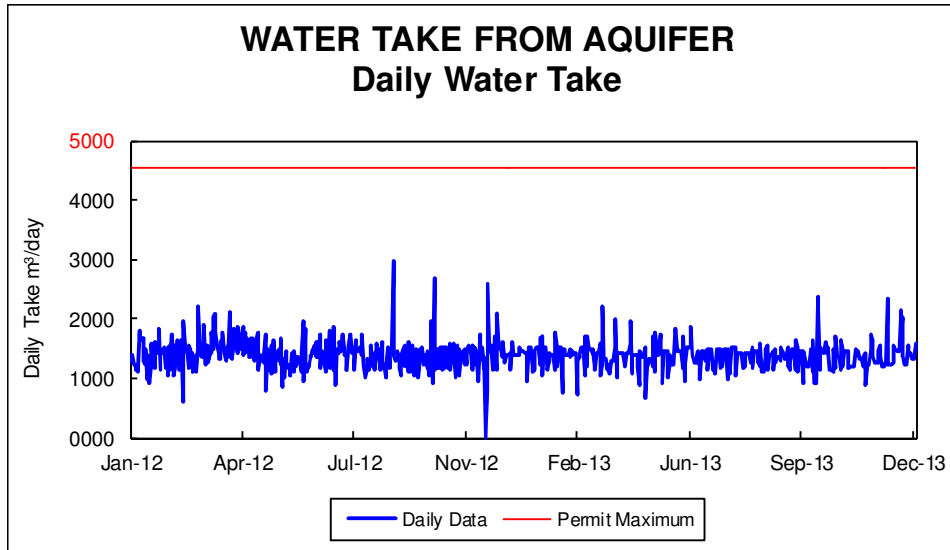
The total volume of water taken from the aquifer was recorded daily until early December 2012. Due to organisational restructuring the readings are no longer done in the weekends or public holidays. The practice now is to take the reading on the first available day and record the average. The data is displayed in the graph below.

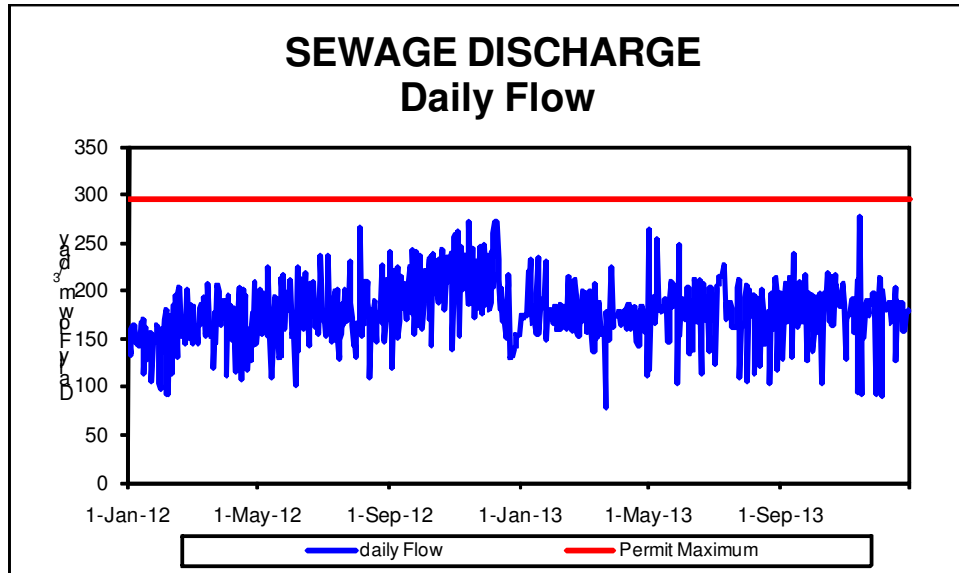
The following graph shows the daily sewage discharge flow during 2012 and 2013. The permit limit for daily flow is 295 m³/day.

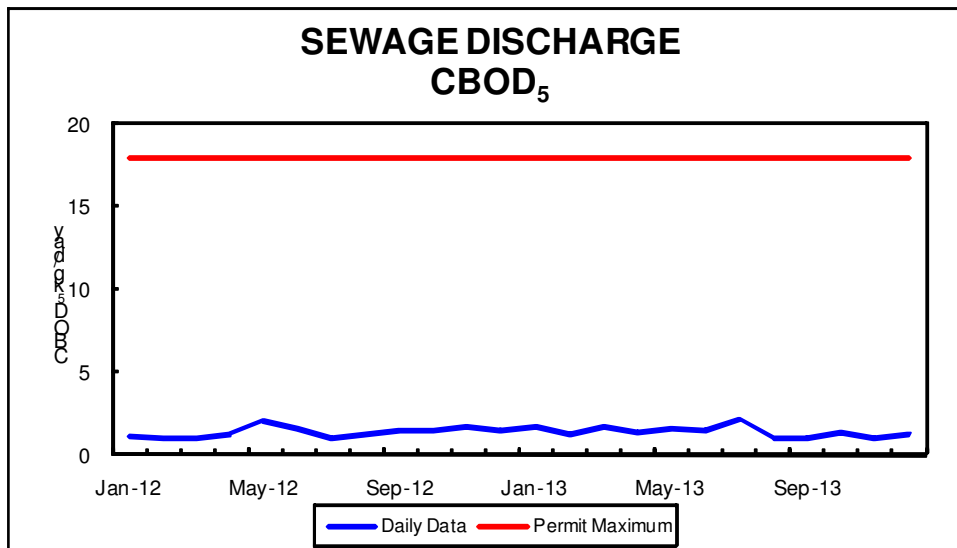
The following graph shows the monthly carbonaceous biochemical oxygen demand (CBOD₅) discharge from the sewage treatment plant during 2012 and 2013. The permit limit for CBOD₅ is 18kg/day.

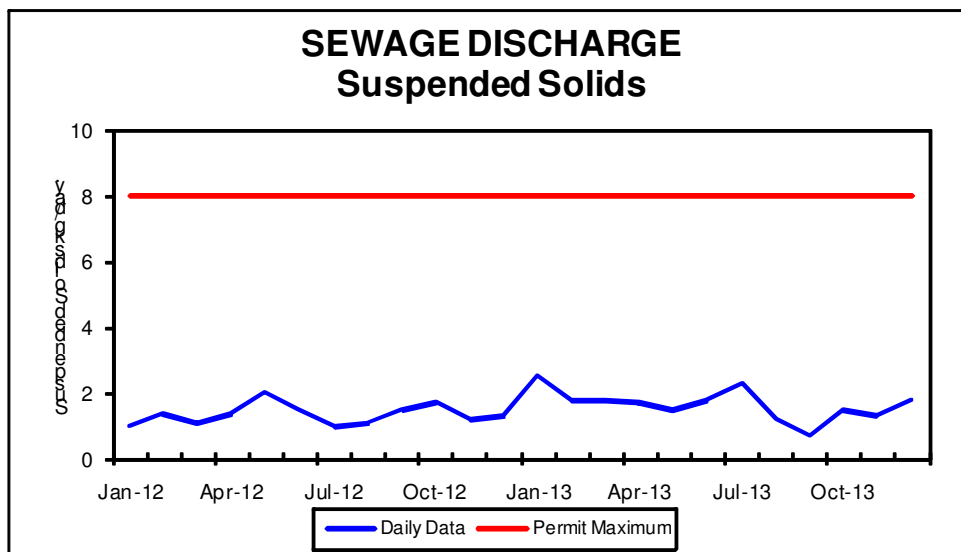
The following graph shows the monthly suspended solids discharge from the sewage treatment plant during 2012 and 2013. The permit limit for suspended solids is 8 kg/day.

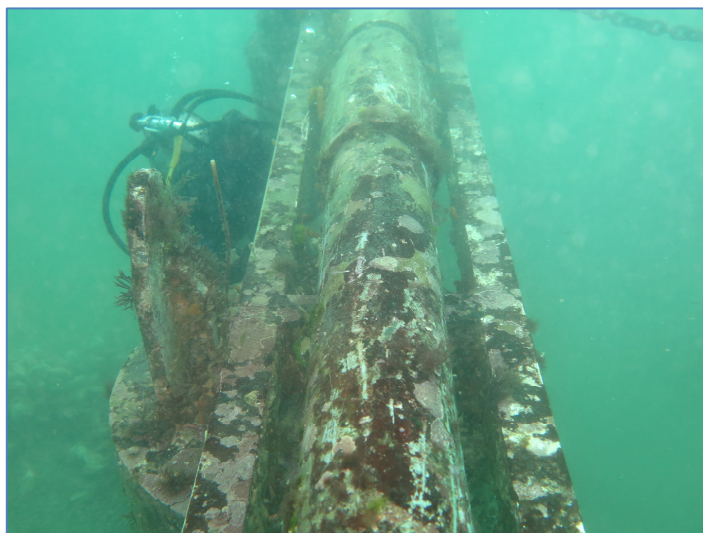
Condition of the diffuser

The Cathode Outfall Discharge Structure including the diffuser was inspected on 23rd November. The structure on inspection was found to be in good condition upright on the seafloor as intended. Growth on the structure was found to be similar to other years. The structure was scraped clean making sure to leave any small snails in place. These seem to stop the sea tulips attaching themselves to the structure. All discharge tubes were cleaned of growth and blockages removed.
