New Zealand Aluminium Smelters Limited

Annual Environmental Monitoring Report 2018

*Report to Environment Southland
on consent monitoring and environmental effects of the
Tiwai Aluminium Smelter for the year ending 31 December 2018*

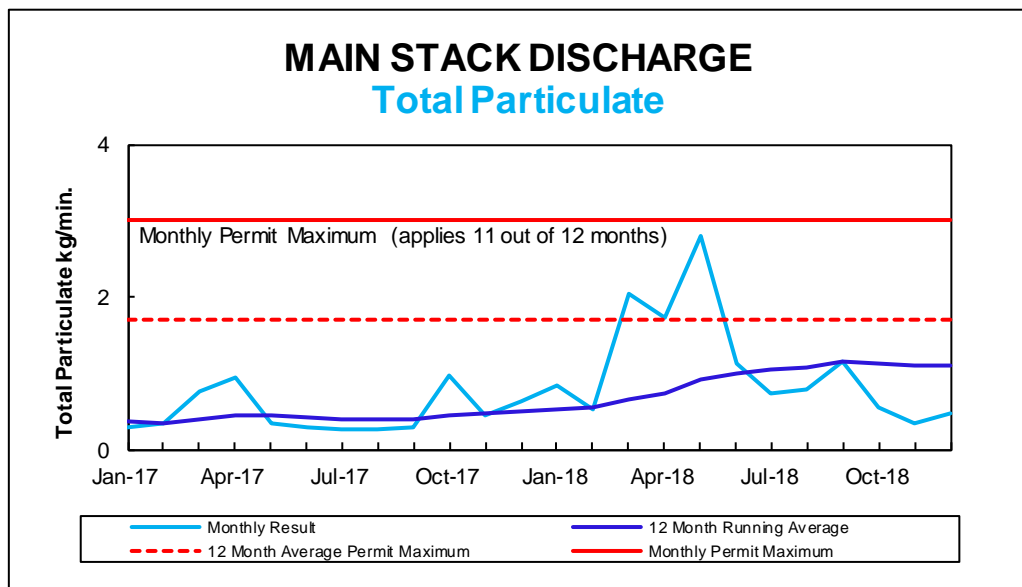
The following graph shows both the average monthly and 12 monthly running average main stack total particulate discharge during 2017 and 2018.

The discharge of total particulate, sulphur dioxide, particulate fluoride and gaseous fluoride from the Stack were within permit limits for 2018. Total particulate has increased significantly over the last 2 years.

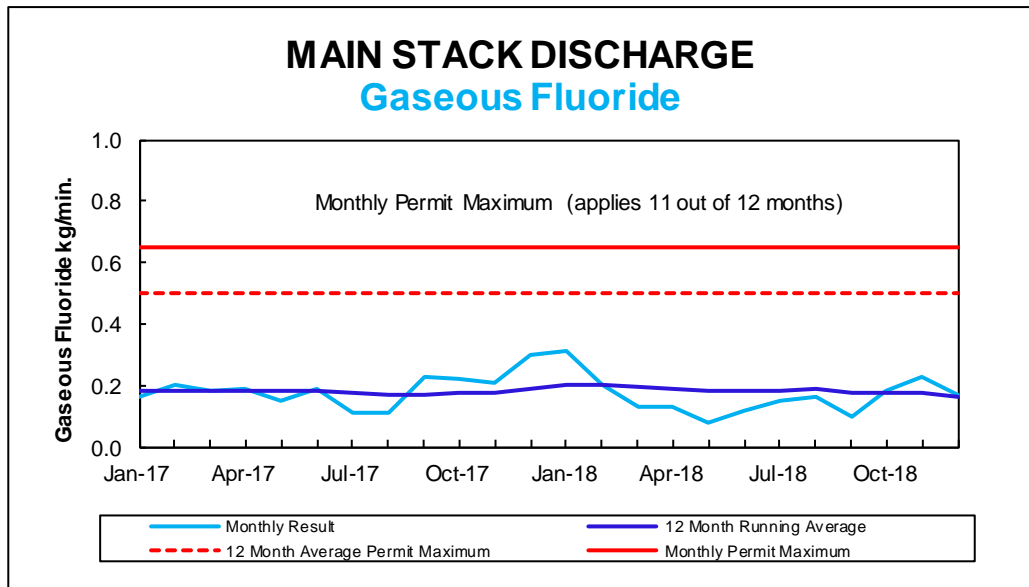
The following graph shows both the average monthly and 12 monthly running average main stack gaseous fluoride discharge during 2017 and 2018.

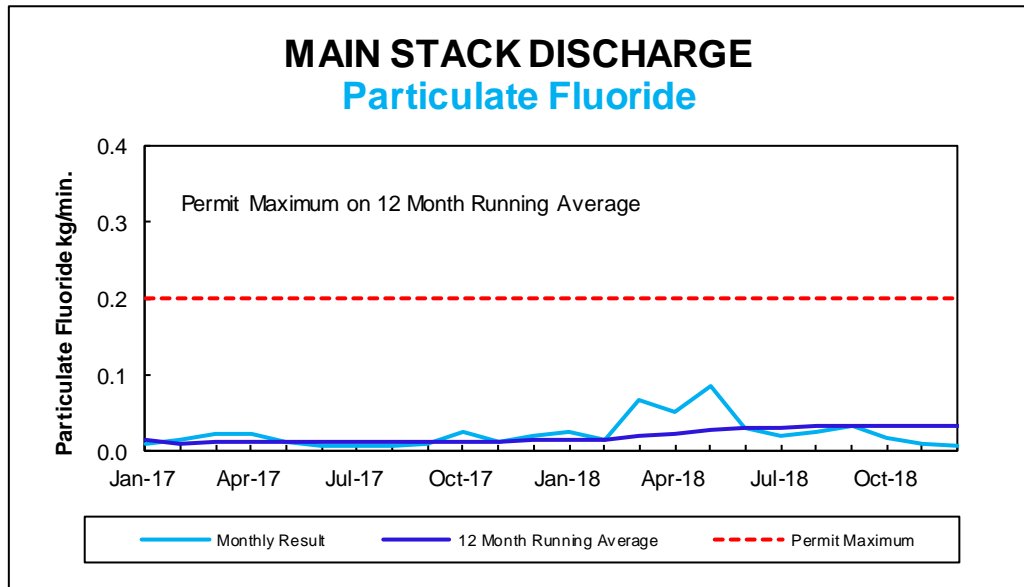
The following graph shows both the average monthly and the 12 monthly running average main stack particulate fluoride discharge during 2017 and 2018.

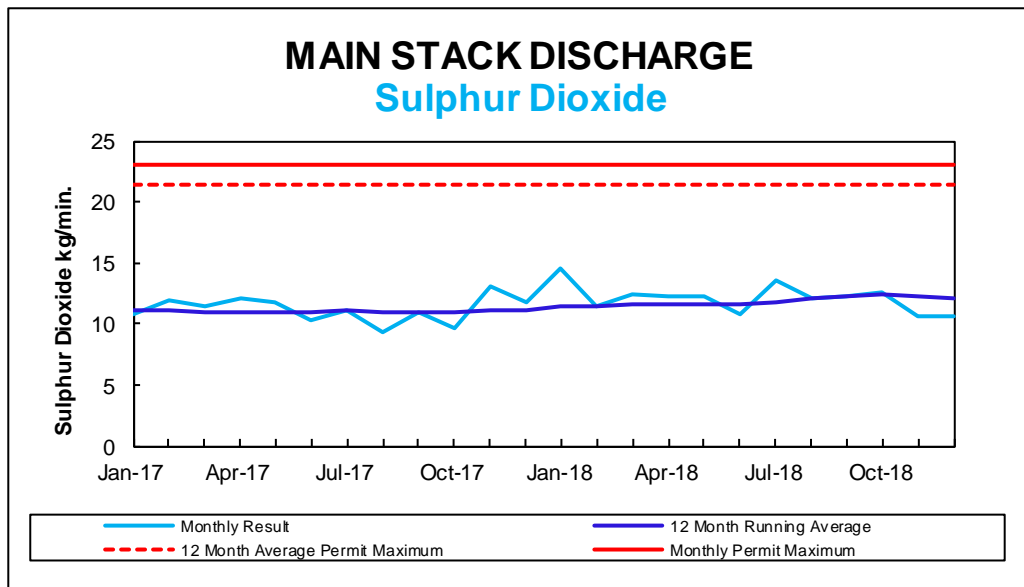
The following graph shows both the average monthly and 12 monthly running average main stack sulphur dioxide discharge during 2017 and 2018.

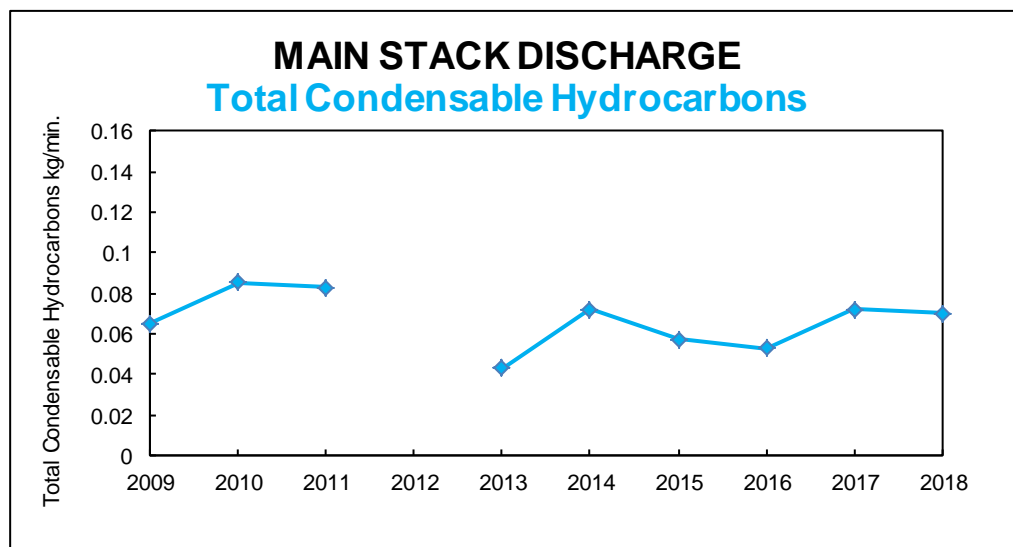
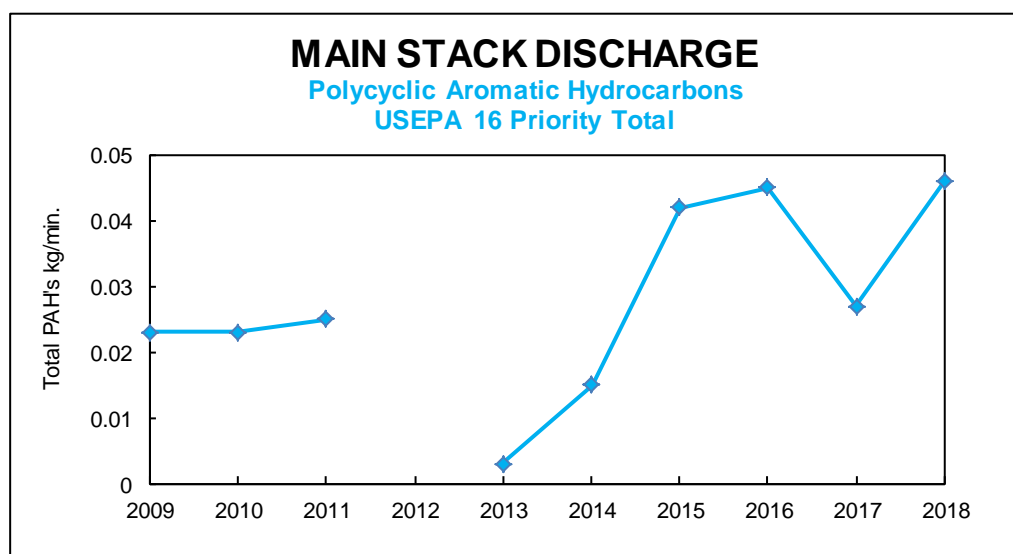
Total Condensable Hydrocarbons and Polycyclic Aromatic Hydrocarbons

The level of total condensable hydrocarbons (TCH) has remained at the level found in 2017. The levels of the 16 USEPA priority PAH's has risen back to levels found in 2015 and 2016. No TCH and PAH monitoring was undertaken in 2012.

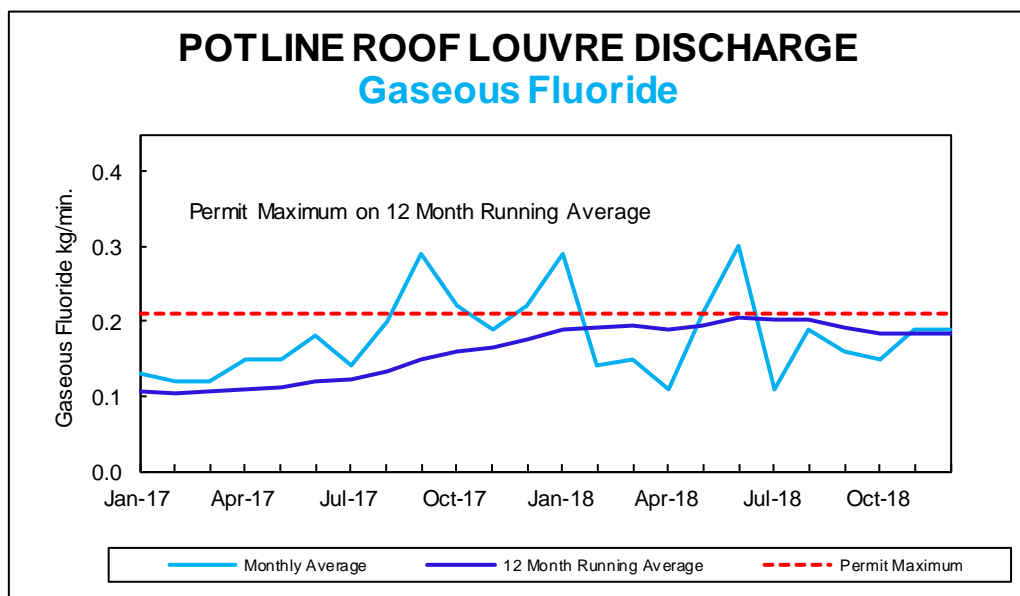
The following graph shows both the average monthly and 12 month running average Potline roof louvre gaseous fluoride discharge during 2017 and 2018.

High Gaseous Fluoride emission levels are still being closely monitored. Vigilant work by Reduction Line Process Controllers on ensuring adequate draft is continuously applied to reduction cells continues to be a high priority. Investigations into other causes for these high emissions are continuing.

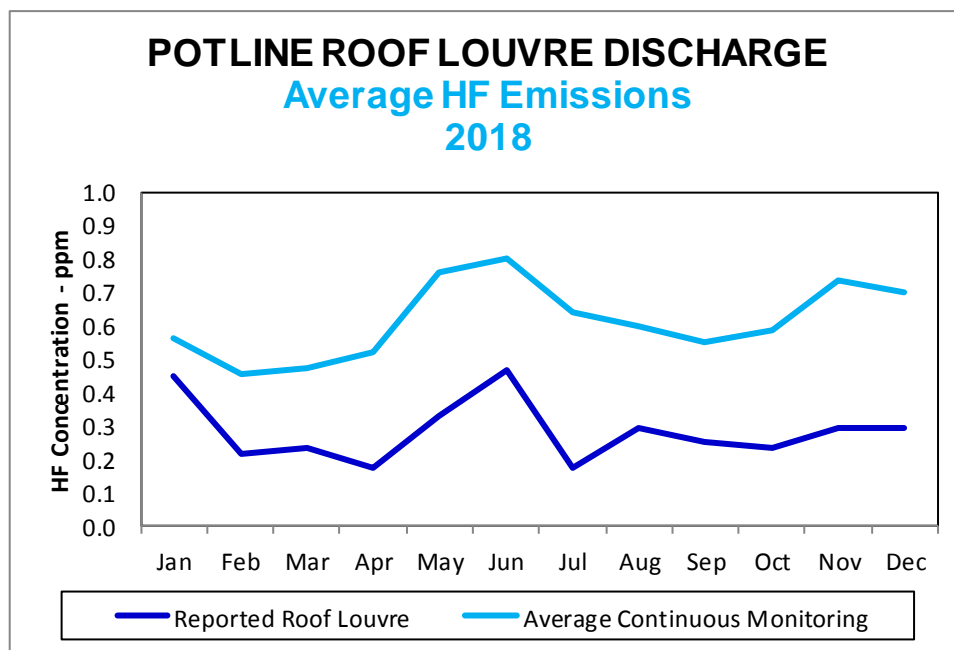
The following graph shows the reported Potline Roof Louvre gaseous fluoride emissions in comparison to the Boreal continuous monitoring results.

Both measurement systems trend each other consistently. The difference in the reported roof louvre emissions and the continuous monitoring instrument data (Boreal) is consistent with the difference measured between these two systems since the Boreal instruments were installed in 2008.

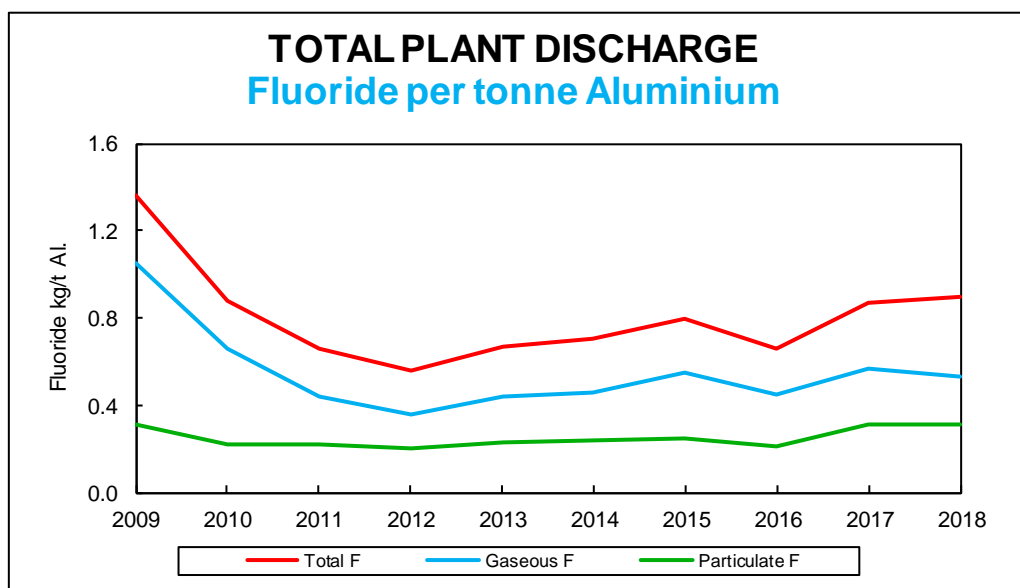
The following graph shows the average total plant fluoride per tonne aluminium for the last 10 years.

The annual total fluoride discharge rate per tonne of aluminium produced, from the plant for 2018, remains similar to 2017.

Since 2012 a trend of increased fluoride discharge is observed.

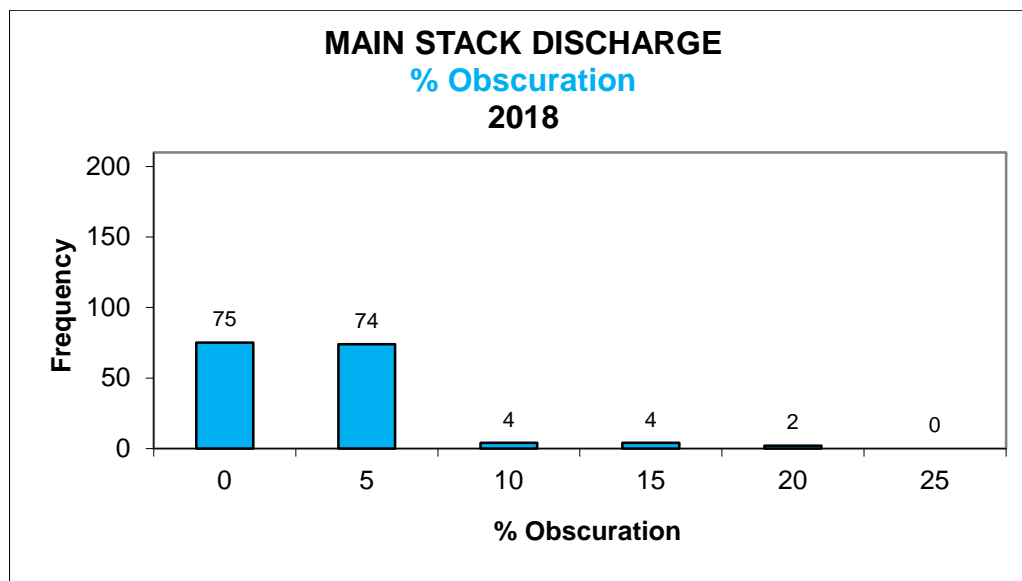
Main Stack smoke discharges were determined by visual observations using the standard Ringlemann chart. The following graph summarises the observations recorded during 2018.

It must be noted that there is no data for January and February 2018 due to the loss of the field record book. For the remaining 10 months, the majority of observations were in the 1 to 5% range. Only on four occasions was an observation in the 10% range made and on four occasions an observation in the 15% range.

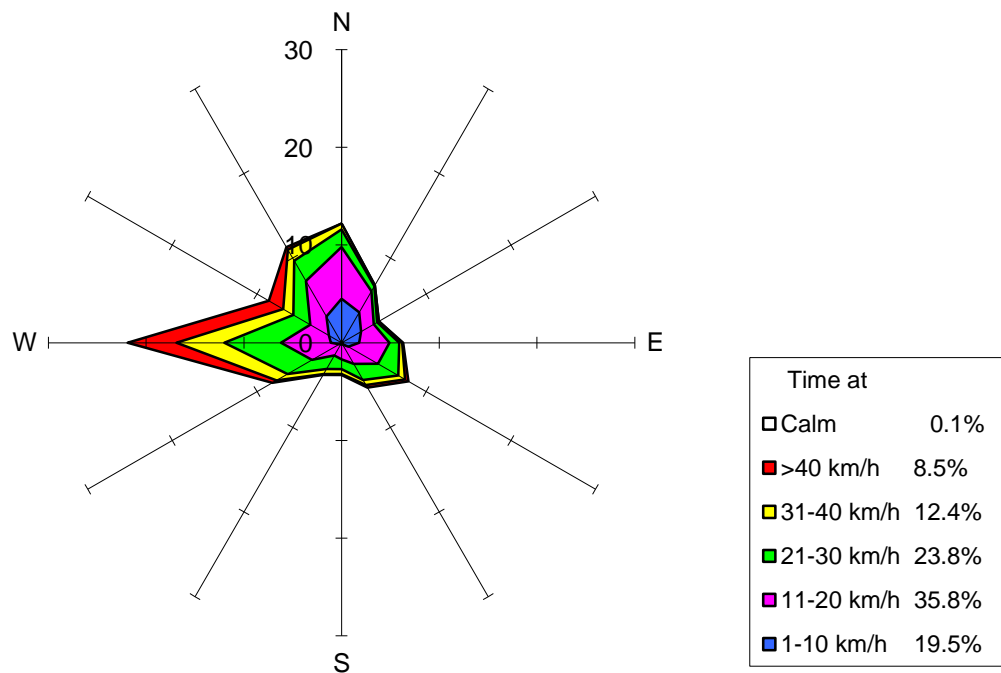
**New Zealand Aluminium Smelters Limited - Tiwai Point
Mean Wind Frequency (%) of Surface Wind Directions
Period: 2018 Annual**

The mean wind frequency diagram shows that the 2018 wind pattern was dominated by westerly winds with some moderate winds from the north.

Dispersion conditions are in general similar to the previous 2 years.

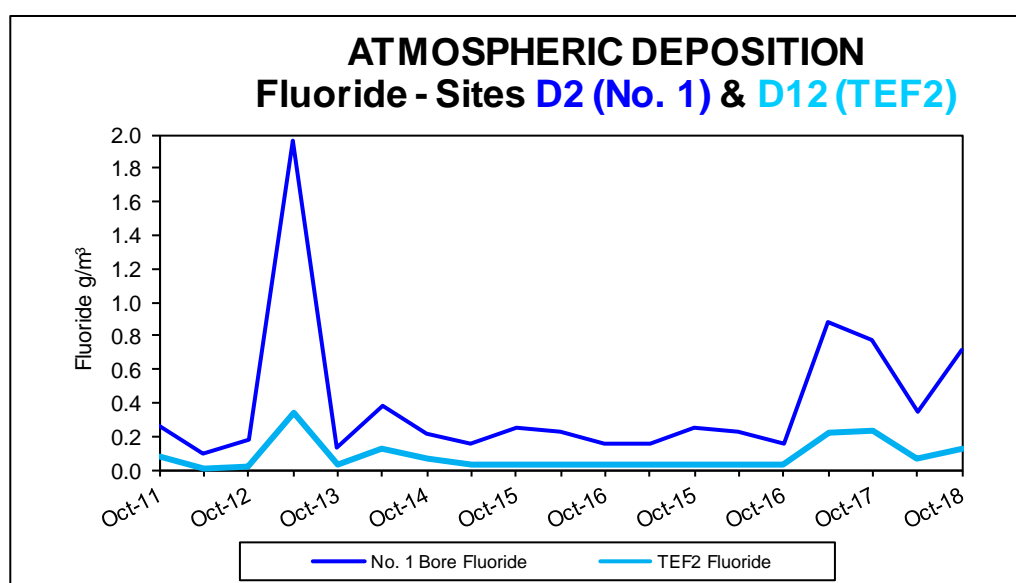
The following graph shows the last 10 years results for Sites D2 and D12.

Fluoride levels at both sites show a drop during March this year due to an above long term average rainfall of 94mm and low roof louvre emissions. Elevated Fluoride concentrations during October reflect very dry conditions with only 54mm of rain, half the long term average, as well as higher roof louvre emissions.

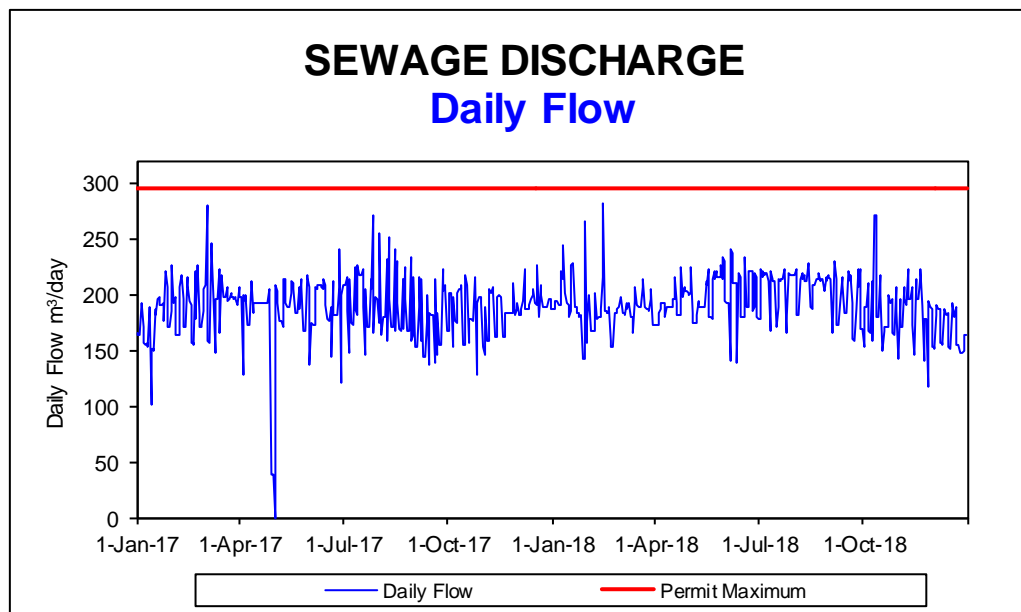
The following graph shows the daily sewage discharge flow during 2017 and 2018. The permit limit for daily flow is 295m³/day.

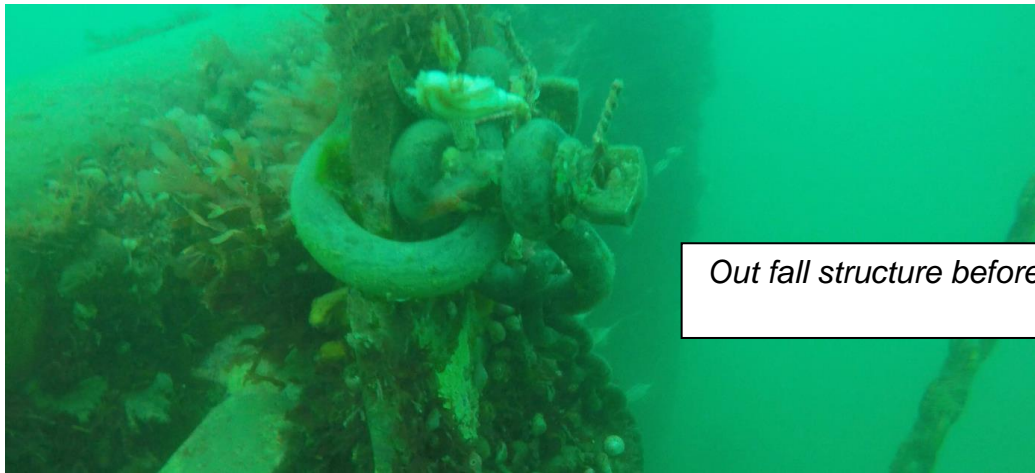
Out fall structure before cleaning

The Cathode Outfall Discharge Structure including the diffuser was inspected on the 5th of March 2018. Overall the structure was found to be in good condition in an upright position on the seafloor as intended with all above parts having between 65-75% of their life remaining until replacement will be needed.

Growth on the structure was found to be similar to other years. The structure was scraped clean, making sure to leave any small snails and shell fish in place as they eat a large portion of the weed that would normally grow during the course of the year. All discharge tubes were cleaned of growth and blockages removed.

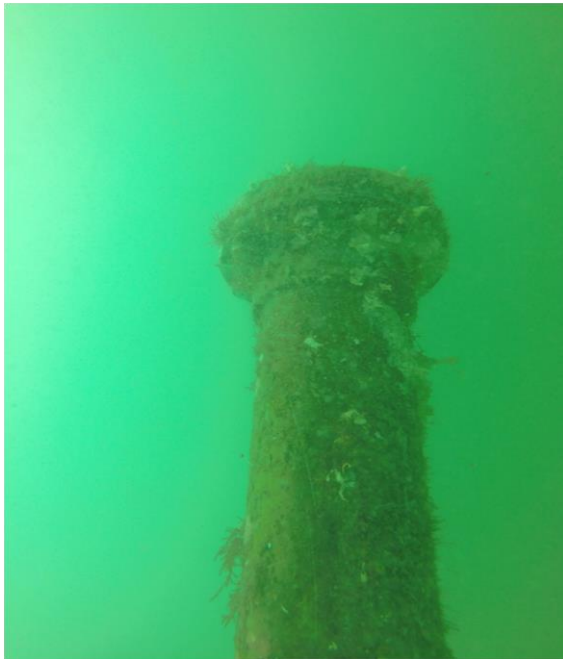
Main diffuser pipe after cleaning

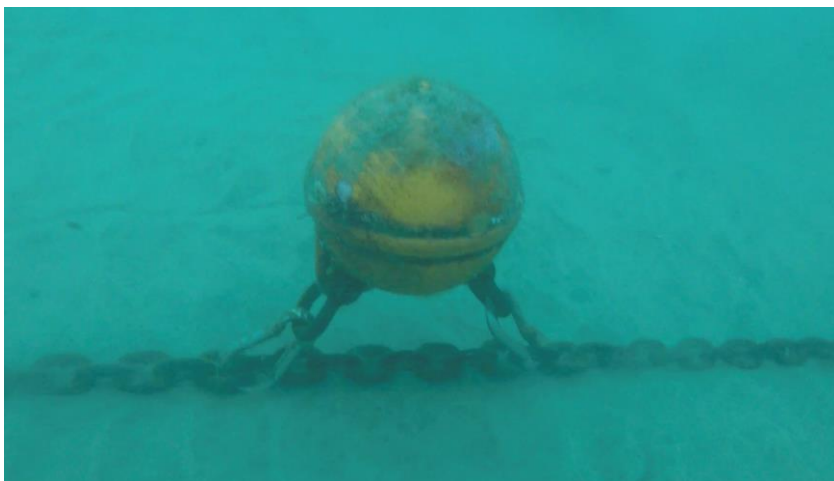
New chain in place

The chain was subsequently replaced on the 25th of July 2018. The zincs, shackles as well as buoy attachment points were found to be in a serviceable condition and were reinstated on the new chain.

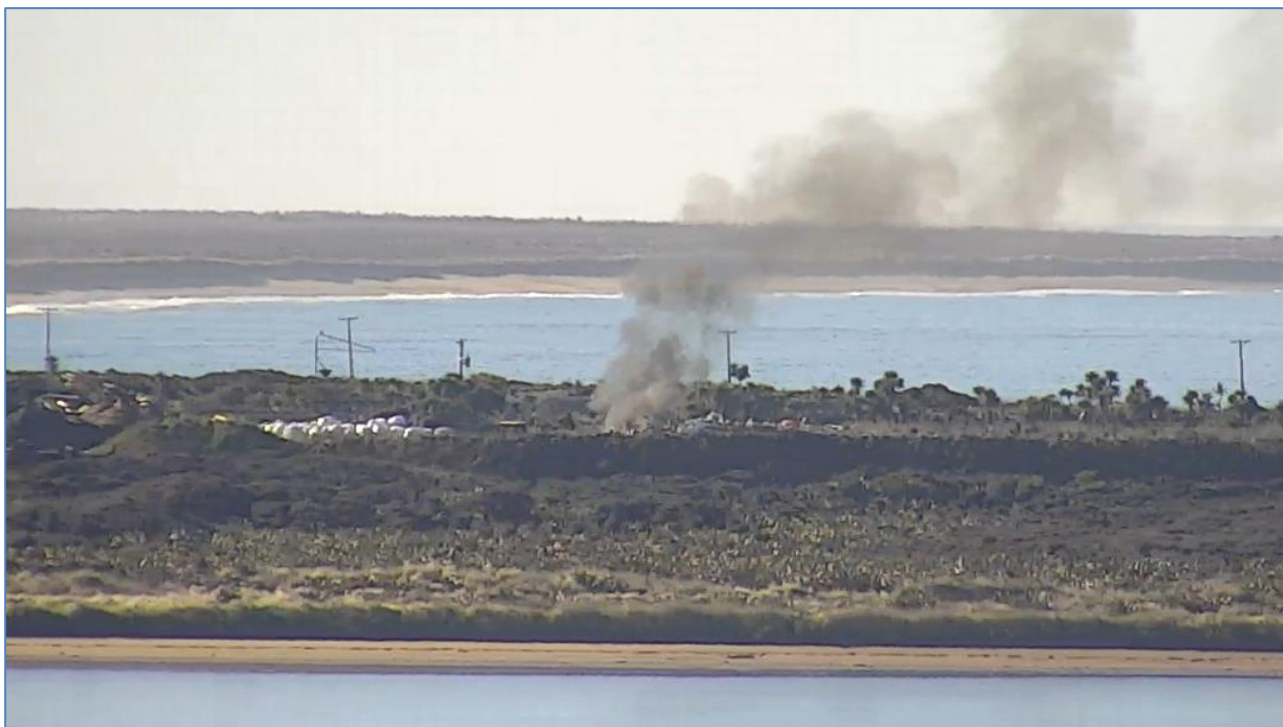
A small fire occurred in the general waste cell on 4th of September 2018. The course of the fire is not known. It was a very hot and sunny day and perhaps some easy combustible material started the fire in the pile. The fire was quickly brought under control by the NZAS fire brigade and extinguished within an hour.

The face was worked from the west to the east along the access road. The long term intentions are to increase the height of the area rather than enlarge the foot print. The general waste area was progressively capped with pea gravel as per the Landfill Management Plan.

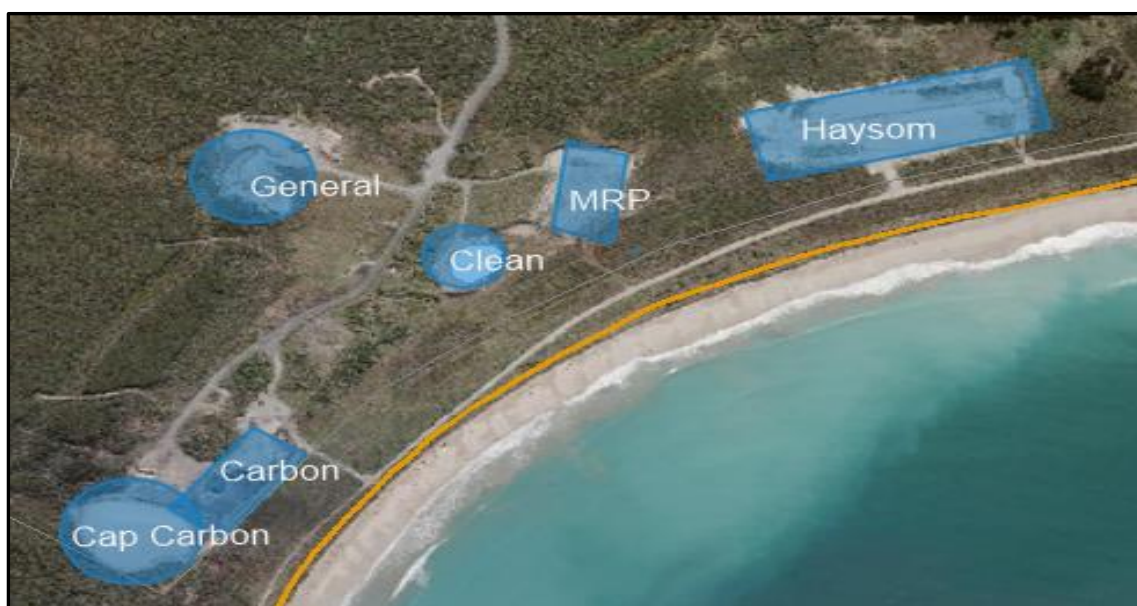
Since December 2013 TrueSouth Surveyors have performed an aerial drone survey of the NZAS landfill using UAV and photogrammetry. This method provides orthometric photos from which volume increases of the various stockpiles can be calculated. The first year data using this method was reported was 2014. The following areas are surveyed annually:

- general waste,
- clean fill,
- carbon,
- MRP dross, and
- Haysom's dross (control site)

The December 2018 survey provided the following estimates for volumes of material deposited during 2018:

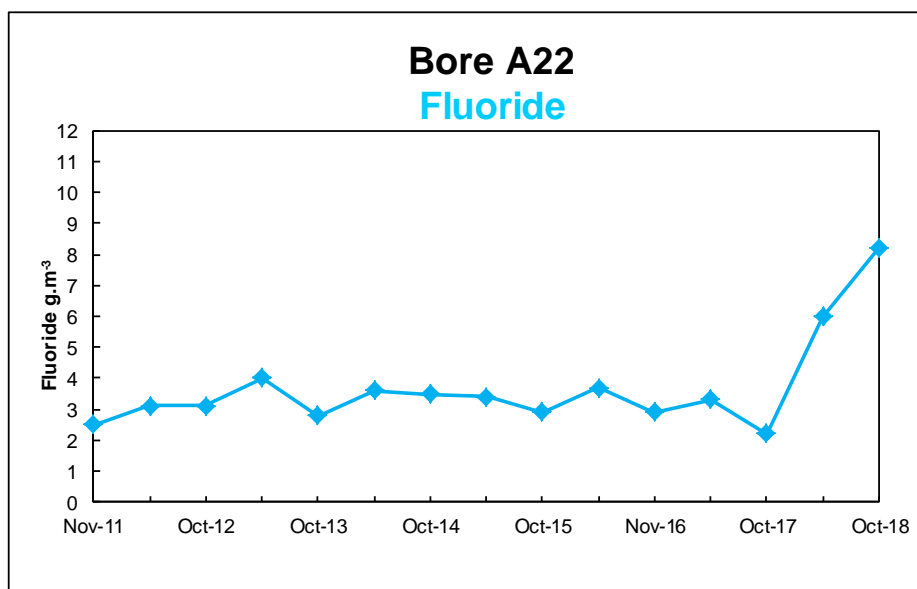
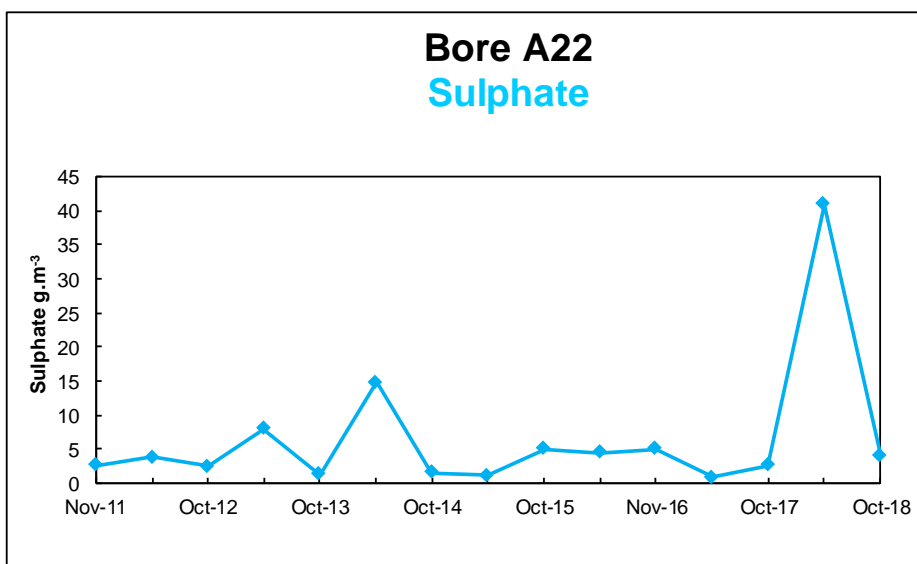
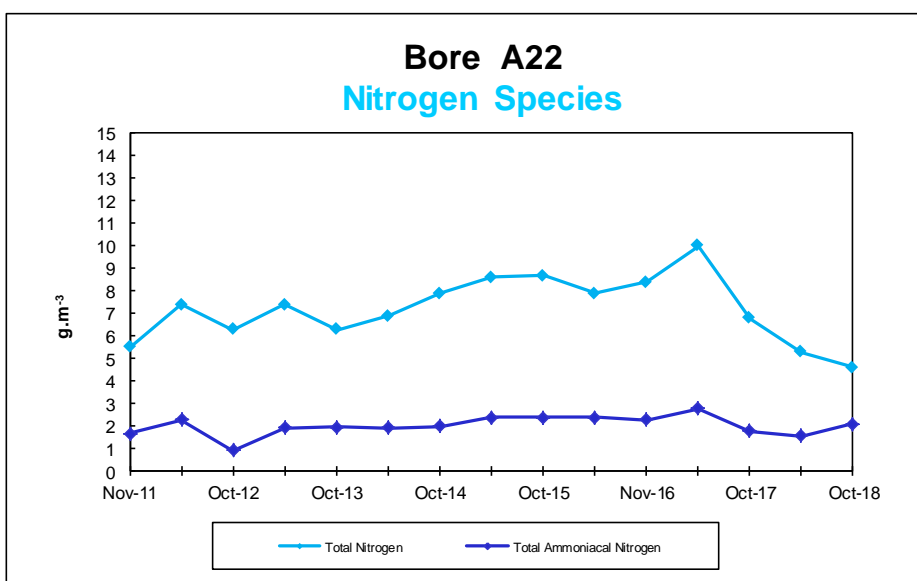
Highest level of fluoride and iron ever recorded for bore A22. There was a fire in the landfill in September 2018 near this bore which may have influenced the sampling performed in October 2018.

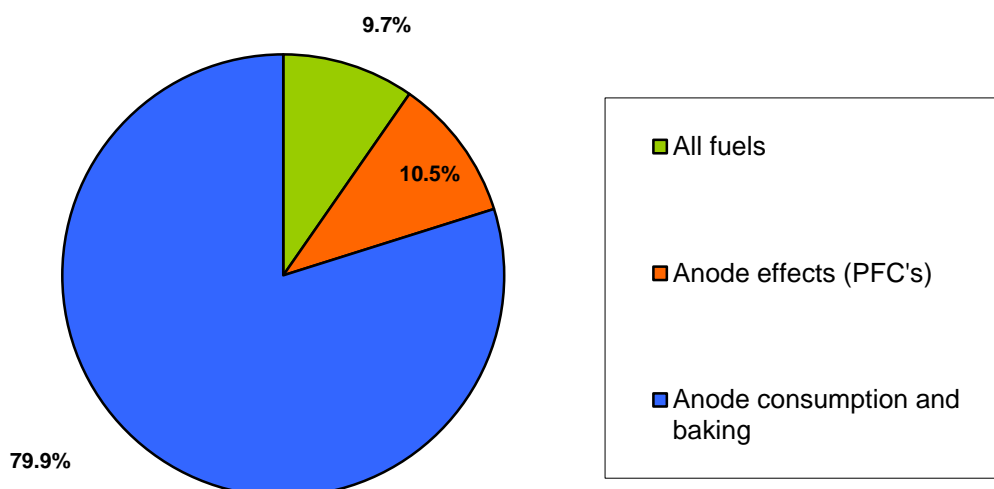
2018 NZAS Greenhouse Gas Profile

The total calculated CO₂ equivalents are emitted from carbon consumption (anodes), perfluorocarbons generation (PFCs) and fuel usage. The percentage distribution is displayed on the next page.

A 2% total increase to the emissions contributed from anode baking and consumption was observed in 2018. The main reason was the start-up of 44 cells in Potline 4 which had been idle for several years. Emission of greenhouse gases during the production of aluminium is unavoidable as the consumption of carbon anode blocks form part of the chemical process to produce aluminium. However emissions can be minimised by manufacturing high quality anodes and ensure that they are not burning when in contact with air in the cells (airburn).
