New Zealand Aluminium Smelters Limited

**REPORT TO THE INTERDEPARTMENTAL COMMITTEE
ON ENVIRONMENTAL EFFECTS OF THE TIWAI ALUMINIUM SMELTER
FOR THE YEAR ENDING 31 DECEMBER 1995**

**MEETING AT TIWAI
14 MAY 1996**

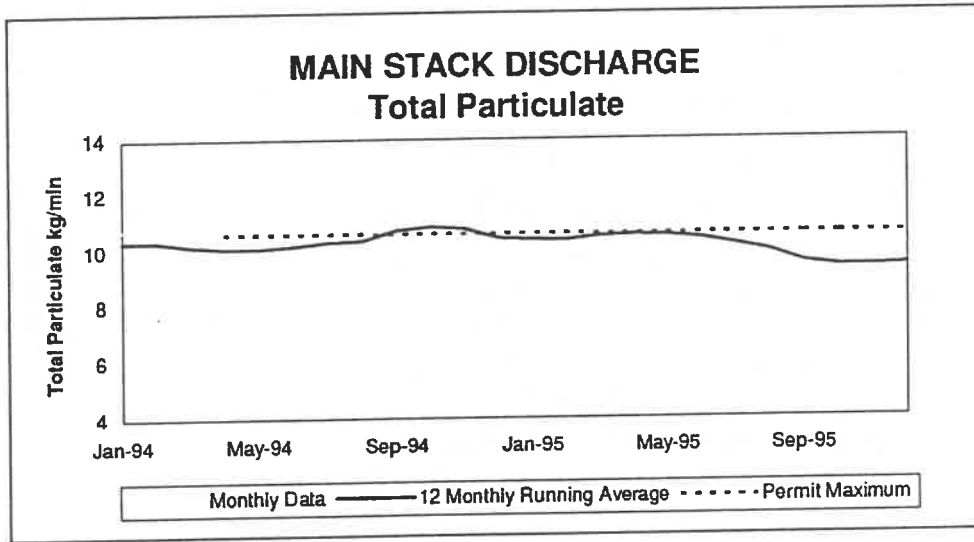
The following graph shows both the average monthly and twelve month running average main stack total particulate discharge during 1994 and 1995.

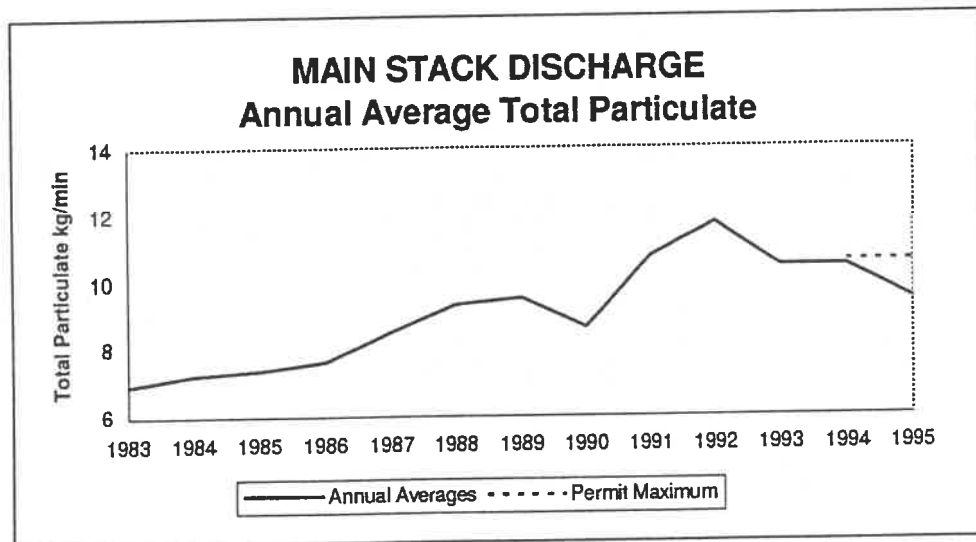
The following graph shows the annual average main stack total particulate discharge.

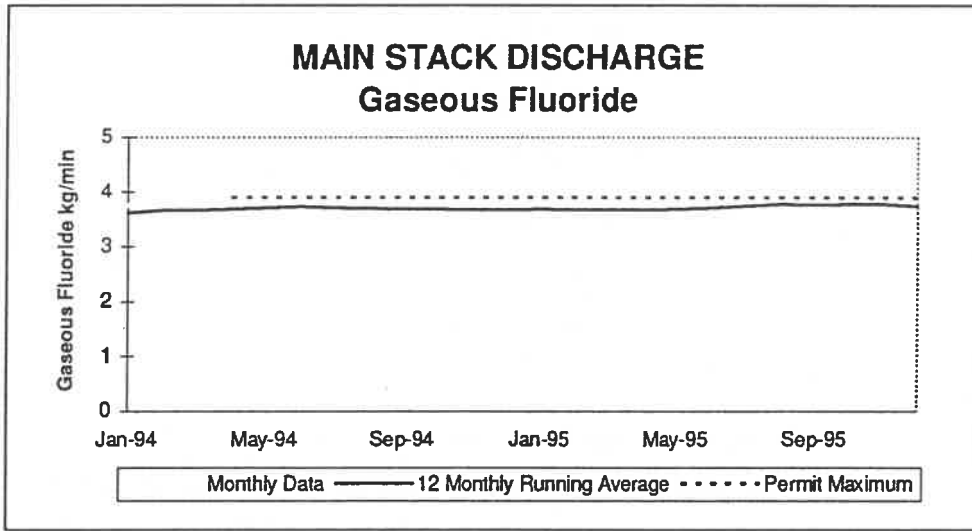
The following graph shows both the average monthly and twelve month running average main stack gaseous fluoride discharge during 1994 and 1995.

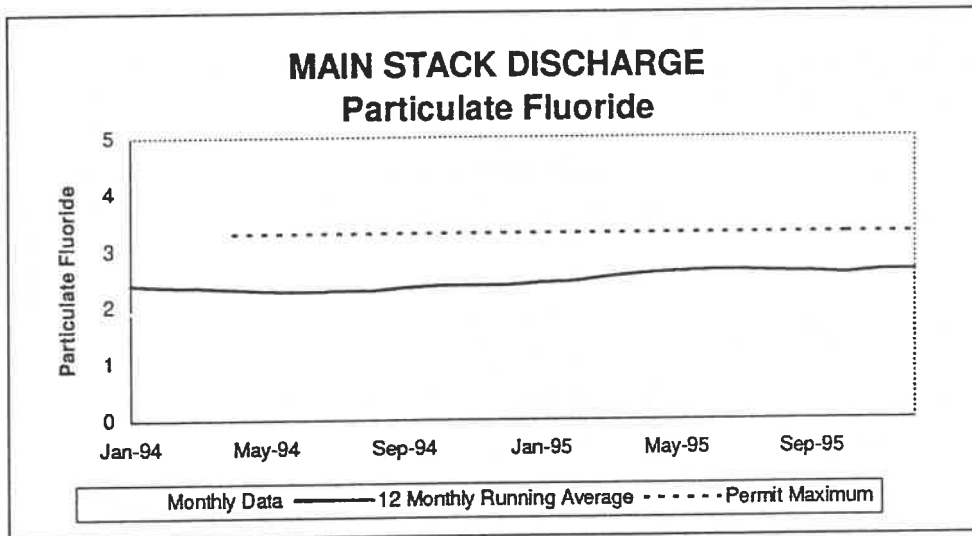
The following graph shows both the average monthly and twelve month running average main stack particulate fluoride discharge during 1994 and 1995.

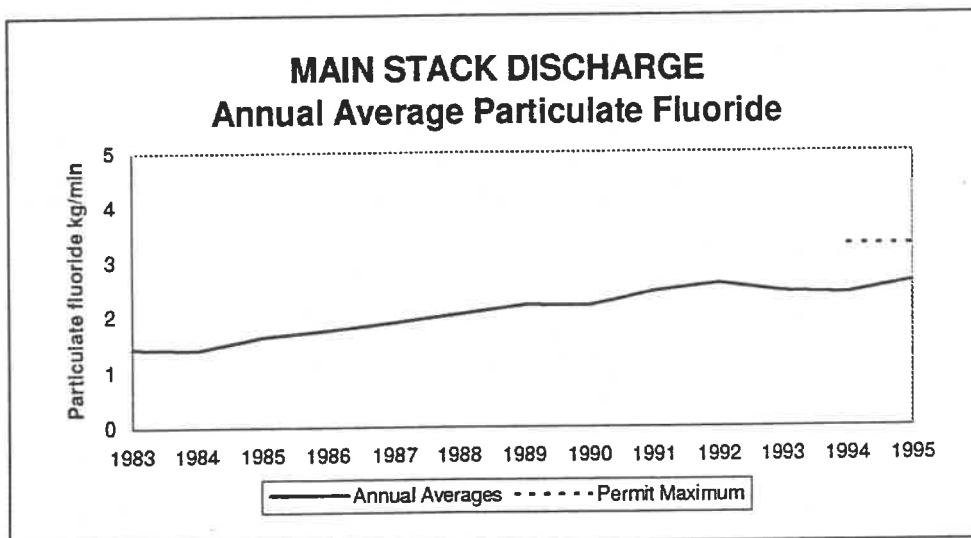
The following graph shows the annual average main stack particulate fluoride discharge.

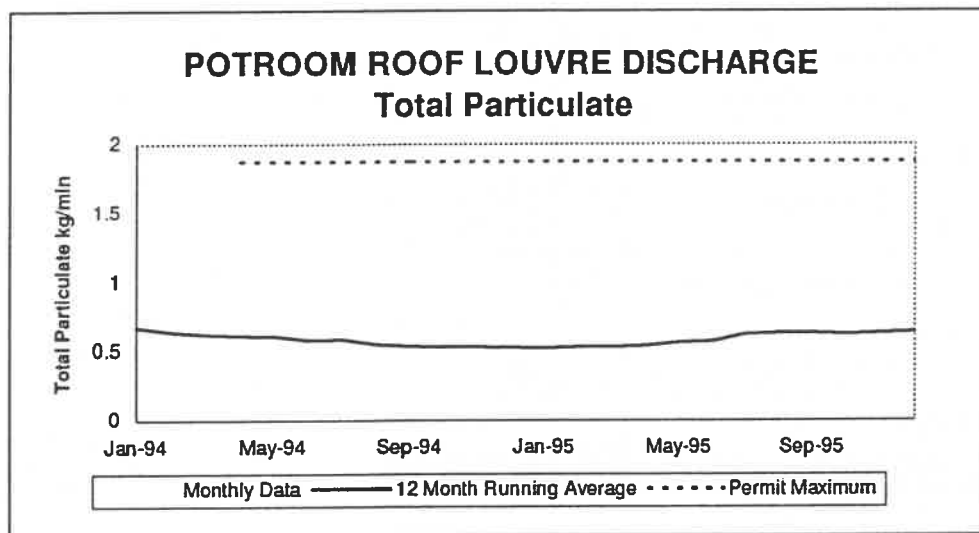
The following graph shows both the average monthly and twelve month running average potroom roof louvre total particulate discharge during 1994 and 1995.

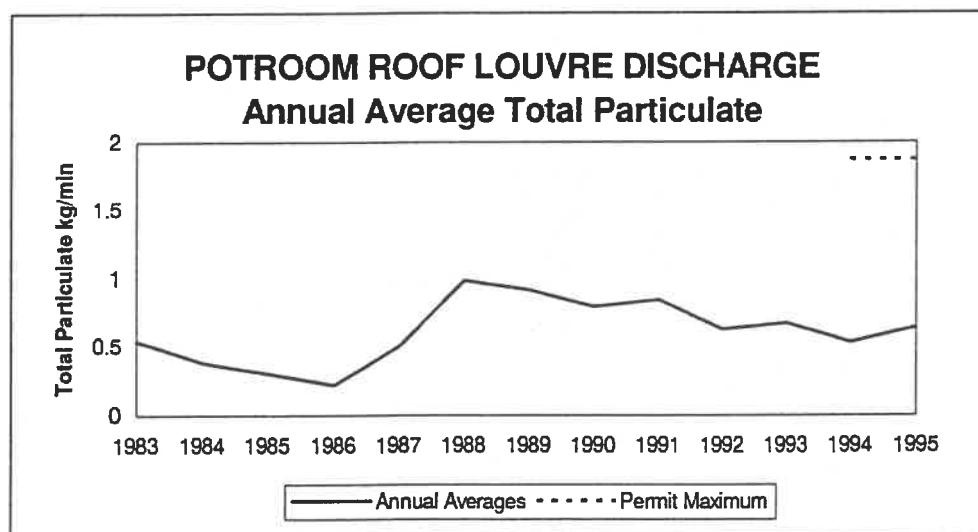
The following graph shows the annual average potroom roof louvre total particulate discharge.

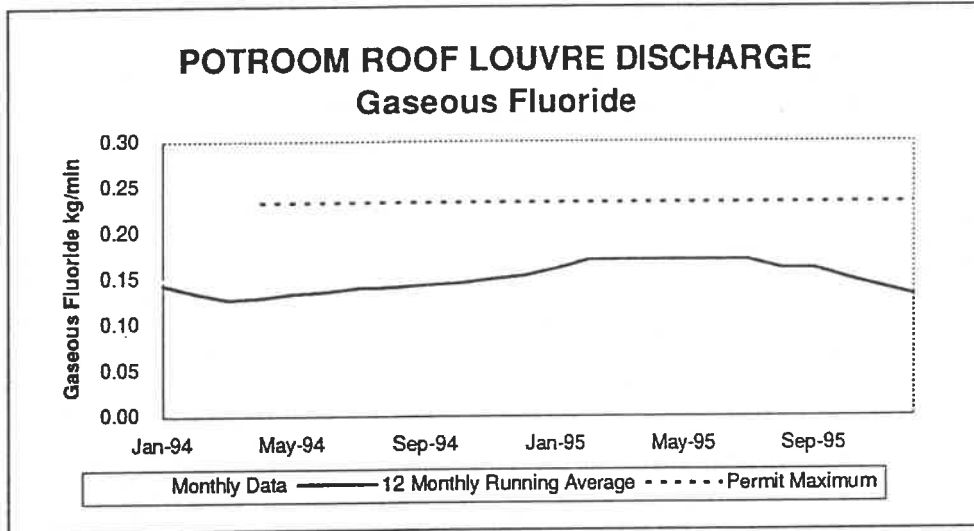
The following graph shows both the average monthly and twelve month running average potroom roof louvre gaseous fluoride discharge during 1994 and 1995.

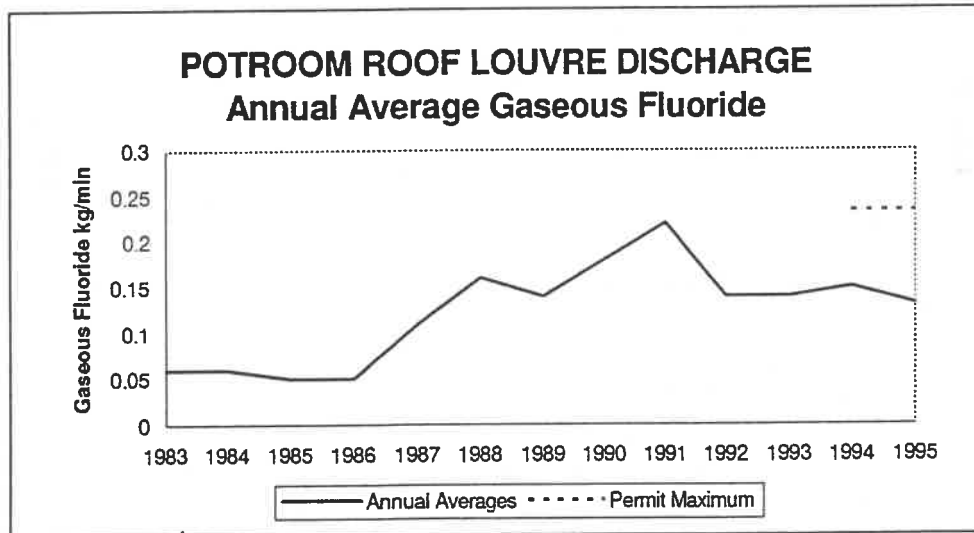
The following graph shows the annual average potroom roof louvre gaseous fluoride discharge.

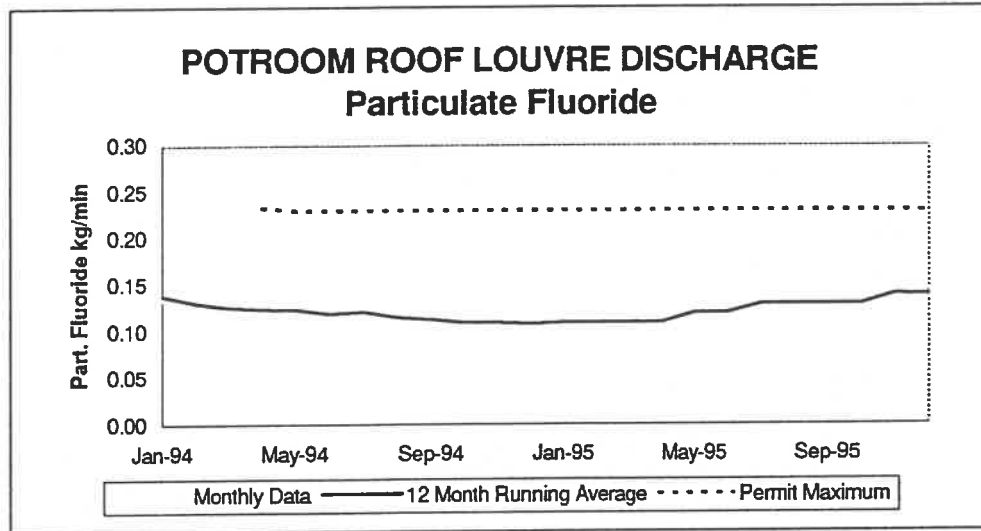
The following graph shows both the average monthly and twelve month running average potroom roof louvre particulate fluoride discharge during 1994 and 1995.

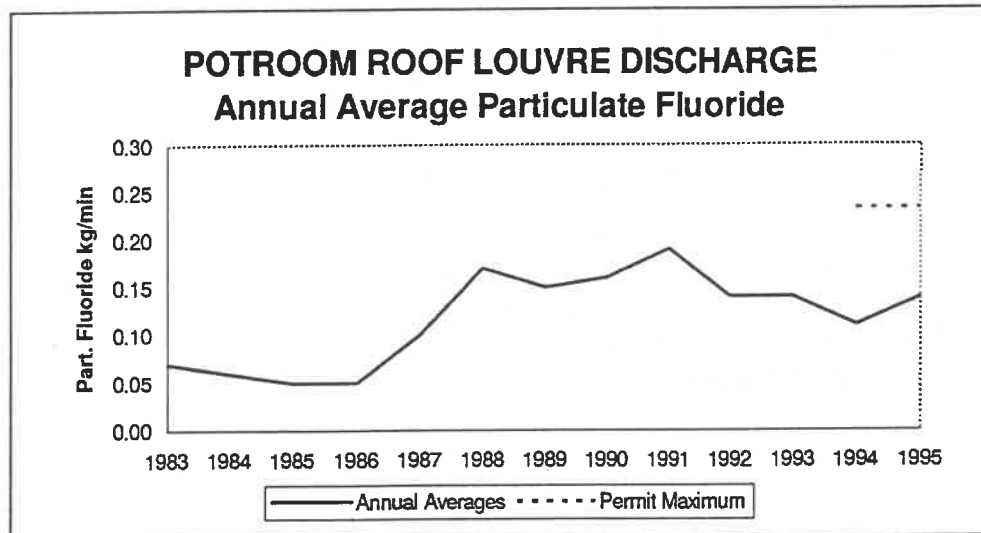
The following graph shows the annual average potroom roof louvre particulate fluoride discharge.

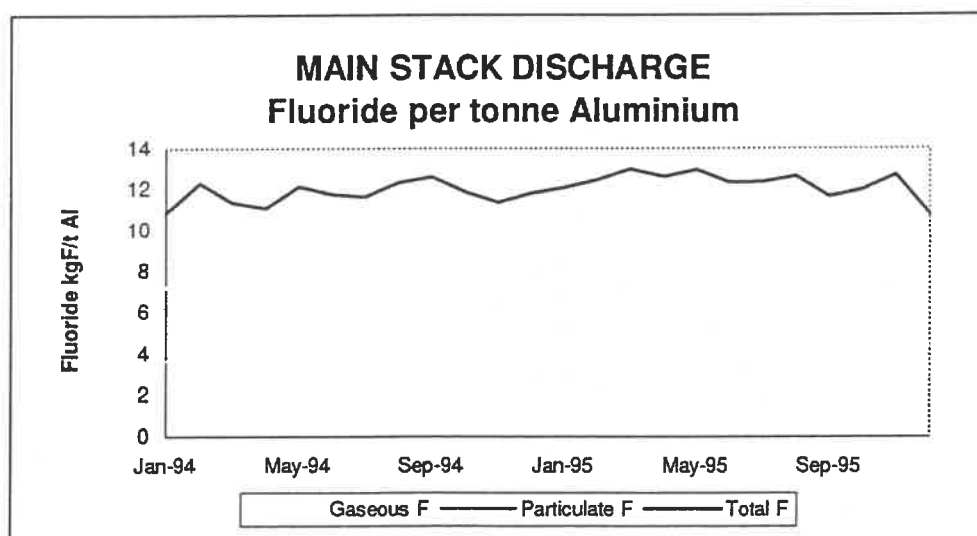
The following graph shows the average monthly main stack fluoride discharge during 1994 and 1995.

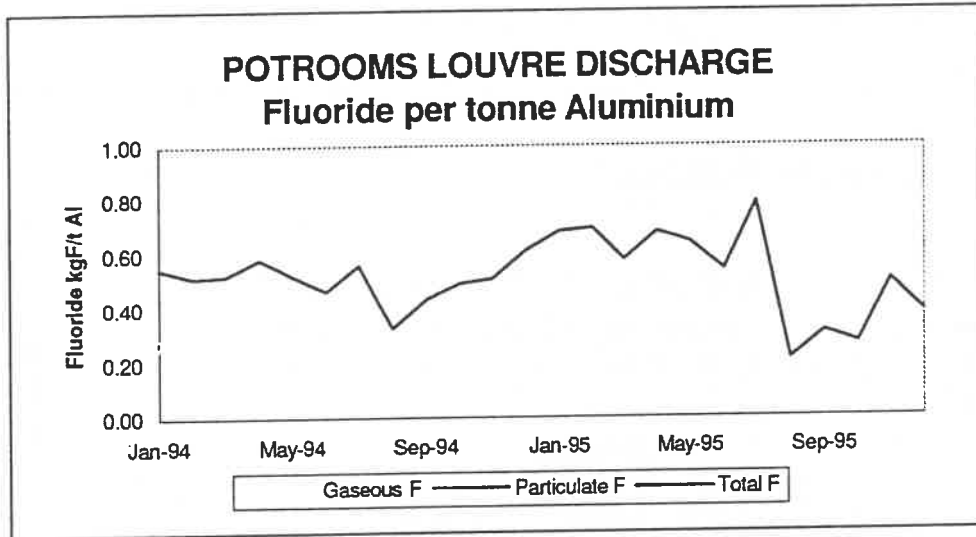
The following graph shows the average monthly potroom roof louvre fluoride discharge during 1994 and 1995.

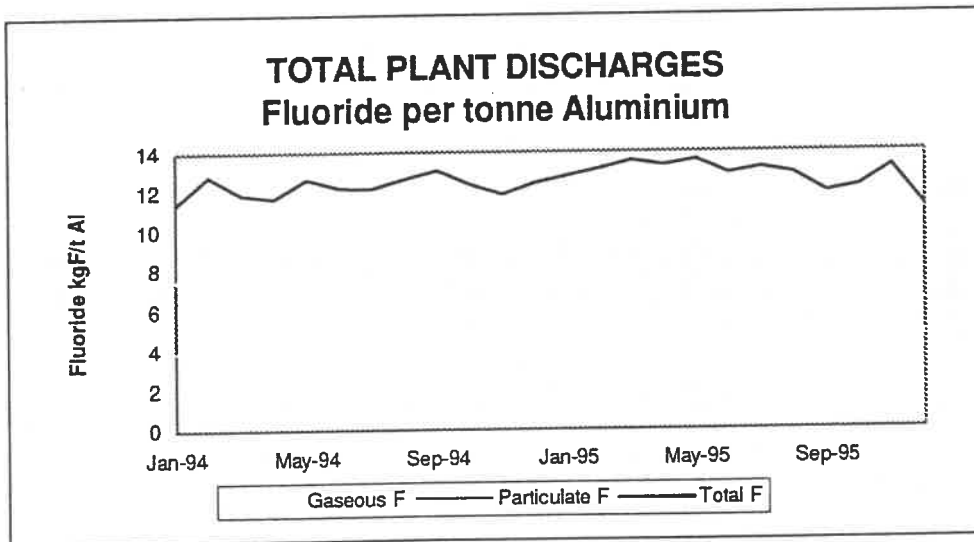
The following graph shows the average monthly total plant fluoride discharge during 1994 and 1995.

Fluoride discharges from the plant were stable throughout 1995.

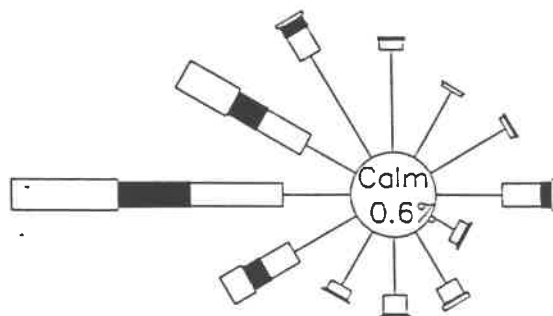
% Time at	
1-10 Knots	55.7
11-16 Knots	20.1
17-21 Knots	10.9
>21 Knots	13.2
Calm	0.6

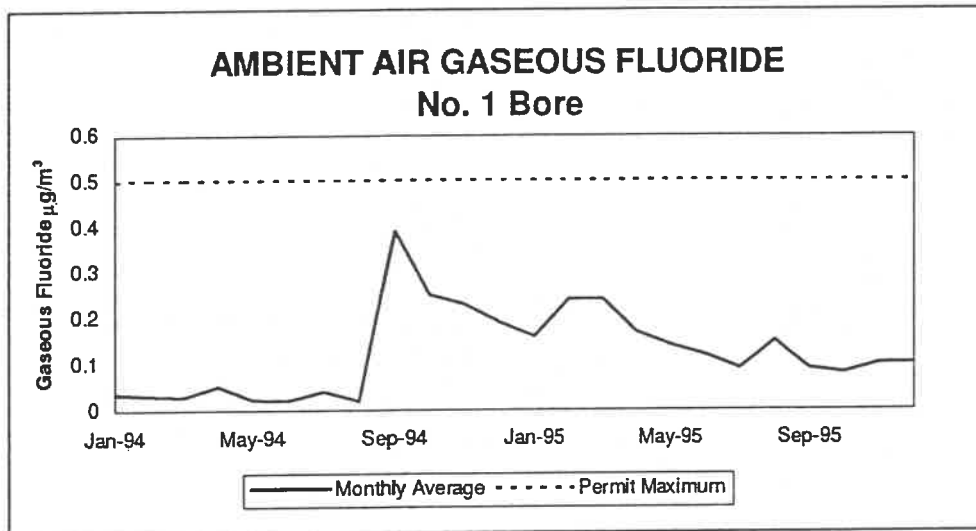
The following graph shows the monthly average ambient air gaseous fluoride concentration measured at the No.1 Bore site during 1994 and 1995.

The 1995 average gaseous fluoride concentration of the ambient air at the No. 1 Bore was $0.14 \mu\text{g}/\text{m}^3$.

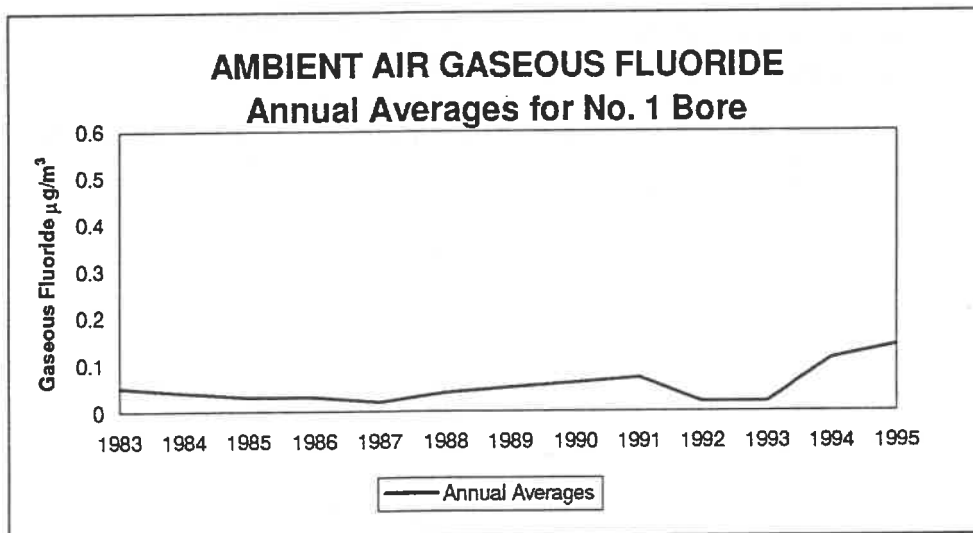
The following graph shows the annual average ambient air gaseous fluoride concentration measured at the No.1 Bore site.

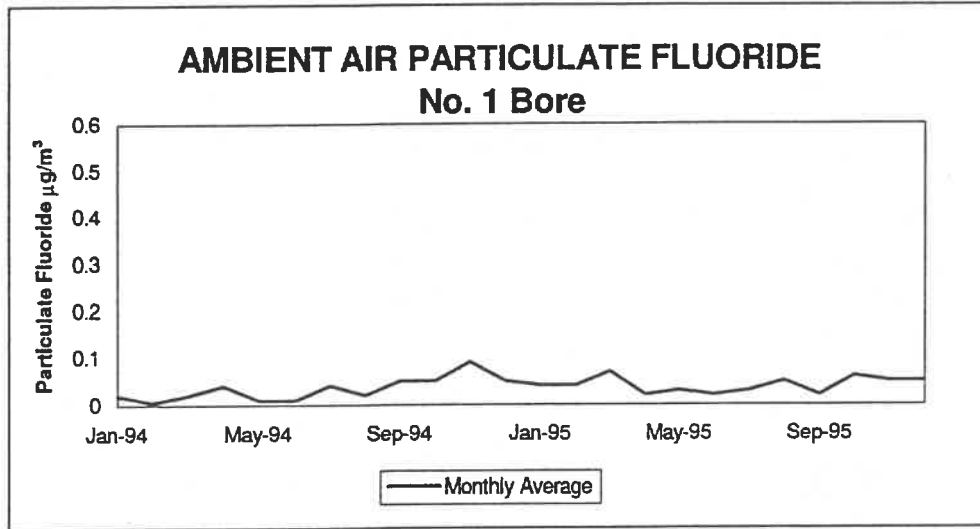
The following graph shows the monthly average ambient air particulate fluoride concentration measured at the No.1 Bore site during 1994 and 1995.

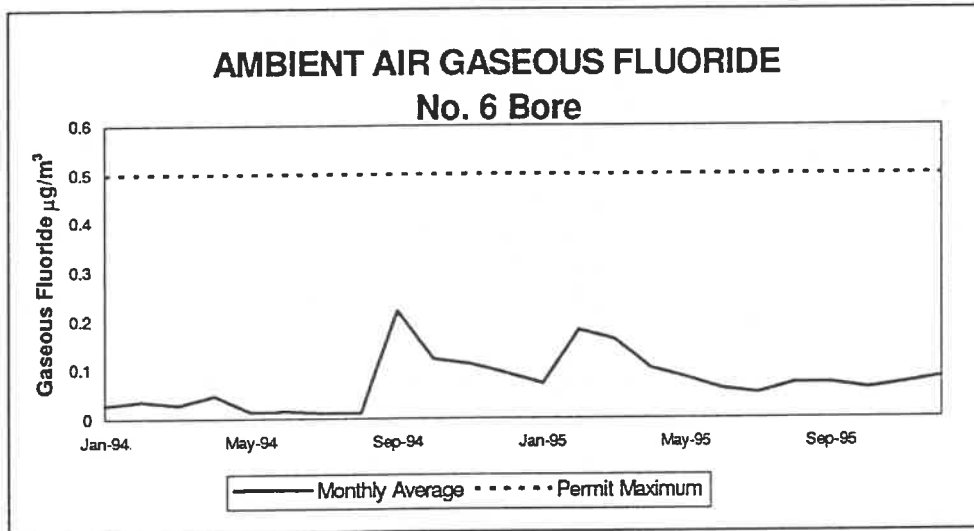
The following graph shows the monthly average ambient air gaseous fluoride concentration measured at the No.6 Bore site during 1994 and 1995.

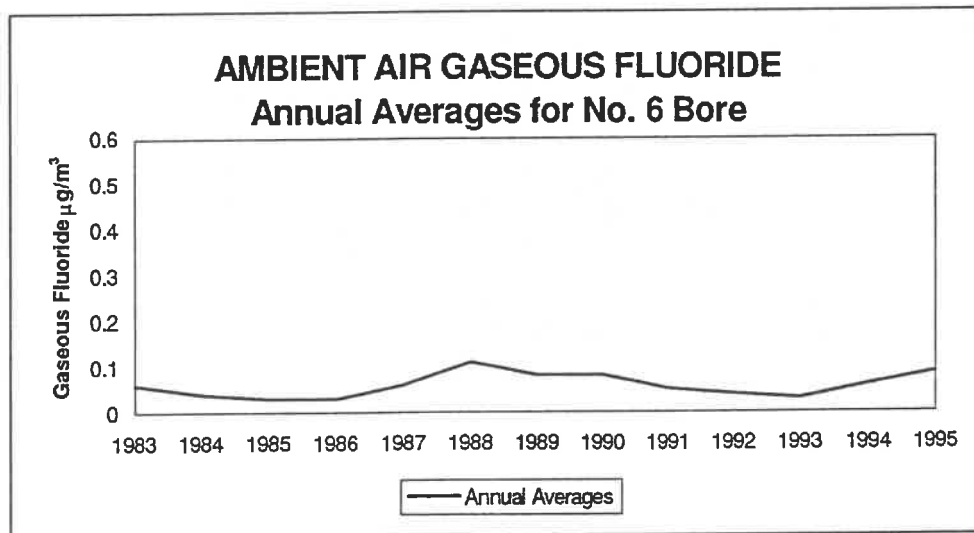
The following graph shows the annual average ambient air gaseous fluoride concentration measured at the No.6 Bore site.

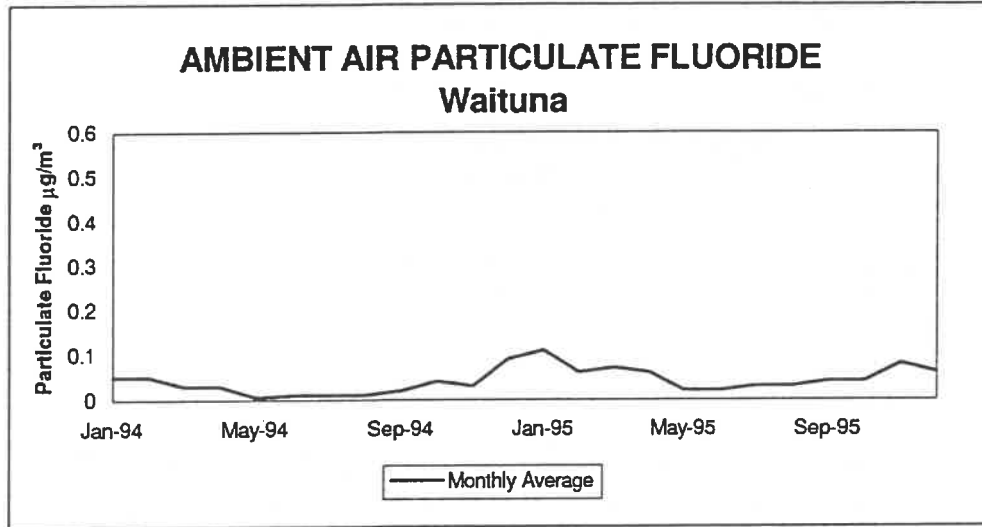
The following graph shows the monthly average particulate fluoride concentration measured at the Waituna site during 1994 and 1995.

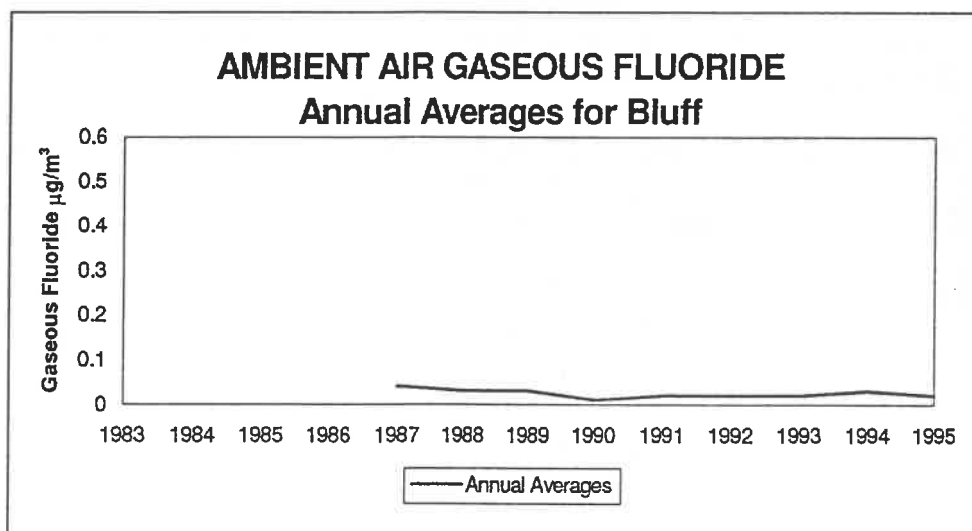
The following graph shows the annual average gaseous fluoride concentration measured at the Bluff site.

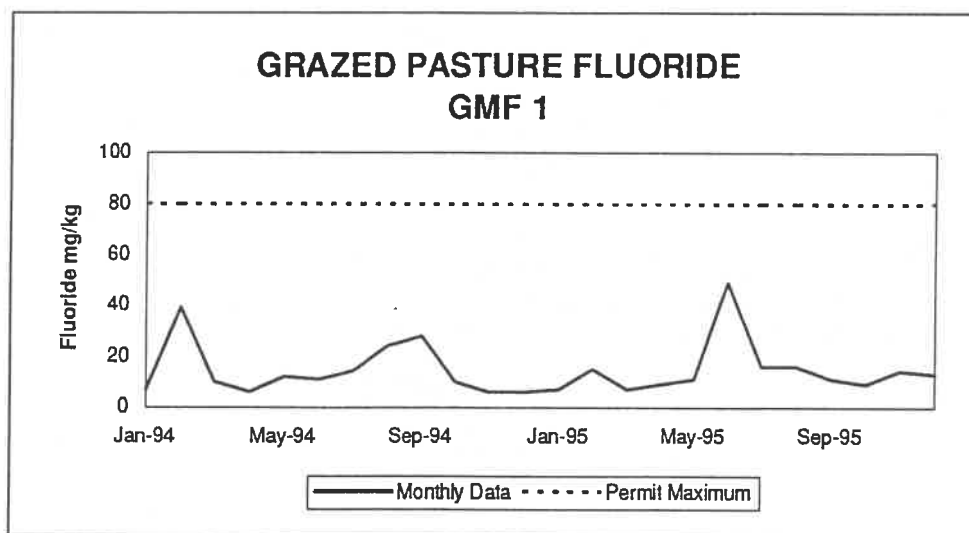
The following graph shows the results of monthly fluoride monitoring of grazed pasture during 1995

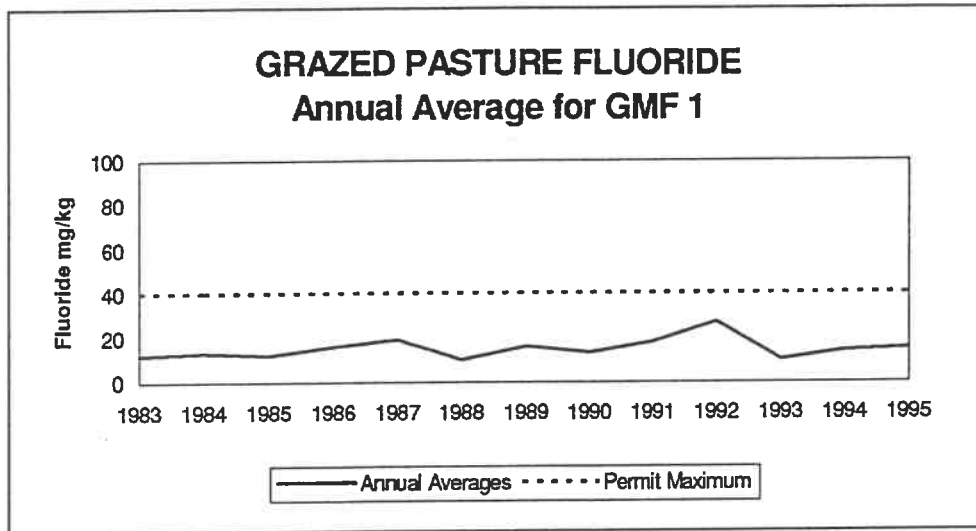
The following graph shows the annual average fluoride concentration in grazed pasture.

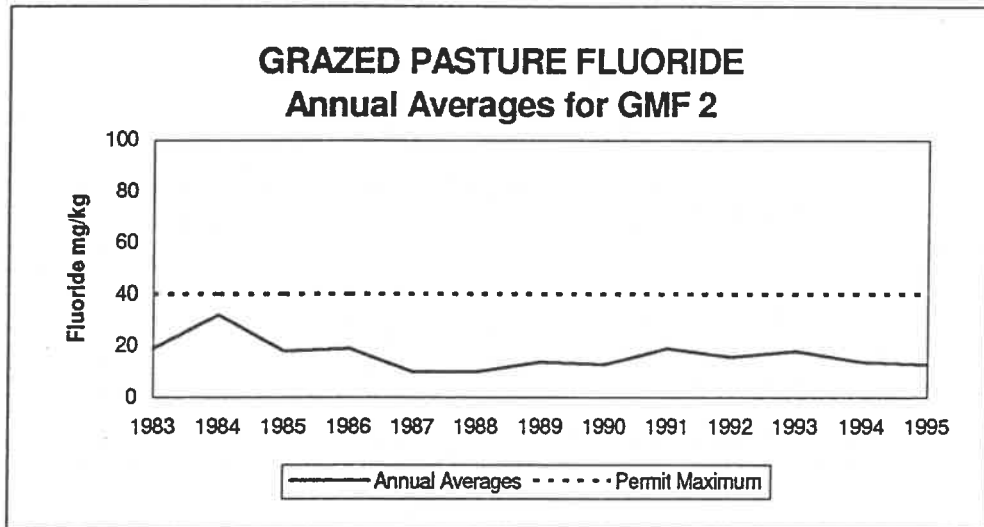
The following graph shows the annual average fluoride concentration in grazed pasture.

The fluoride in grazed pasture was within the permit standards for this farm during 1995 and no trends are evident.

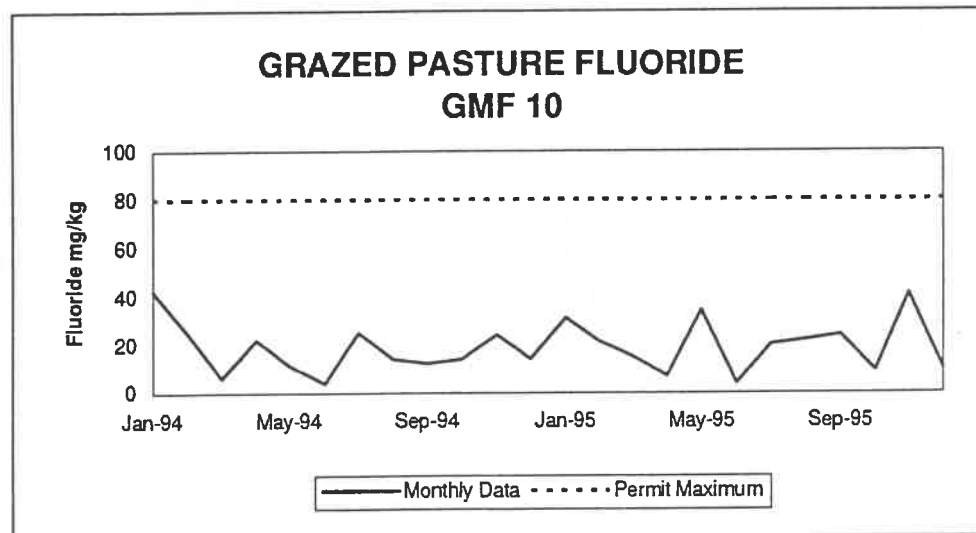
The following graph shows the results of monthly fluoride monitoring of grazed pasture during 1994 and 1995.

The fluoride in grazed pasture was within the permit standards and no trends are evident. The elevated grazed pasture fluoride concentrations measured in May and November were most likely caused by strong westerly winds transporting smelter sourced fluoride material to the farm. This is similar to the situation at nearby GMF 16.

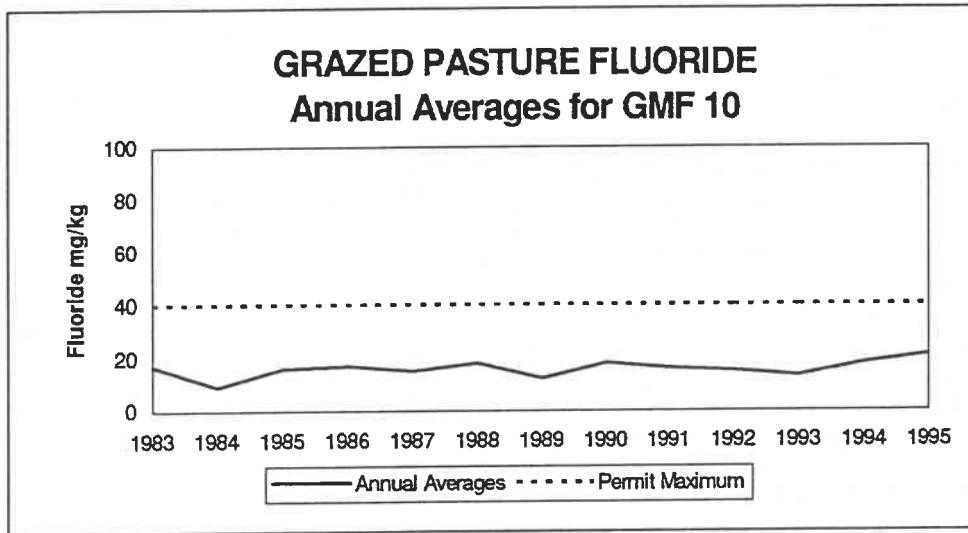
The following graph shows the annual average fluoride concentration in grazed pasture.

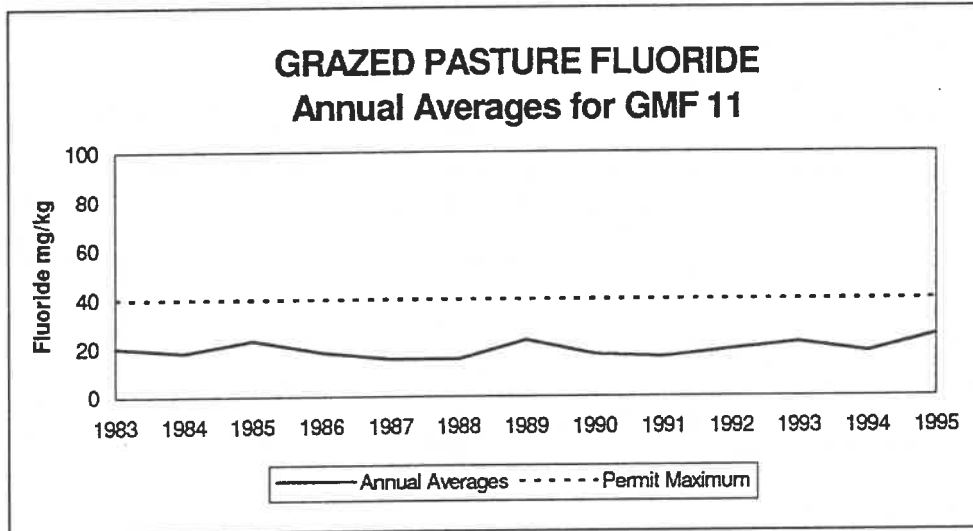
The following graph shows the annual average fluoride concentration in grazed pasture.

The fluoride in grazed pasture was within the permit standards and no trends are evident.

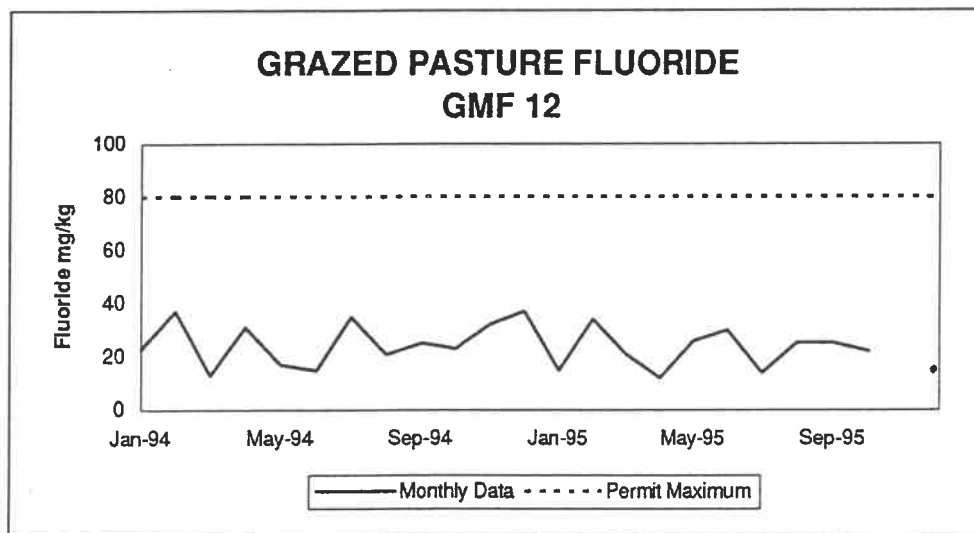
The following graph shows the results of monthly fluoride monitoring of grazed pasture during 1994 and 1995.

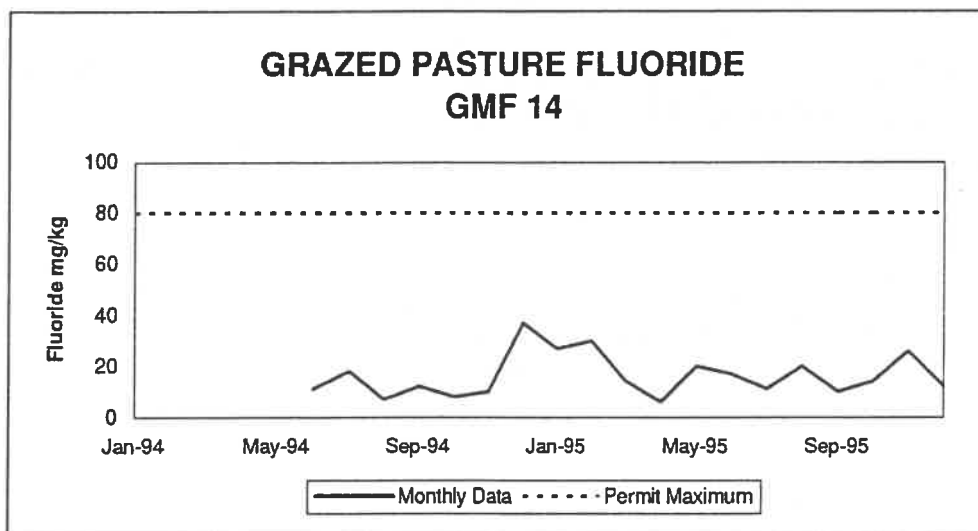
The following graph shows the results of monthly fluoride monitoring of grazed pasture during 1994 and 1995.

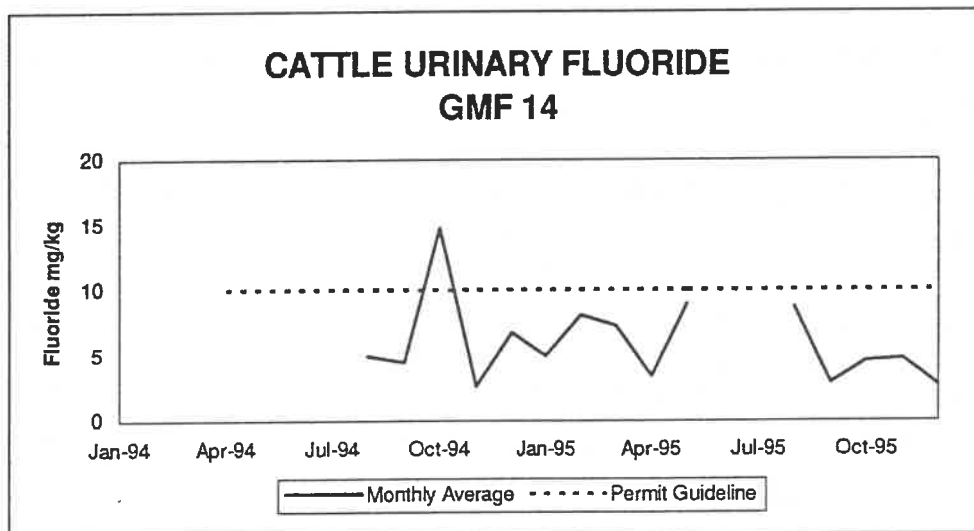
The following graph shows the monthly average for fluoride in cattle urine during 1994 and 1995.

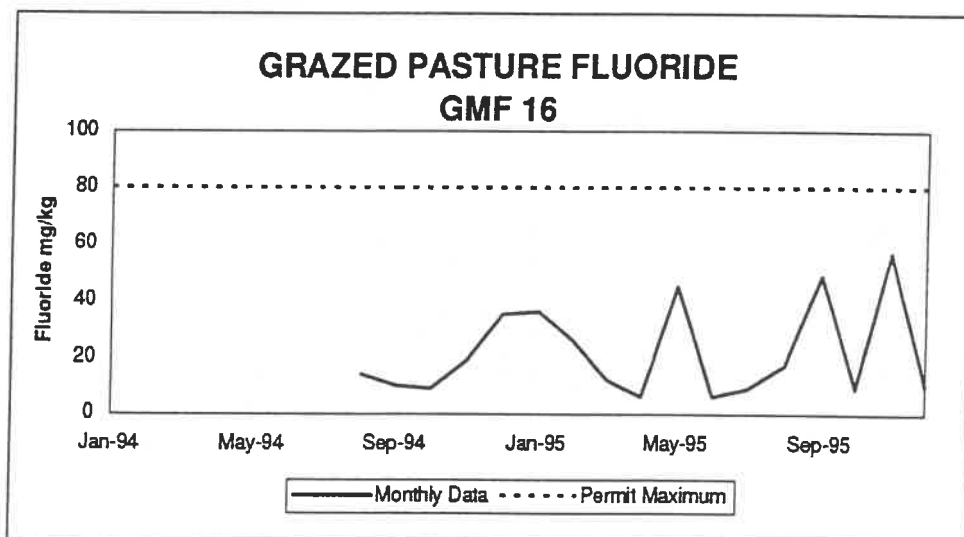
The following graph shows the results of monthly fluoride monitoring of grazed pasture during 1994 and 1995.

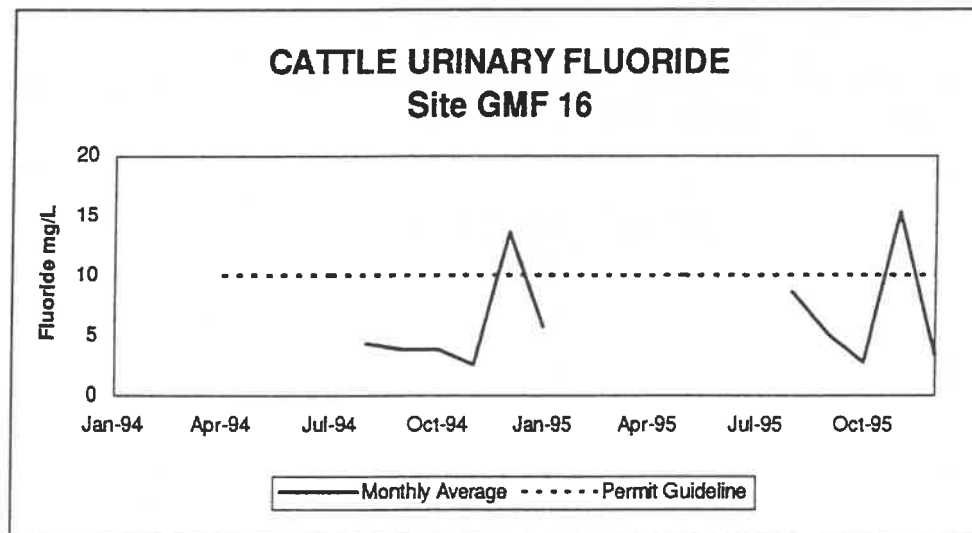
The following graph shows the monthly average for fluoride in cattle urine during 1995.

Three of the four cattle urinary fluoride concentrations that exceeded the permit guideline were collected in November. The fluoride in grazed pasture during November was 57 mg/kg which was the highest for the year. This would suggest that the urinary fluoride concentration of 23.6 mg/L is also indicative of the upper limit of the concentrations for this farm. The high results were most likely caused by strong westerly winds transporting smelter sourced fluoride material to the farm. No urine samples were collected from February to July as the cattle were not milked during this time.

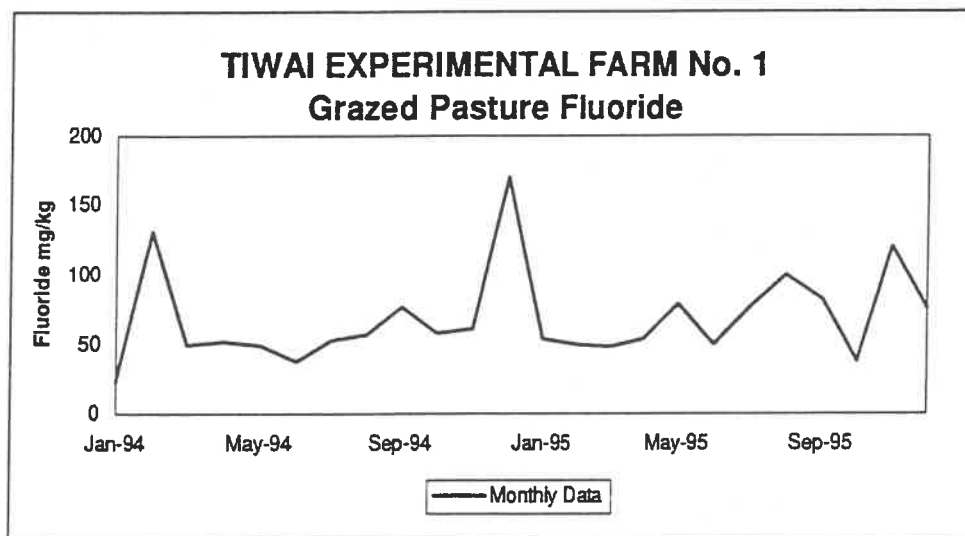
The following graph shows the results of monthly fluoride monitoring of grazed pasture during 1994 and 1995.

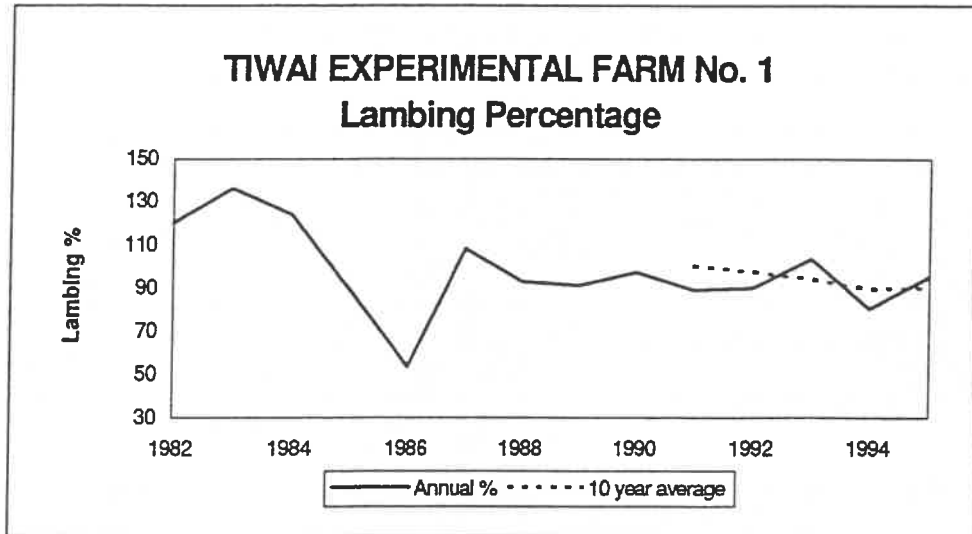
The following graph shows the lambing percentage recorded at TEF1 since 1982.

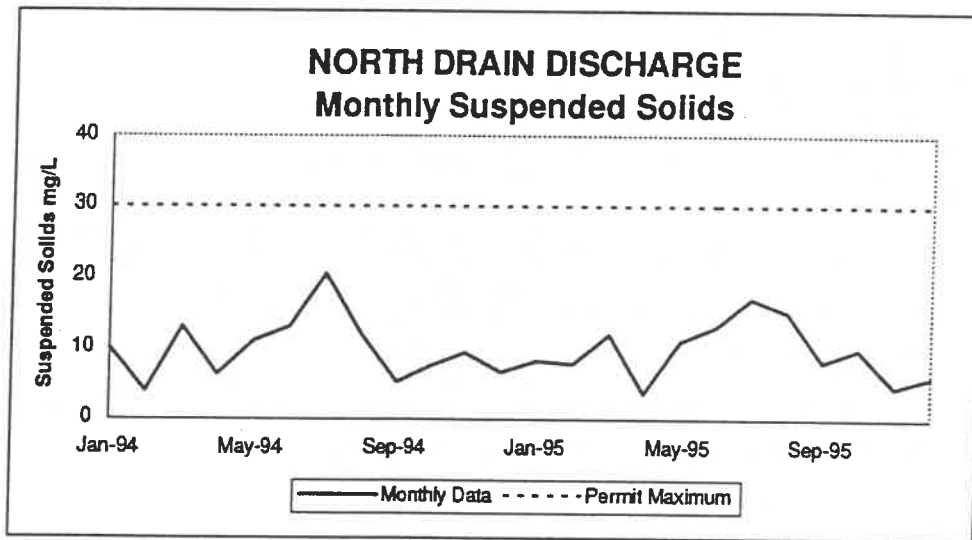
The following graph shows the monthly average concentration of suspended solids discharged from the North Drain during 1994 and 1995.

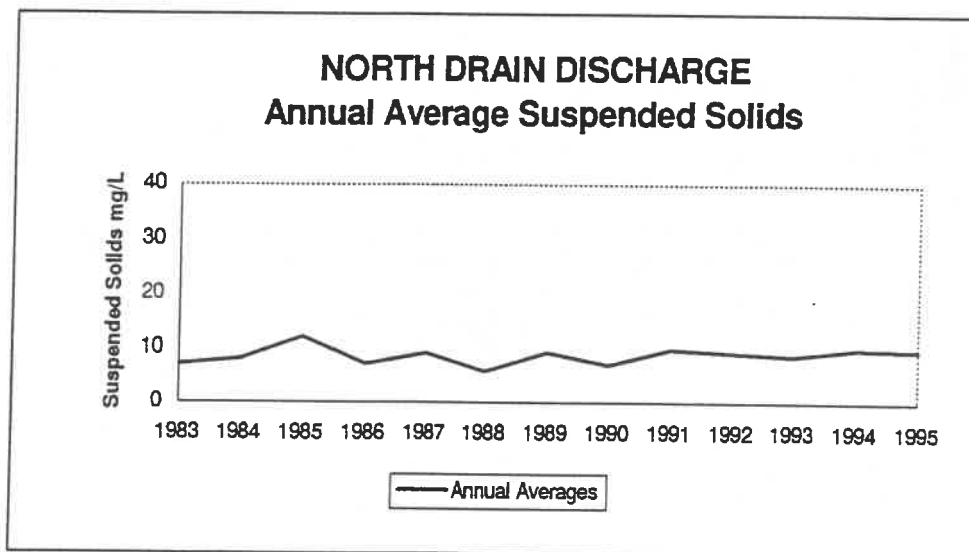
The following graph shows the annual average concentration of suspended solids discharged from the North Drain.

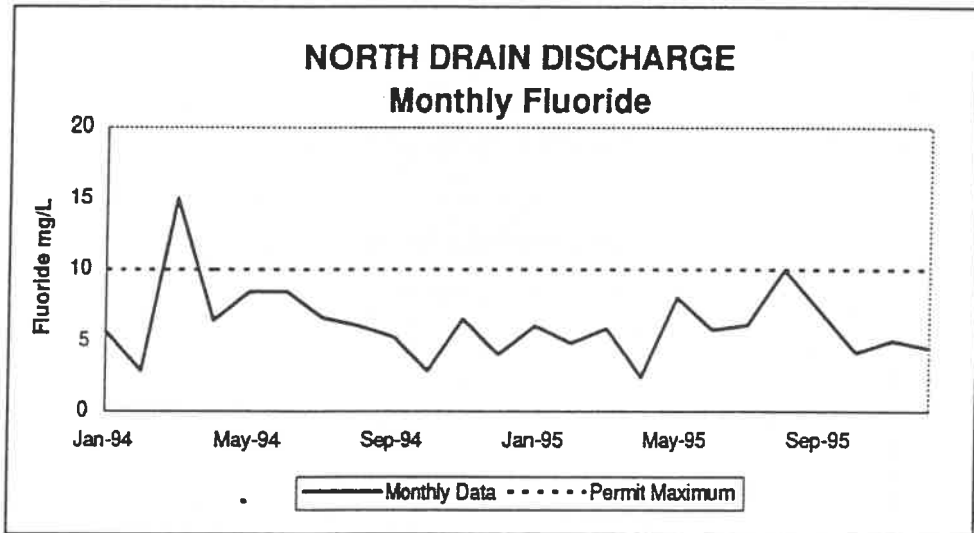
The following graph shows the monthly average concentration of fluoride discharged from the North Drain during 1994 and 1995.

The North Drain receiving water fluoride concentration permit standard was exceeded during May 1995. The high concentration of 2.2 mgF/L was the result of significant rainfall combined with calm conditions. The rainfall produced a drain discharge with a high fluoride content and the calm conditions provided poor receiving water mixing. The effects of weather conditions on the North Drain fluoride discharge was more fully discussed in the 1992 report to the Interdepartmental Committee.

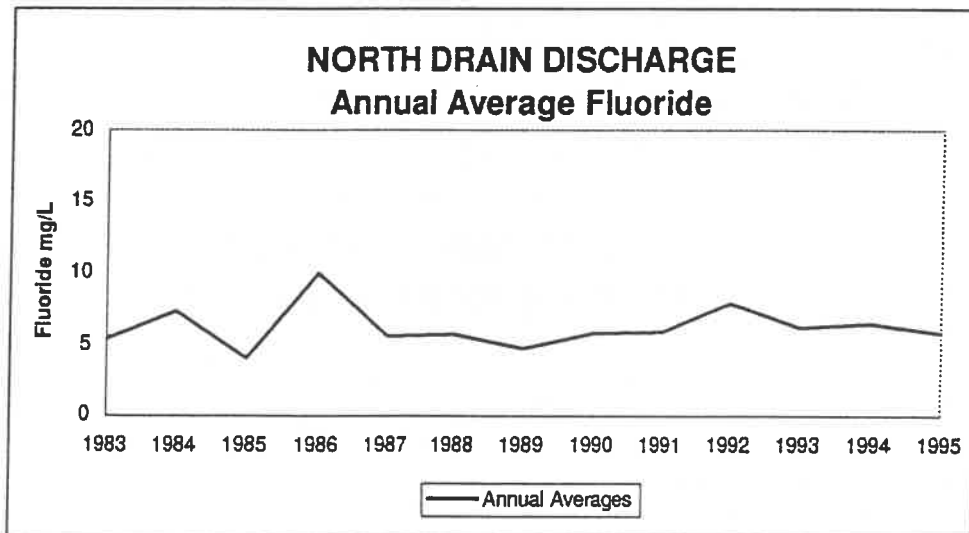
The following graph shows the annual average concentration of fluoride discharged from the North Drain.

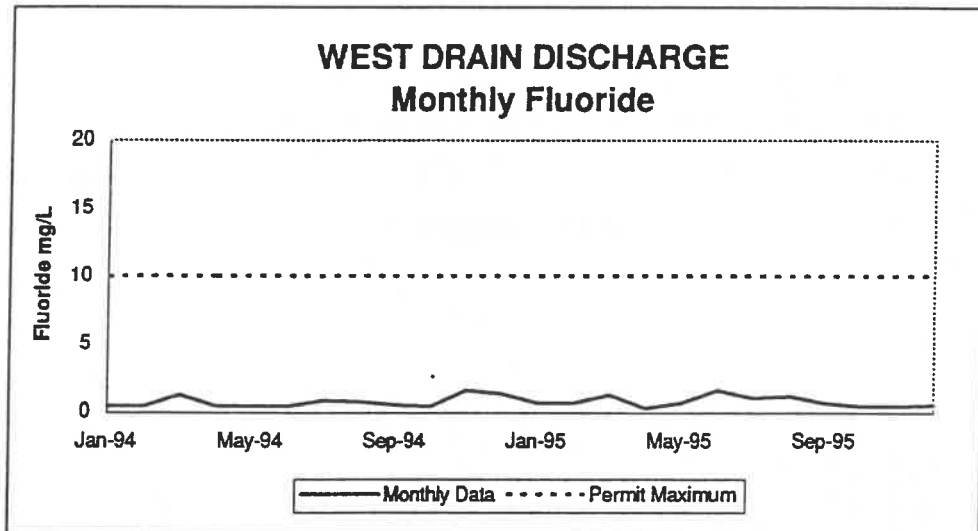
The following graph shows the monthly average concentration of fluoride discharged from the West Drain during 1994 and 1995.

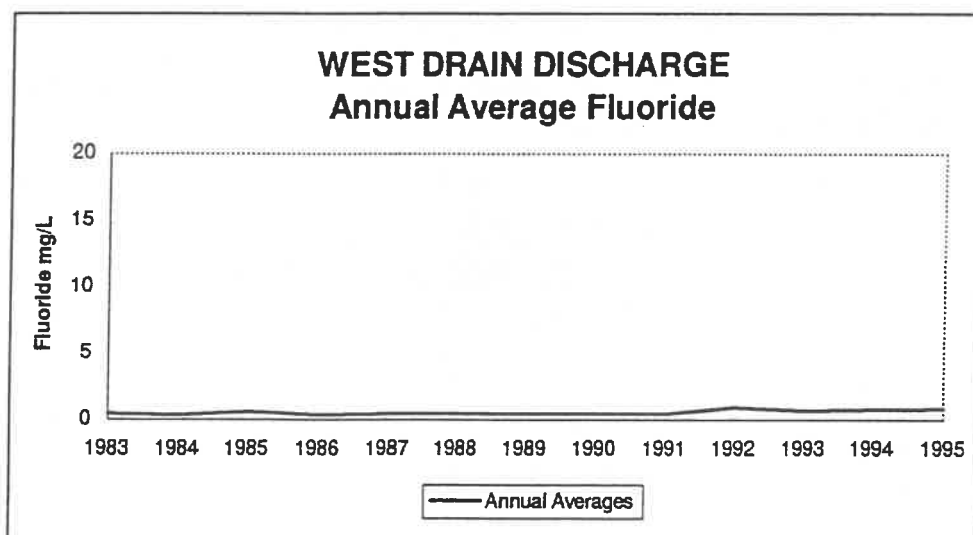
The following graph shows the annual average concentration of fluoride discharged from the West Drain.
