New Zealand Aluminium Smelters Limited

**REPORT TO THE INTERDEPARTMENTAL COMMITTEE
ON ENVIRONMENTAL EFFECTS OF THE TIWAI ALUMINIUM SMELTER
FOR THE YEAR ENDING 31 DECEMBER 1995**

**MEETING AT TIWAI
14 MAY 1996**

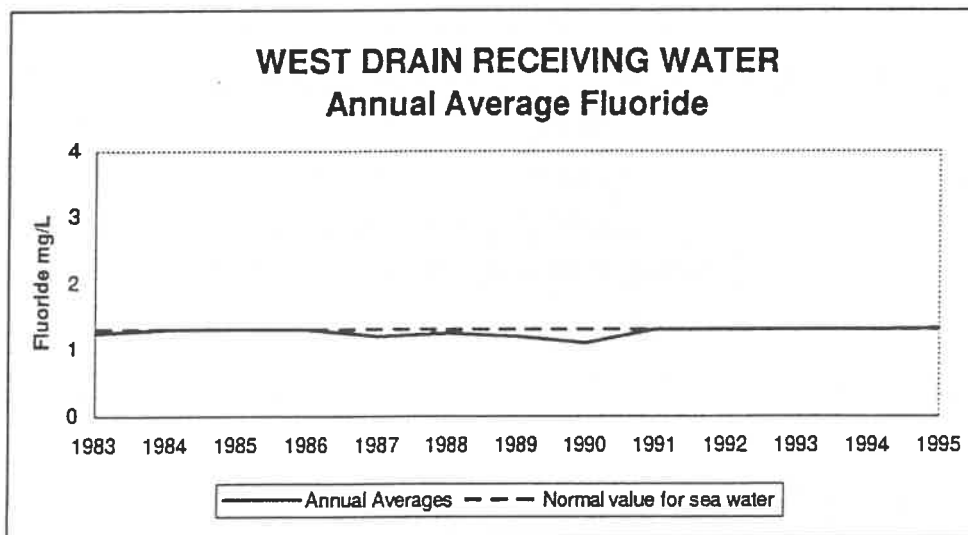
The following graph shows the annual average fluoride concentration of the West Drain receiving water.

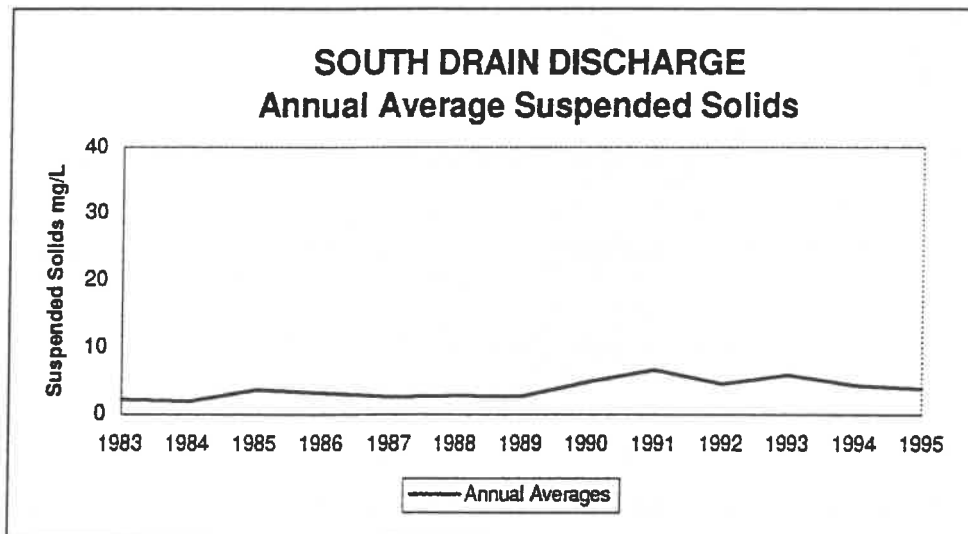
The following graph shows the annual average concentration of suspended solids discharged from the South Drain.

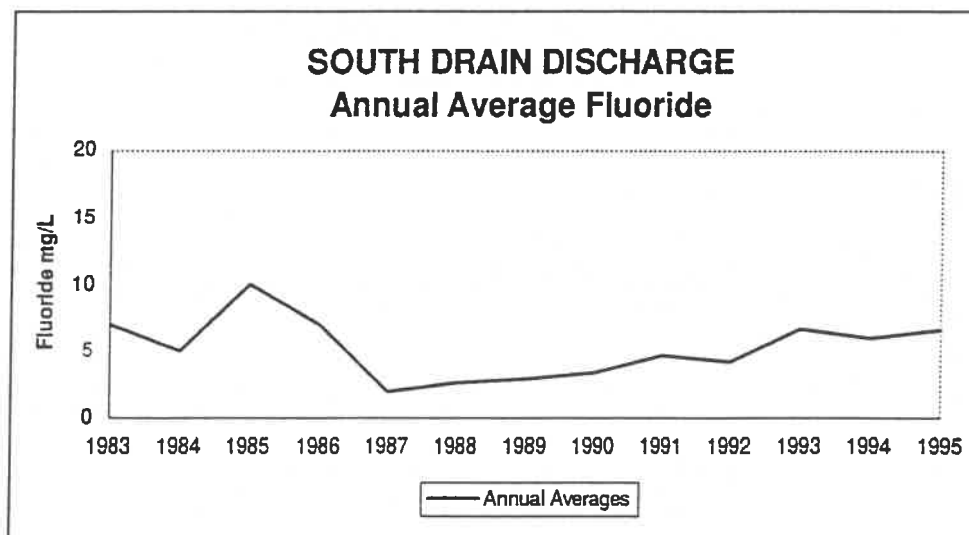
The following graph shows the annual average concentration of fluoride discharged from the South Drain.

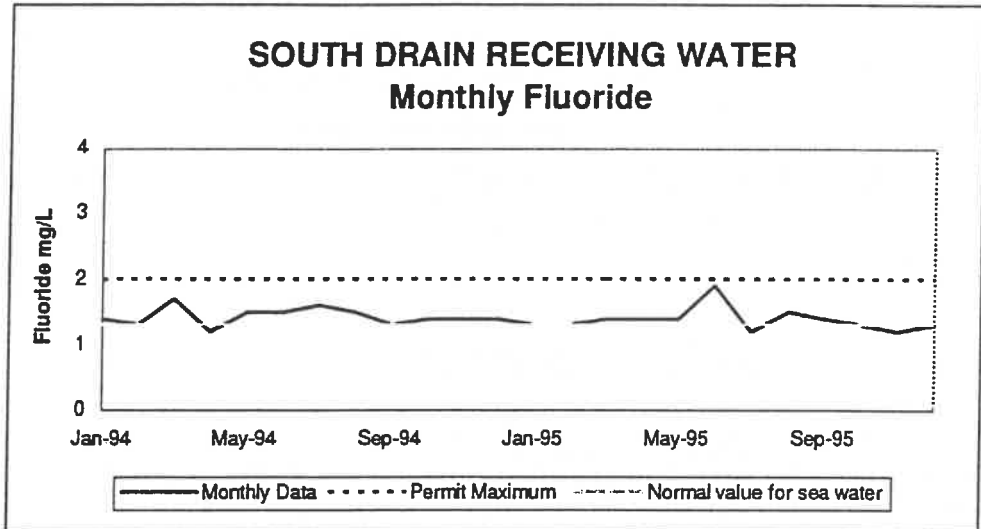
The following graph shows the monthly average fluoride concentration of the South Drain receiving water during 1994 and 1995.

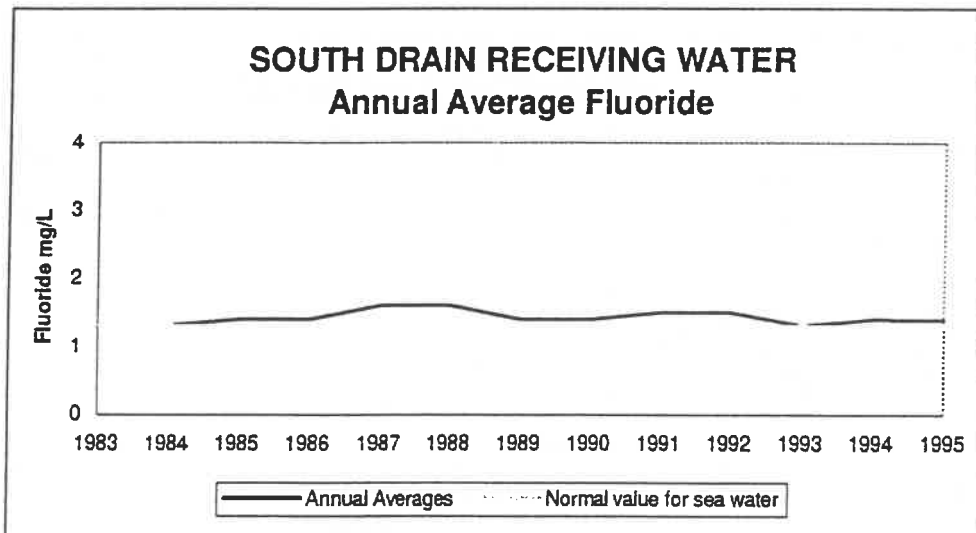
The following graph shows the annual average fluoride concentration of the South Drain receiving water.

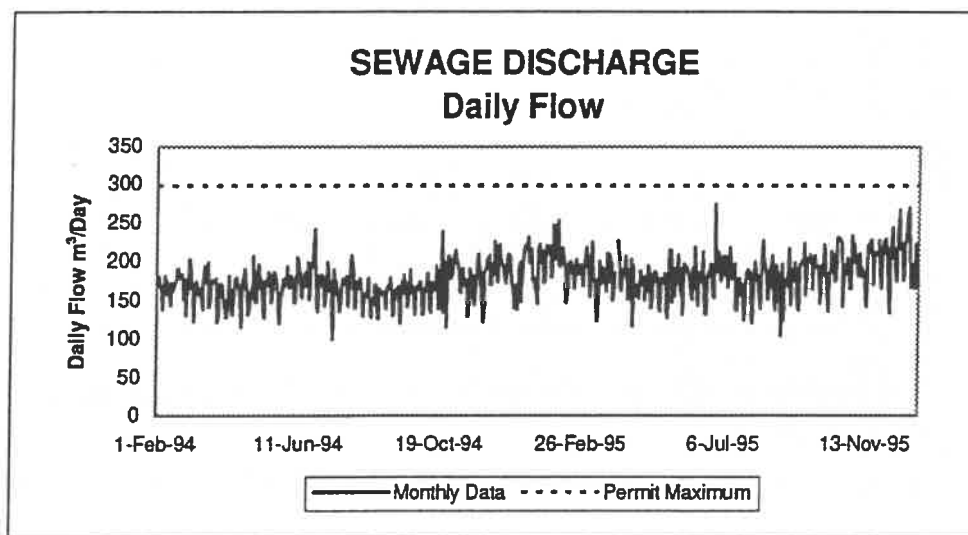
The following graph shows the daily sewage discharge flow during 1994 and 1995.

The increasing sewage discharges in the latter part of 1995 reflected the increased construction activities at NZAS. The discharges are expected to return to stable conditions when the Upgrade activity is finished.

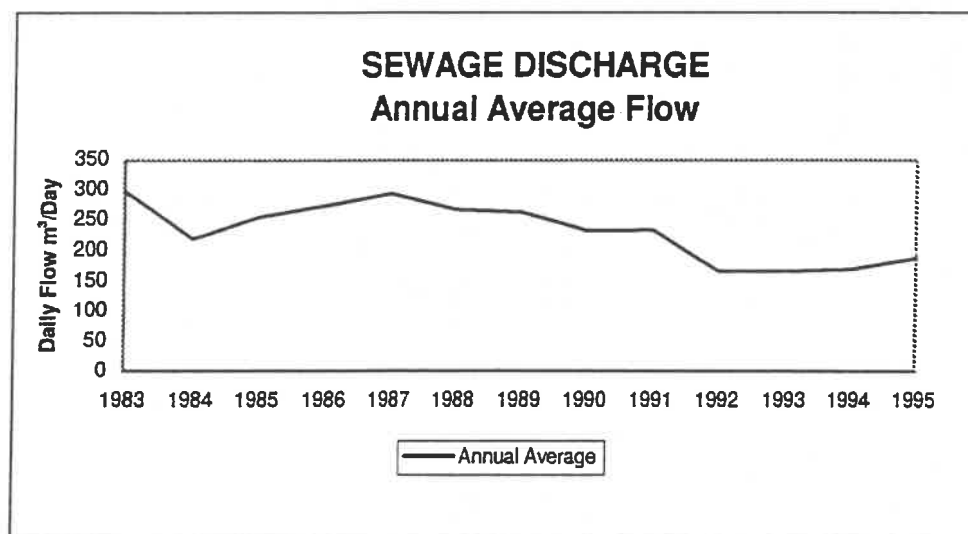
The following graph shows the annual average daily sewage discharge flow.

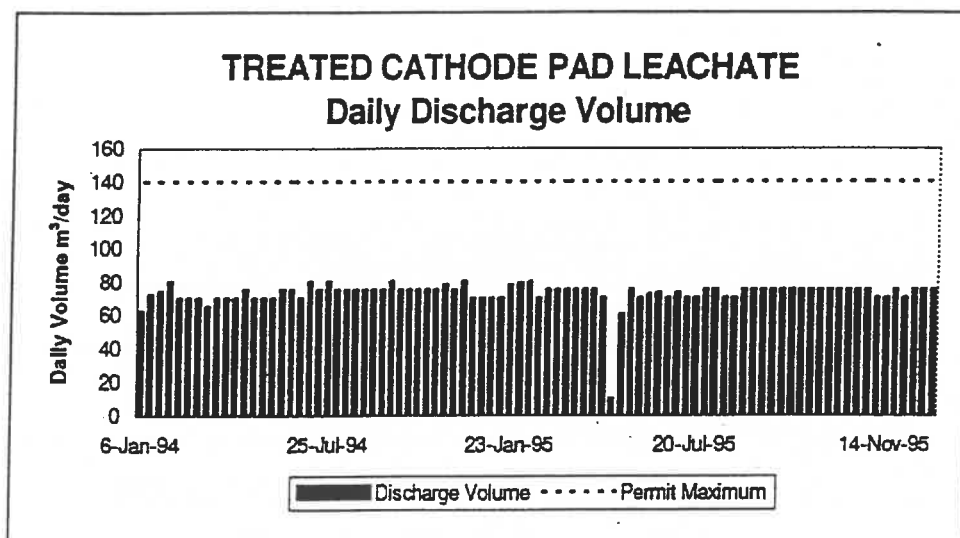
The following graph shows the volume of individual discharges of treated cathode pad leachate during 1994 and 1995.

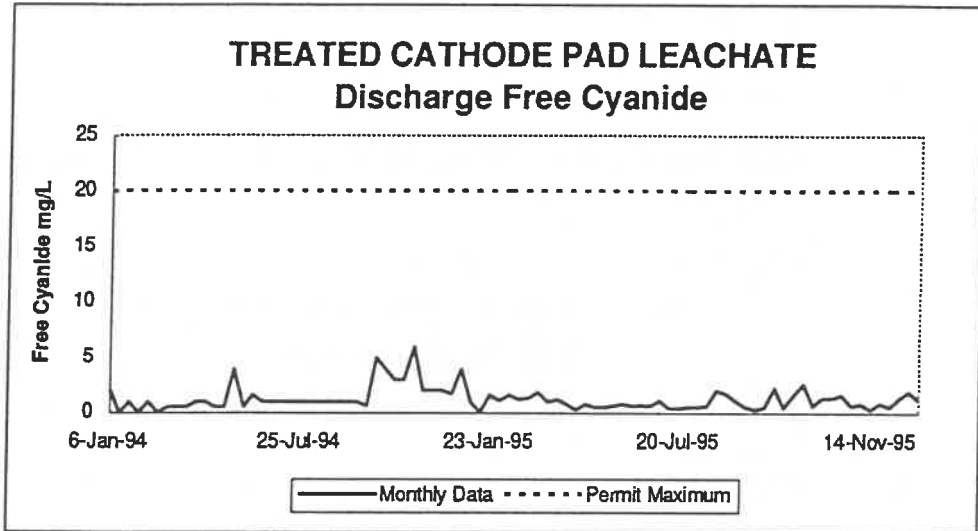
The following graph shows the free cyanide concentration of individual discharges of treated cathode pad leachate during 1994 and 1995.

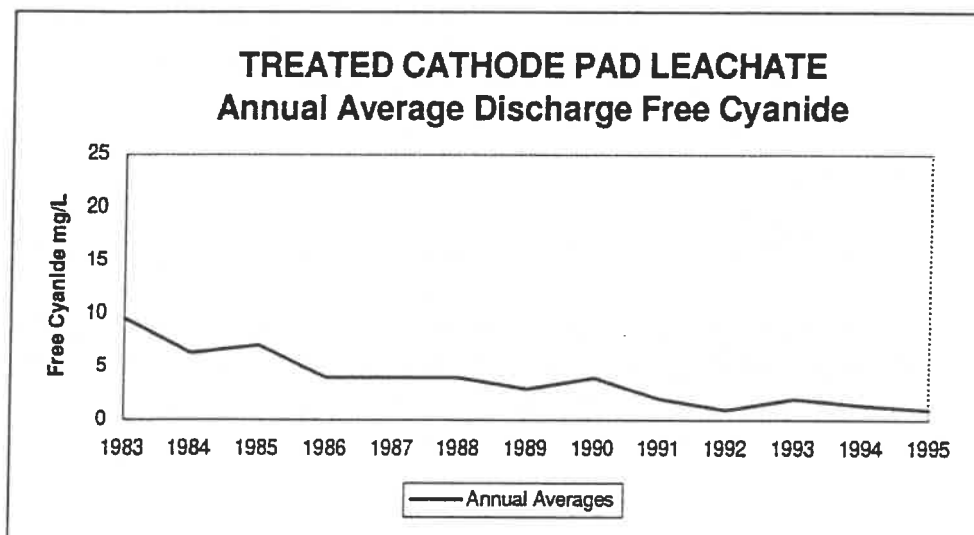
The following graph shows the annual average free cyanide concentration of treated cathode pad leachate discharged.

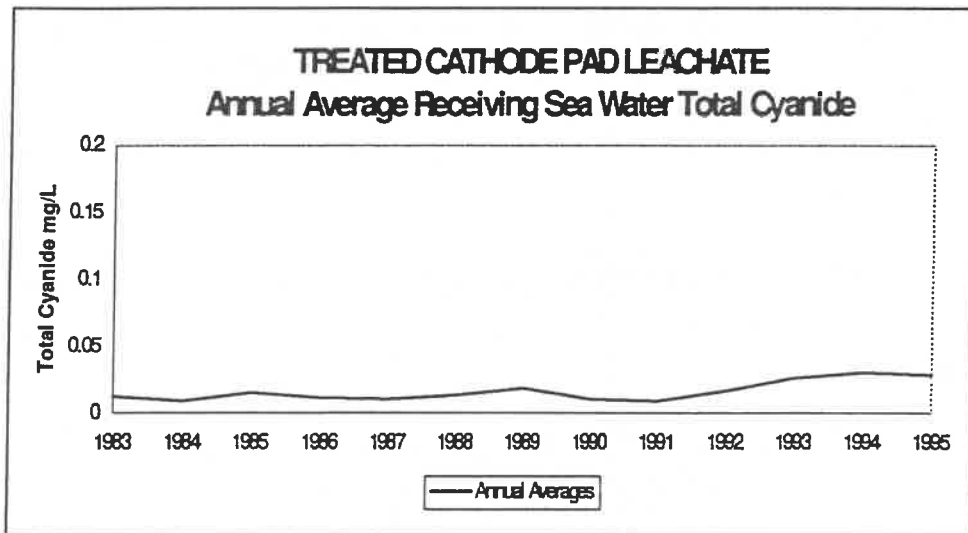
The following graph shows the annual average total cyanide concentration of the receiving sea water during the discharge of treated cathode pad leachate.

Monitoring results indicated the receiving seawater total cyanide concentrations were above the permit condition four times during 1995. As indicated in previous reports to the Interdepartmental Committee this was most likely due to the seepage of contaminated groundwater onto the beach. The annual average concentration during 1995 was similar to that measured during 1993 and 1994.
