Tiwai Peninsula

preliminary report - contaminated site

Tiwai Point – contaminated site

Report in response to ES Briefing Note

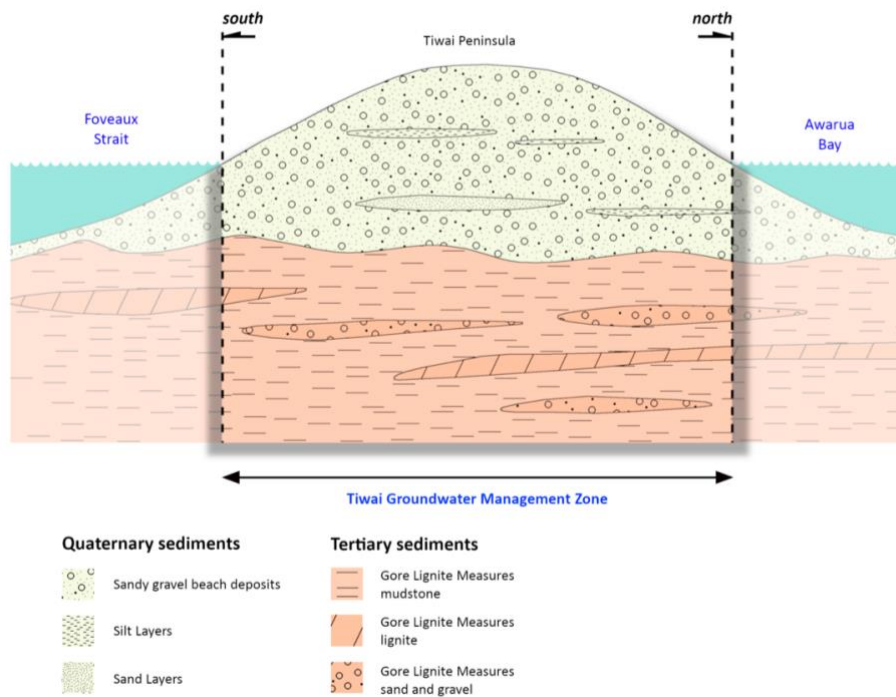
Figure 1: Cross-section of the Tiwai Peninsula showing geology. Sand and sand/gravel deposits extend to a depth of 20-25 metres. Source: Environment Southland.

Figures 1 and 2 highlight the connectivity between what happens on the land, with groundwater and neighbouring coastal waters. Contaminants from the land surface can quickly travel through the gravel substrate to underlying groundwater. The groundwater is shallow and highly connected to the surrounding coastline.

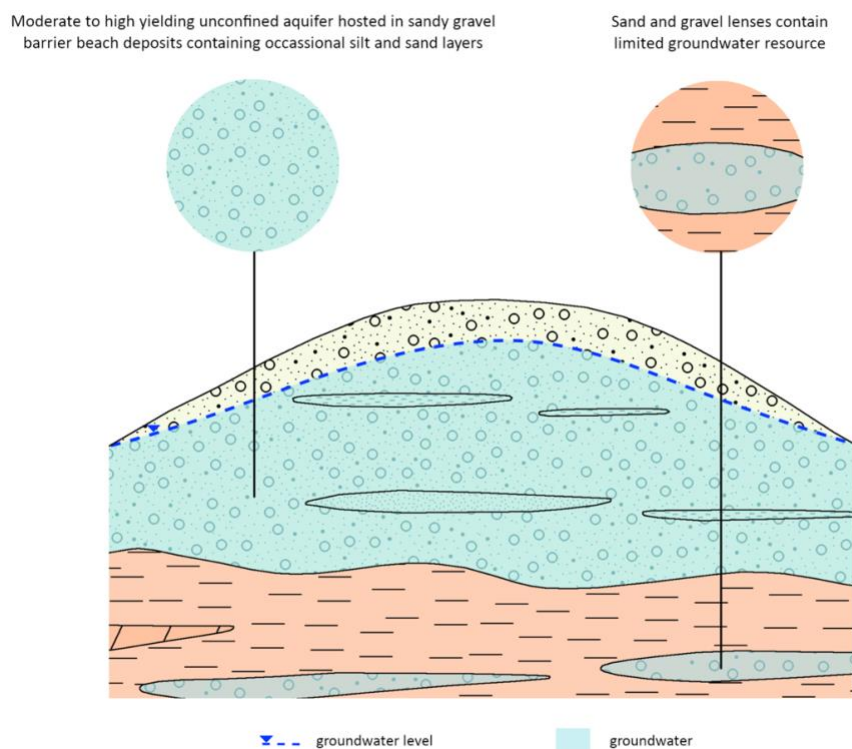
Sand and sand/gravel deposits host a shallow unconfined aquifer system that effectively forms a freshwater lens underlying the peninsula (Figure 2). Depth to groundwater ranges from 2-5 metres, increasing with elevation towards the middle of the peninsula. Within the deeper mudstone, there are lenses of sand and gravel that host limited confined groundwater resources.

Figure 2: Cross-section of groundwater resources in the Tiwai Groundwater Management Zone. Source: Environment Southland.

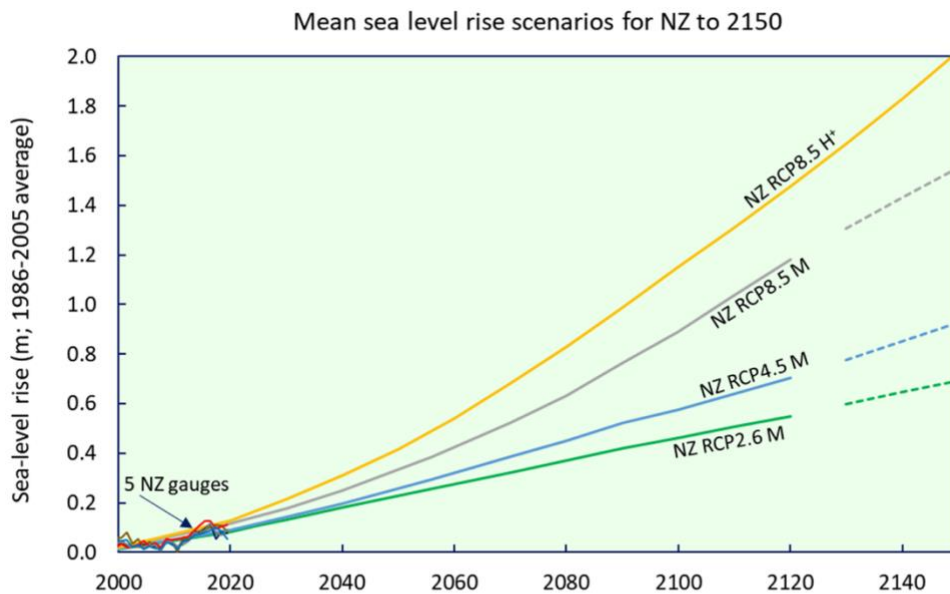
Figure: Four scenarios of New Zealand-wide sea-level rise projections recommended in the Ministry for the Environment's 2017 coastal guidance, based on the IPCC 5th Assessment Report, with the extensions to 2150 and the highest scenario, based on Kopp et al (2014). Measurements up to 2019 are from: Auckland, Moturiki, Wellington, Lyttelton, Dunedin. Sea level height is relative to the average mean sea level over the recent period 1986-2005, which IPCC use as a zero baseline for projections.

Figure 3: Mean sea level rise modelled for New Zealand to 2150 by NIWA.

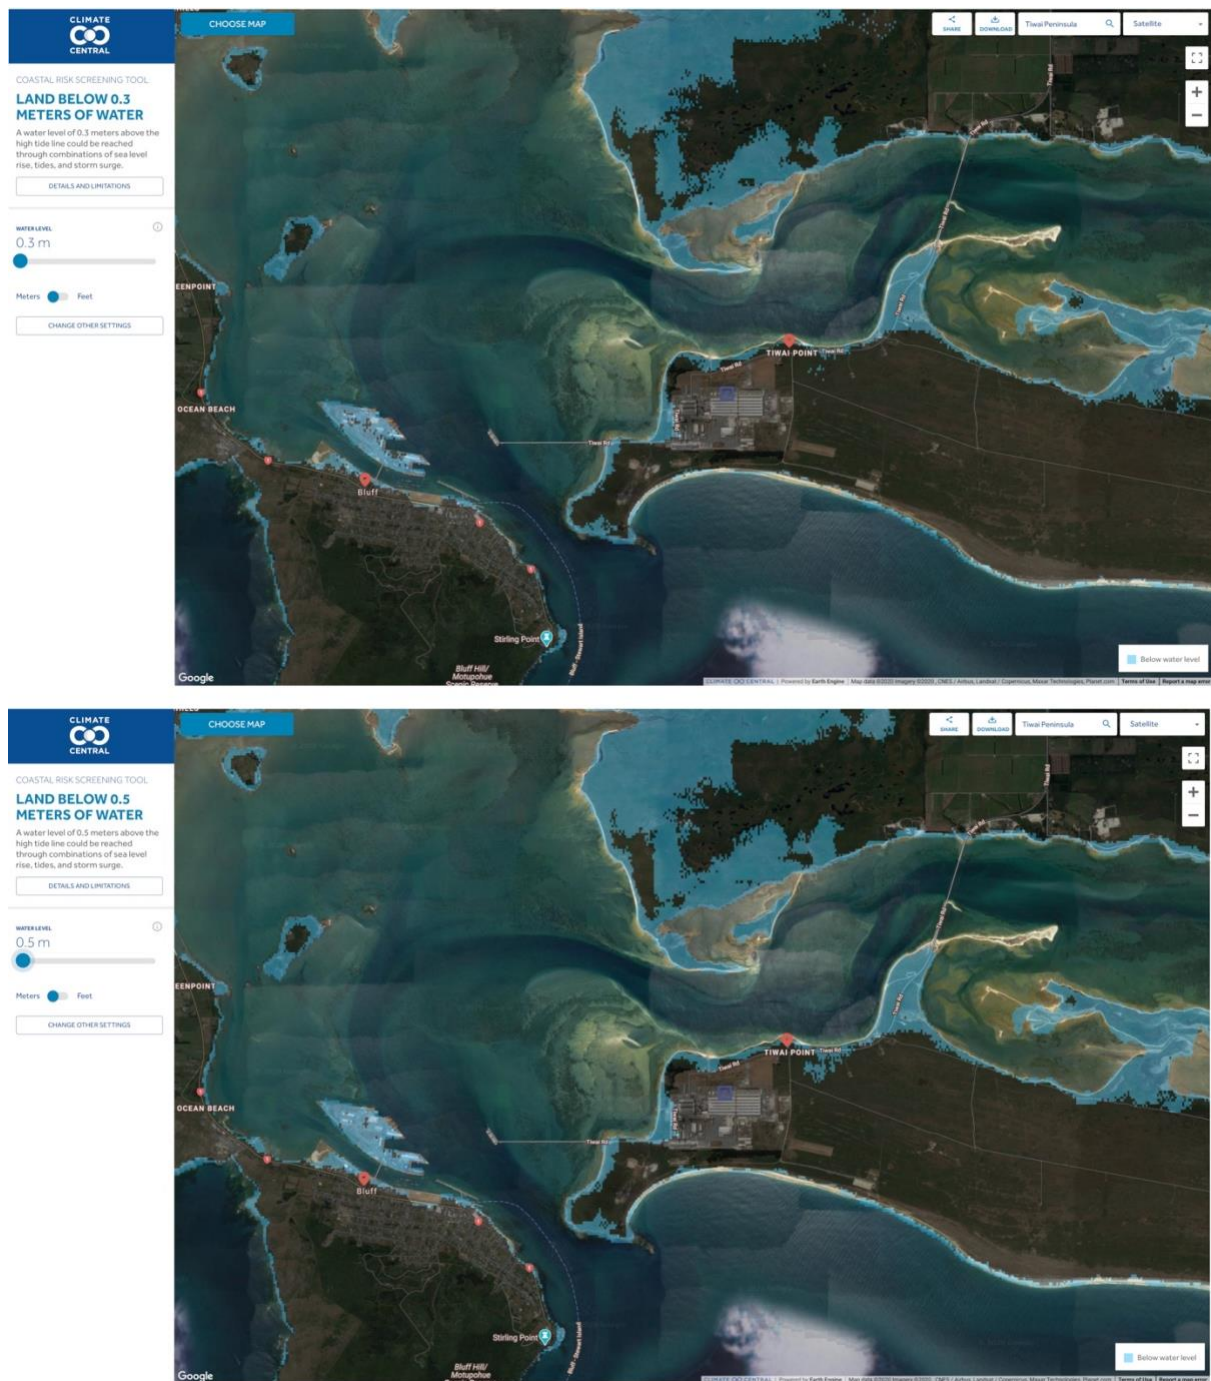
Figure 4: Changing coastline for Top: 0.3 metre sea level rise. Bottom: 0.5 metre sea level rise.

As noted previously, the geology of the Tiwai peninsula is predominantly sand and gravel, meaning that it is at high risk of coastal erosion from sea level rise. Therefore, it is likely that the perimeter shoreline could be much reduced, particularly post large storm events.

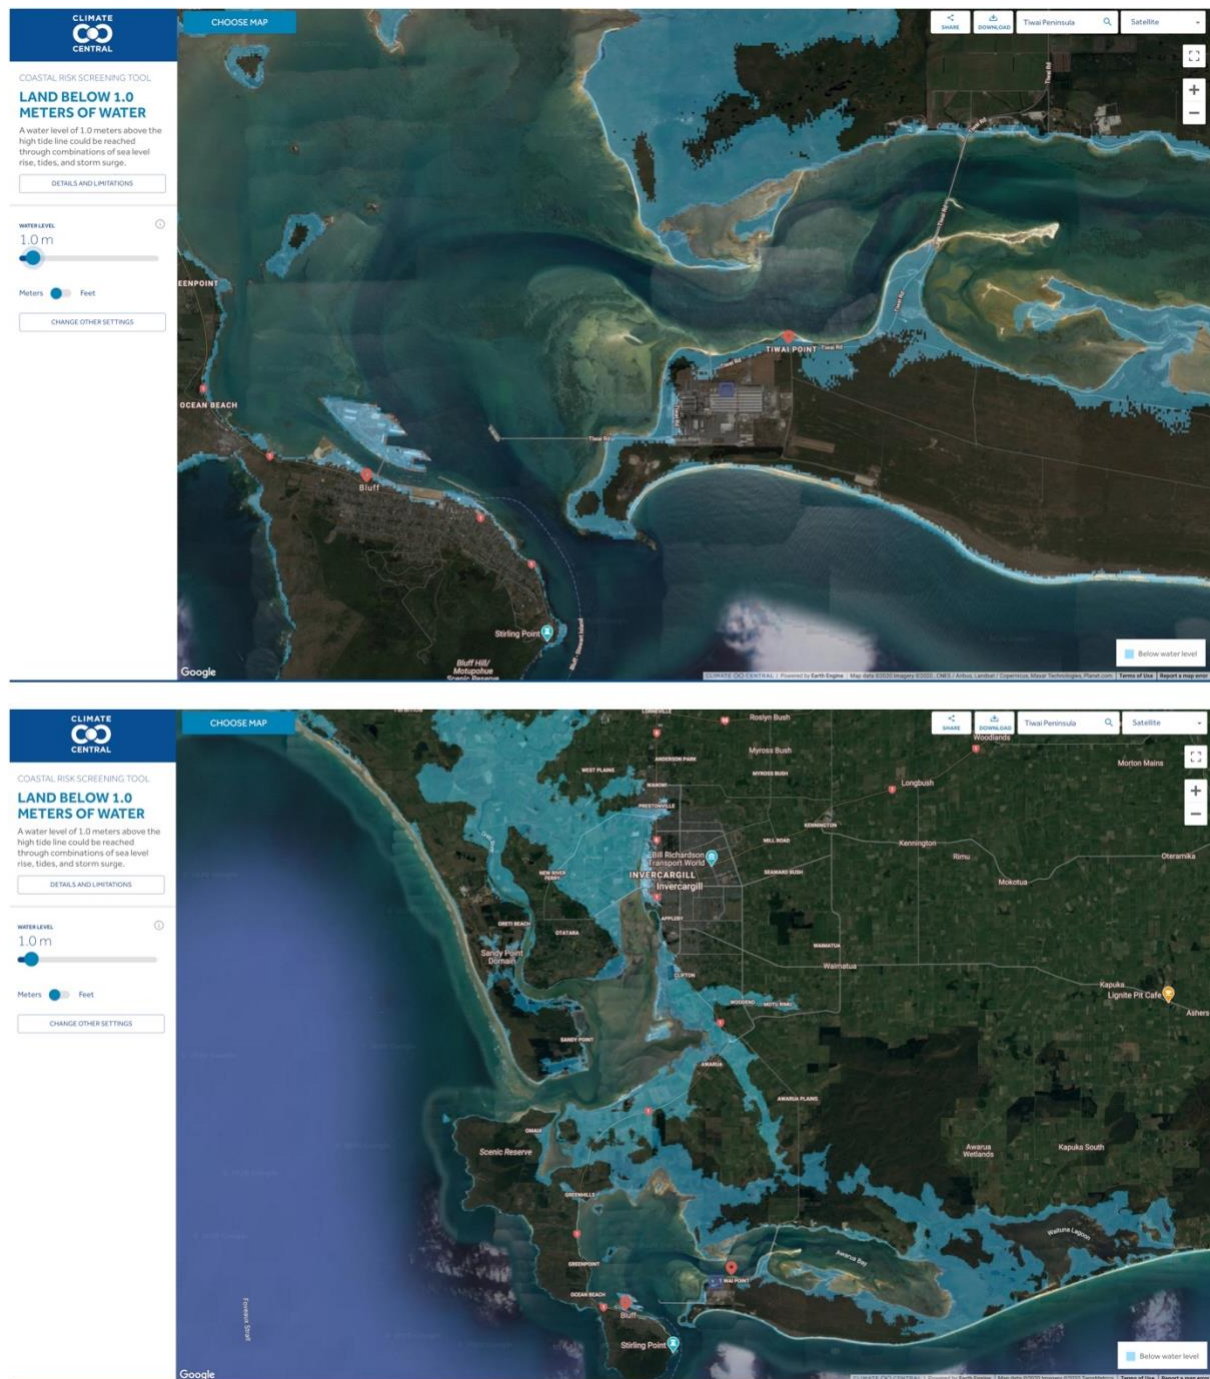
Figure 5: Changing coastline for 1 metre sea level rise. Top: Tiwai Peninsula. Bottom: Dramatic changes in coastline and accessibility for the greater area surrounding Invercargill. Many areas would effectively become islands.

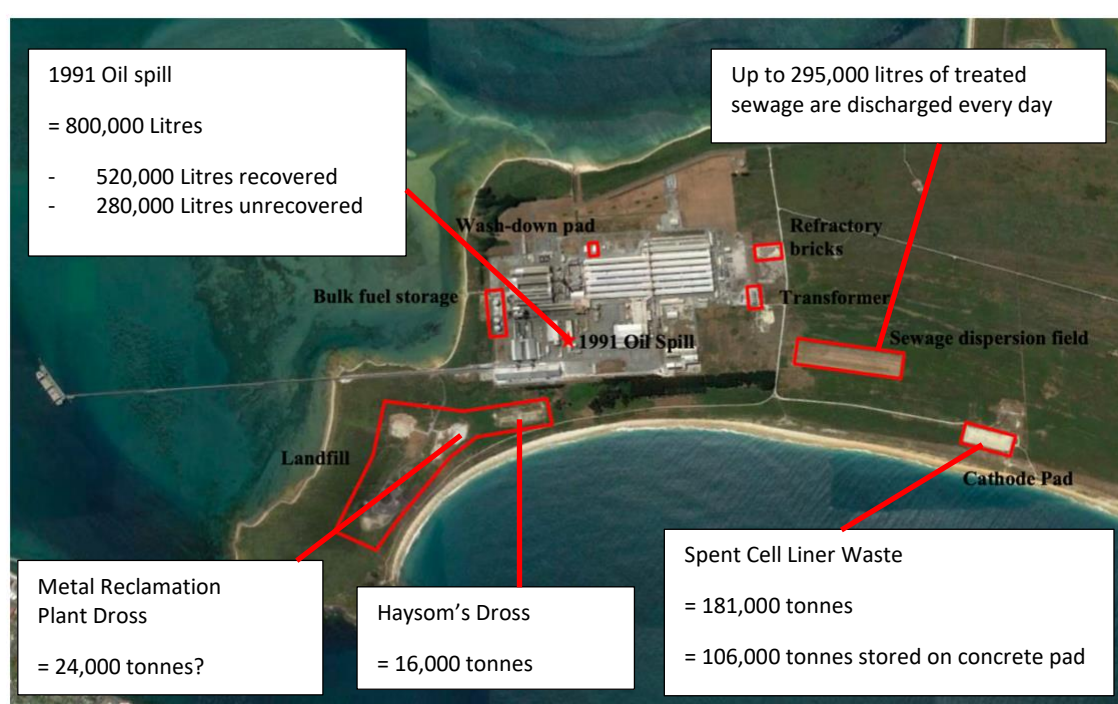
1. Landfill
2. Bulk fuel storage
3. Wash-down pad
4. 1991 oil spill
5. Refractory bricks
6. Transformer
7. Sewage dispersion field
8. Cathode pad – at risk from coastal erosion

Figure 1: Aerial image of the Tiwai site (Google Earth, dated 13/01/2018?). Red areas show known and potential sites of soil or groundwater contamination.

Figure 6: Aerial map provided by ES showing known and potential sites of soil or groundwater contamination. Text boxes have been added to provide more summary information.

The Briefing Note provided by Environment Southland (ES) contains a map (Figure 1) showing eight known and potential sites of soil or groundwater contamination at Tiwai Point.

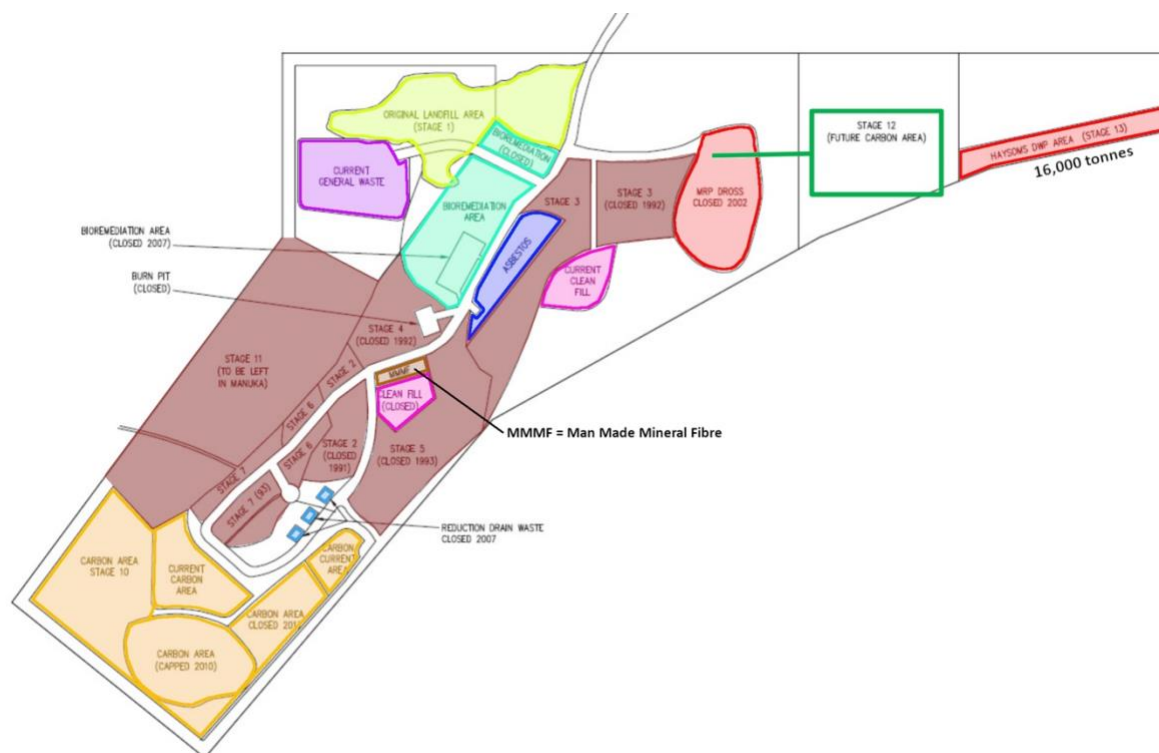
Figure 7: Map of the Tiwai Landfill from the 2019 NZAS environmental monitoring report. Colour has been added by the author to group areas with similar contaminant types. Areas shaded dark red contain undisclosed material/contaminants. The area shaded yellow is the original landfill area.

Operation of the NZAS landfill on the smelter's Tiwai Point property is covered by Discharge Permit No. 202196 issued by the Southland Regional Council (Environment Southland) on 8 December 2004. A detailed map of the landfill as it was in 2019 is provided in Figure 7.

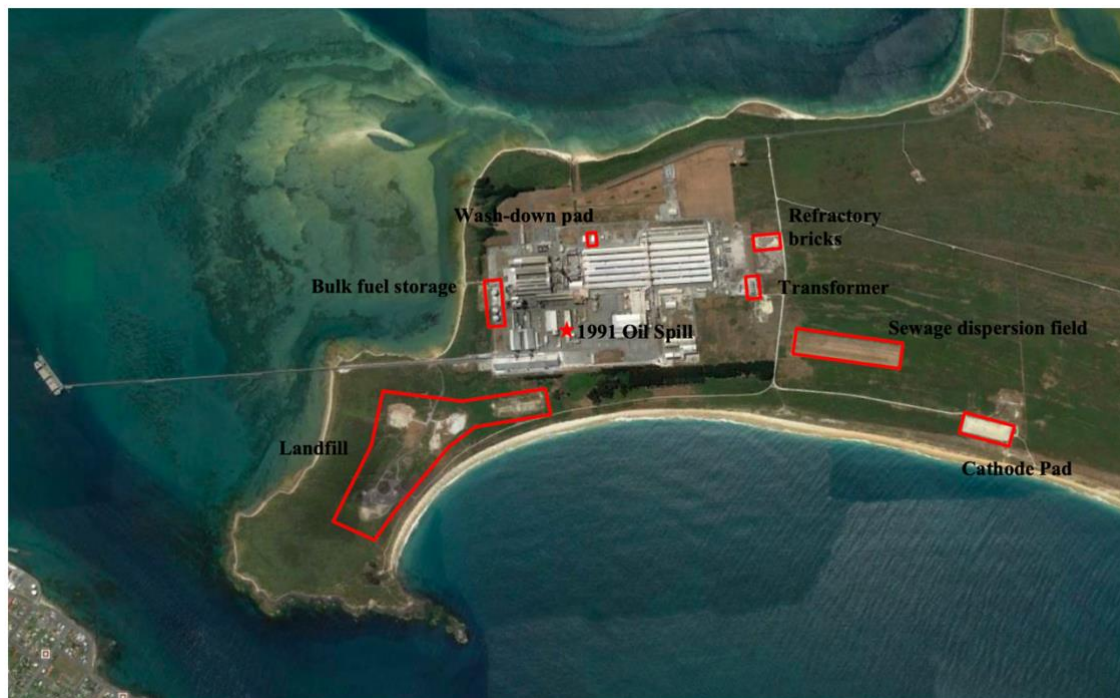
NZAS stores large quantities of heavy fuel oil, pitch and petroleum coke (see map below).

Figure 1: Aerial image of the Tiwai site (Google Earth, dated 13/01/2018?). Red areas show known and potential sites of soil or groundwater contamination.

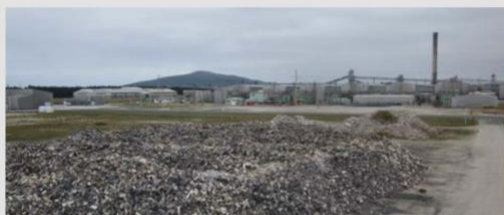
Rubble pile near the East Gate

If you've driven past the East Gate lately, you will have noticed that the massive pile of bricks has disappeared. The rubble was made up of bricks from the latest carbon bake rebuild completed in February 2013, crushed concrete light posts, crushed fluewall tops, other refractory material etc.

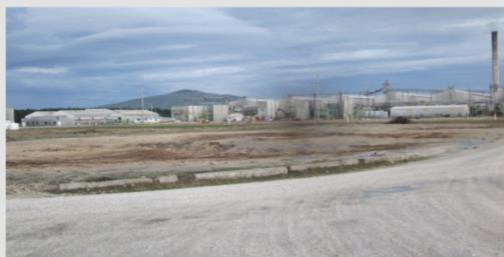
Cleared area

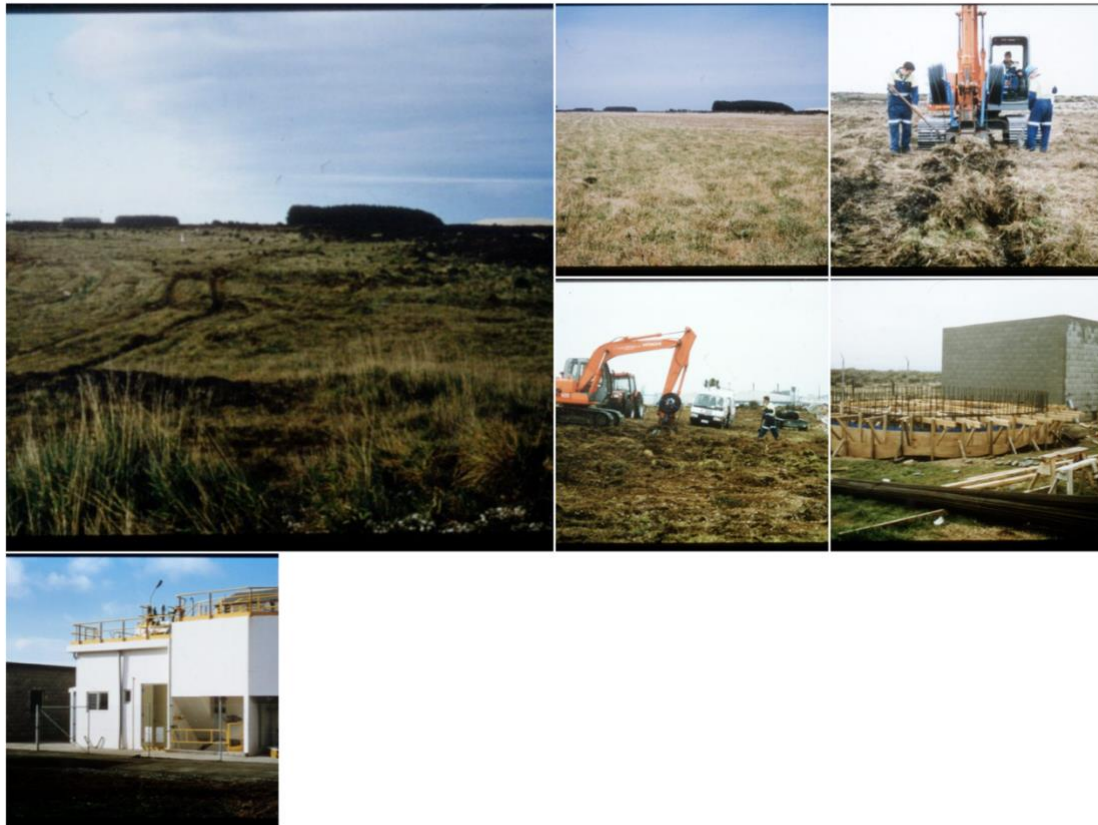
Ecogent supplied design services and subsurface drip irrigation for the Tiwai Point Aluminium Smelter. Refinery wastewater is irrigated under 6 hectares of Department of Conservation lands which to this day it remains the largest industrial SDI installation in NZ. More details coming soon...

The system used was designed by Ecogent – Environmental Engineering Solutions.

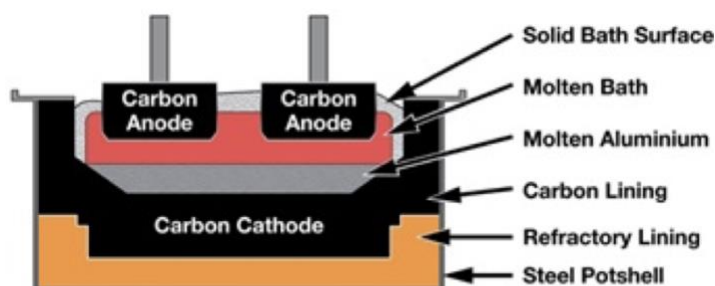
The lining of the pot is typically made of two layers - an insulating refractory lining and an interior carbon lining. Over time, the cell lining wears and can form cracks that reduce its ability to hold the liquid metal in the cell. When the lining of the pot comes to the end of its life, typically after 4-7 years, it is classified as spent pot lining (SPL).

Figure 1: Cross section of aluminium pot (Regain 2019)

This process occurs within carbon-lined steel pots (Figure 1) to produce molten aluminium metal.

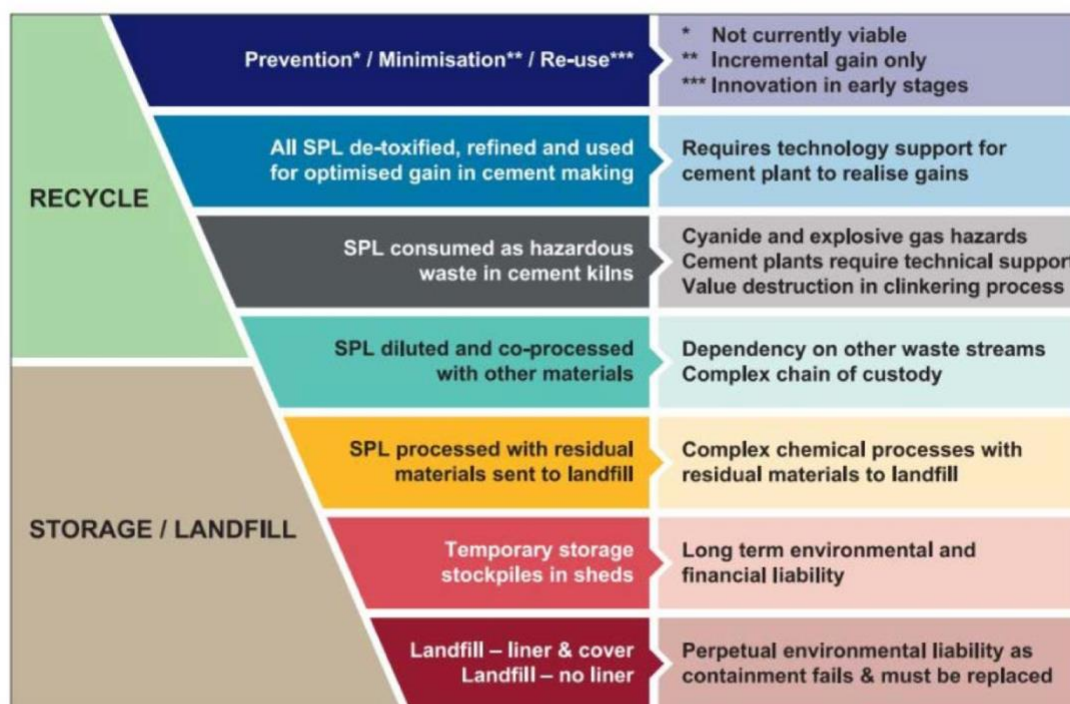
Figure 6: SPL disposal and waste management hierarchy
(Aluminium International Today, 2018)

- Avoidance – minimising waste generated through the optimisation of processes;
- Segregation – separating wastes to increase reuse or recycling;
- Reuse – using SPL as a resource;
- Recycling – making SPL suitable for use in other processes;
- Energy recovery – conversion of waste materials into useable heat, electricity or fuel; and
- Appropriate disposal – with minimum impact on the environment and human health.
