New Zealand Aluminium Smelters Limited NZAS Closure Preliminary Study

Geology Report

12533899-4100-CI-RPT-00001

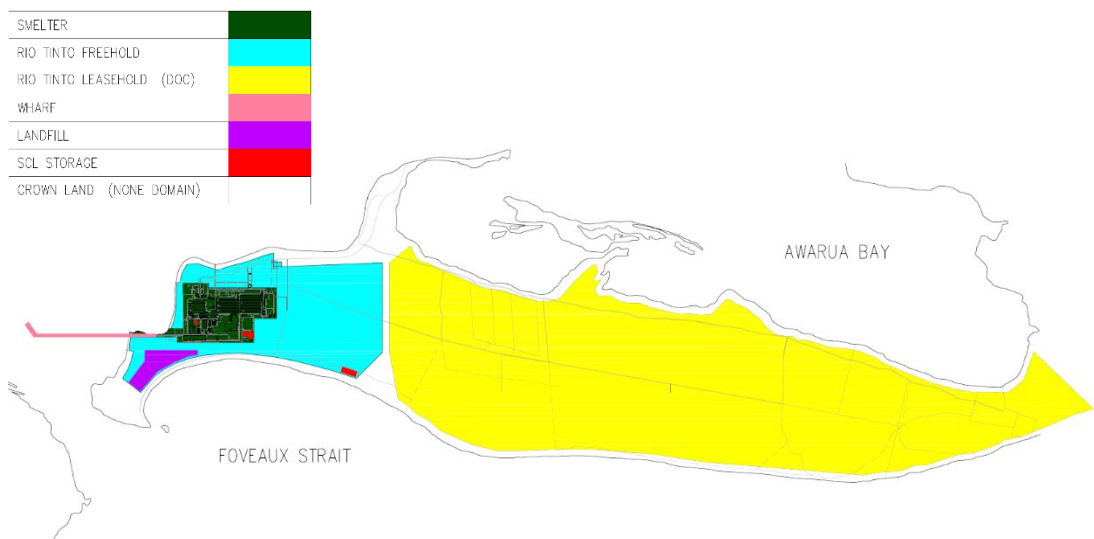
Figure 2-1 Tiwai Point and Peninsula domain map

The Tiwai Point and Peninsula has been subdivided into domains according to the 2020 basis of design as follows (GHD, 2020; Figure 2-1):

- Landfill – located at Tiwai Point consisting of NZAS built landfill south of the Smelter Domain, including the Haysom Dross site;
- Smelter – located at Tiwai Point and includes all buildings and infrastructure of the Smelter;
- Wharf – located at the west end of the peninsula. In this report the Wharf is included in the Smelter Domain;
- Spent Cell Liner (SCL) Storages – located on the south coast of the Freehold Domain, where the SCL is stored on pads;
- RT Freehold Land – located on Tiwai Peninsula, east of the Smelter Domain; and
- RT Leasehold Land – comprises most of the Tiwai Peninsula and contains the bores that comprise the water bore field supplying water to the Smelter.

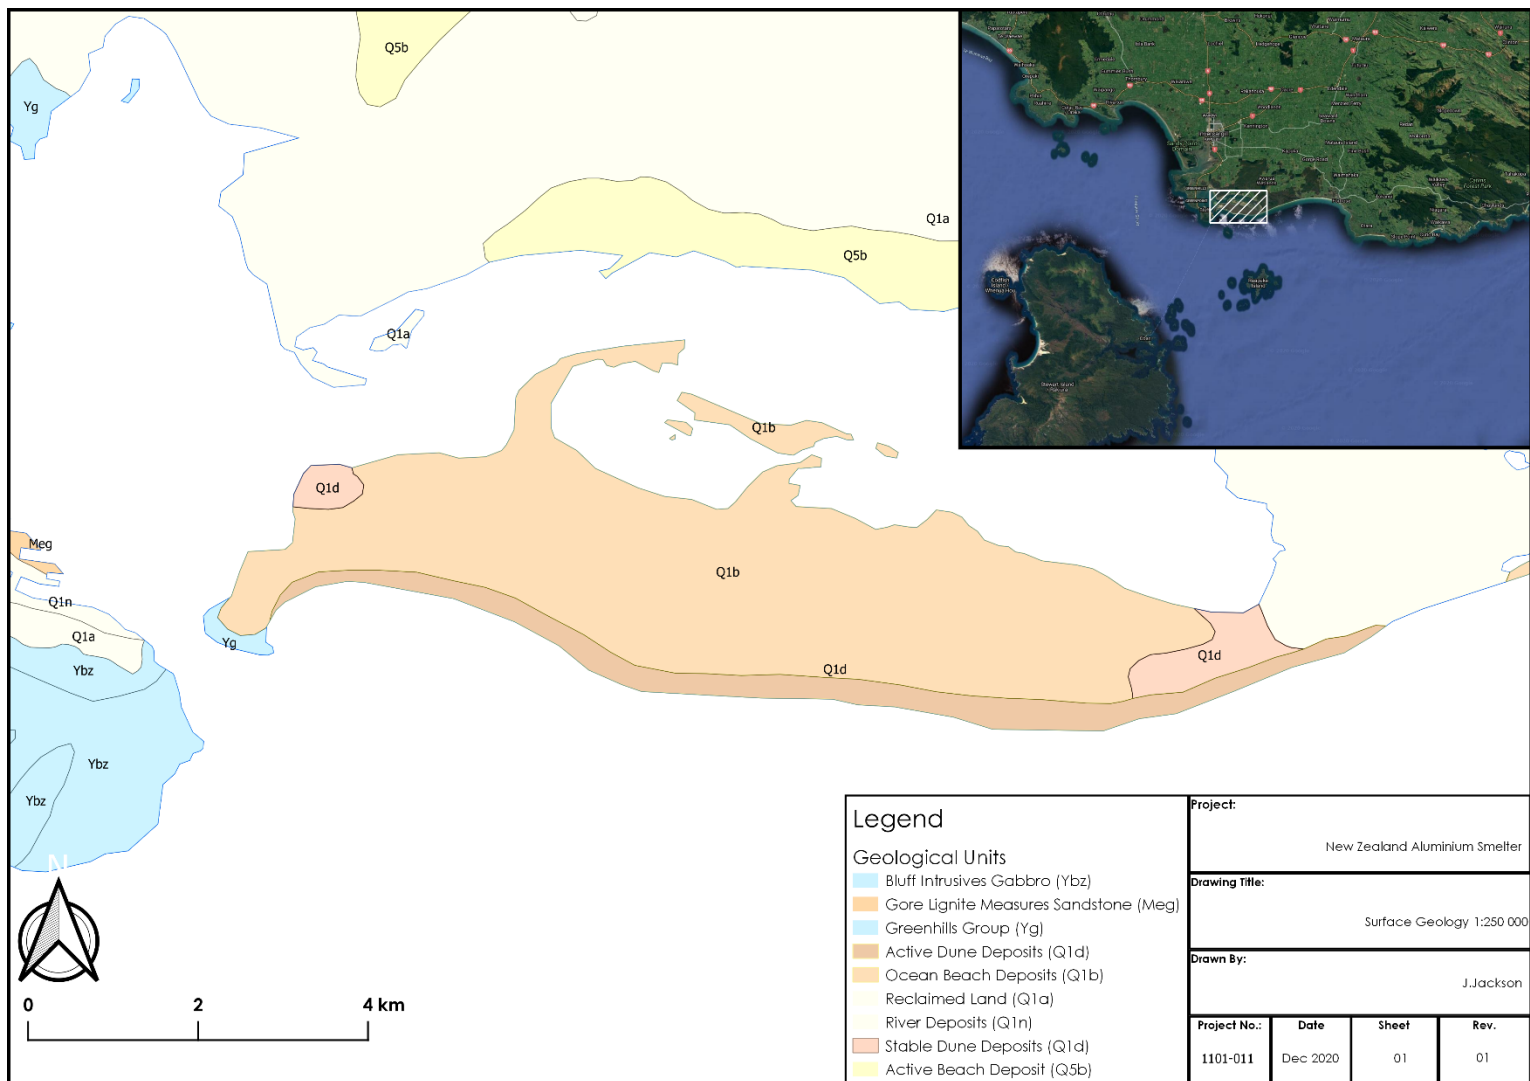
Figure 3-1 Geological map of the Tiwai Peninsula

The Tiwai Point Peninsula is predominantly comprised of Quaternary unconsolidated beach deposits comprised of beach (pea) gravels and sands (Figure 3-1). An extensive area of pea gravel occurs as well-developed ridges orientated east-west along the peninsula (Q1b; Turnbull and Allibone, 2003). Pea gravels are comprised of well-rounded, flattened mostly quartz and some darker clasts likely of eroded local basement rocks (Greenhills Group; Figure 3-2). The ridges represent a complex mass of prograde beach fronts marking former positions of the oceanic shoreline (Figure 3-3). Sand and gravels have been reworked from the floor of Foveaux Strait, which was land connection to Stewart Island during the last glacial period (Kirk and Lauder, 2000). During the last post-glacial sea level rise, considerable volumes of coarse sediments were swept up to form Tiwai Peninsula.

Active sand dune and back-beach ridge fields comprised of sand and gravel are mapped along the southern beach and beneath the Smelter Domain (Q1d), as well as on the far eastern extent of the peninsula where it connects with the mainland. Beneath the sand and gravels are older sediments comprising clays, sandy mudstones, muddy sandstones, sandstones and lignites (GCNZ, 1990). In places, test bores have intersected > 60 m thickness of unconsolidated sediments overlying basement rock, although the exact location of these bores is not known as it is not provided on the drill logs (GCNZ, 1990). Generally, these deeper test bores comprise pea gravel and sands to 16 to 25 m below ground level (bgl), then progressively with depth more clays, and the dominance of mudstones and sandy mudstones over sands and gravels, and the presence of lignite.

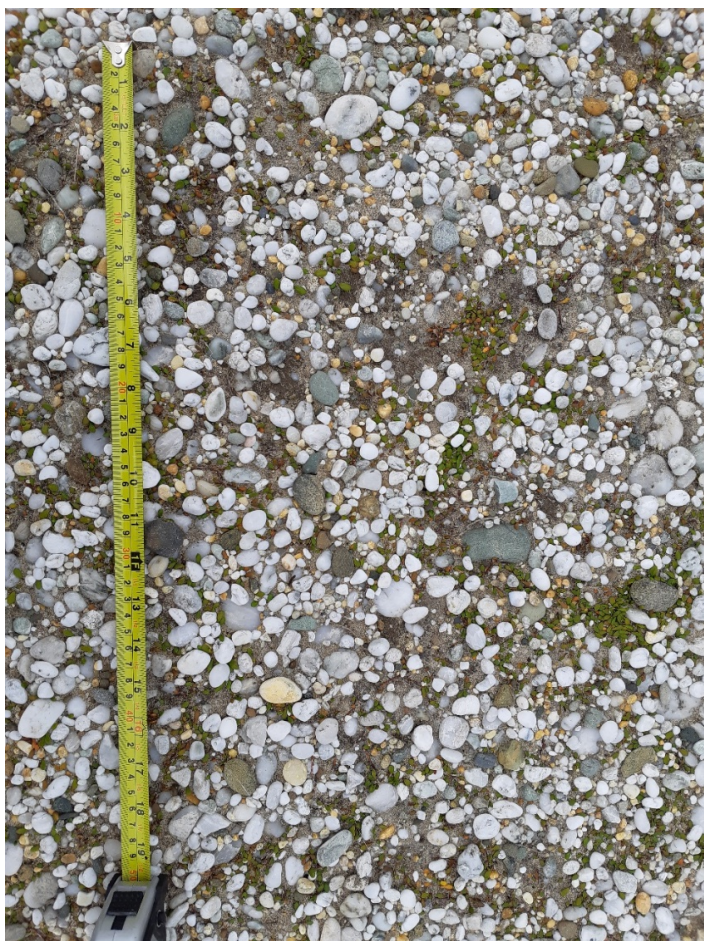
Figure 3-2 Surficial unconsolidated sediments comprised of pea gravels

Length of tape measure = 0.5 m

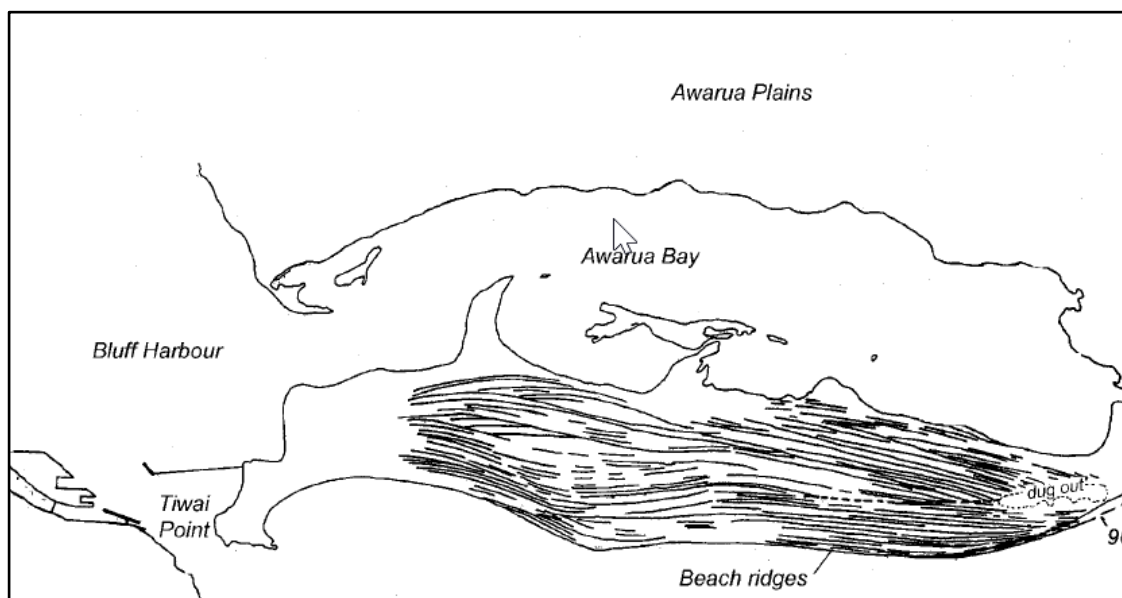
Figure 3-3 Geomorphology of beach ridges at Tiwai Peninsula

Steep coarse sand and gravel beach ridges of Tiwai Peninsula separate the internal water body of Awarua Bay from Foveaux Strait and open ocean (Figure 3.3). Awarua Bay is a long estuarine arm at the eastern end of the Bluff Harbour. The wave energy generated by frequent storm events in the South Ocean contributes to alternating areas of accretion and erosion driven by the longshore sediment transport patterns, although some of this is dispersed by Stewart Island and other smaller islands to the south (MetOcean, 2017).

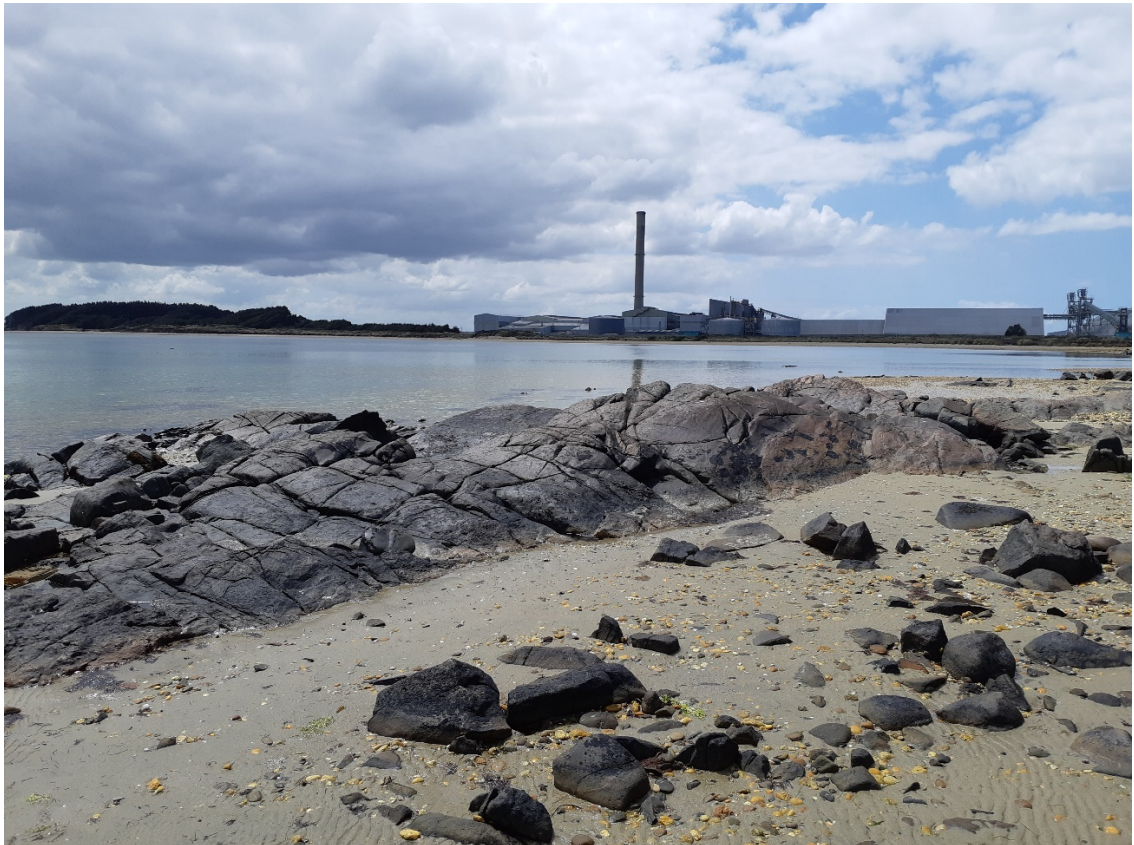
Figure 3-4 Outcrop of Greenhills Group near Tiwai Wharf (looking east)

Hard rock outcrops of basement rocks at Tiwai Point comprise basalt, keratophyre, altered diorite, albite-actionolite schist and granite of the Greenhills Group (Figure 3-4; Mossman, 1970; Turnbull and Allibone, 2003), which also outcrop along the Bluff Peninsula. Basement rock

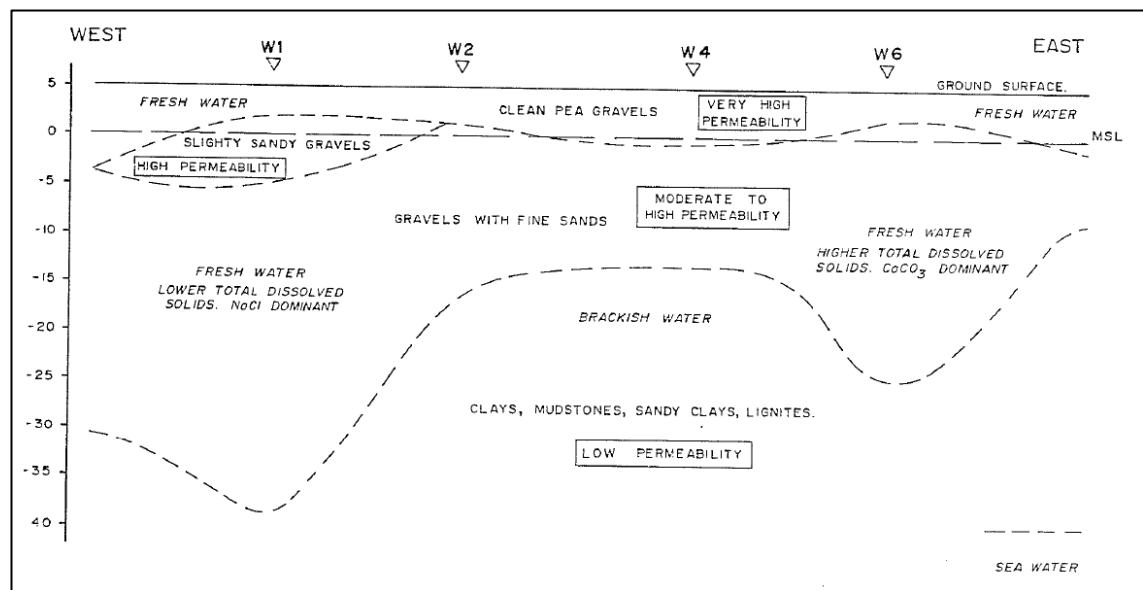
Figure 3-5 Cross section through the Tiwai Peninsula illustrating water quality types

Minimal information on the geochemistry or mineralogy of the unconsolidated sediments at NZAS is available. The groundwater aquifer in the Leased Land Domain is mainly a sodium chloride type water with a component of calcium bicarbonate (Figure 3-5; Woodward-Clyde 1994b). For the production wells (well 1, 1A, 2, 3, 4 and 6), groundwater is slightly acid to slightly alkaline (pH 6.8 to 7.7) with moderately low dissolved solids (up to 250 mg/L) and low salinities (up to 69 mg/L Cl; GCNZ, 1990). A trend was identified in water types, with sodium chloride dominated water in well 1A at the west end of the bore field to calcium bicarbonate dominated water at the east end, with corresponding increase in total dissolved solids from west to east. GCNZ suggested that the groundwater through flow is greater in the west where higher permeabilities exist. The water in the west is similar in its major components to rainwater. In the east, slower groundwater movement due to less permeable materials, has provided sufficient time for greater dissolution of material which includes shell fragments, increasing total dissolved solids and dominance of calcium bicarbonate type water.

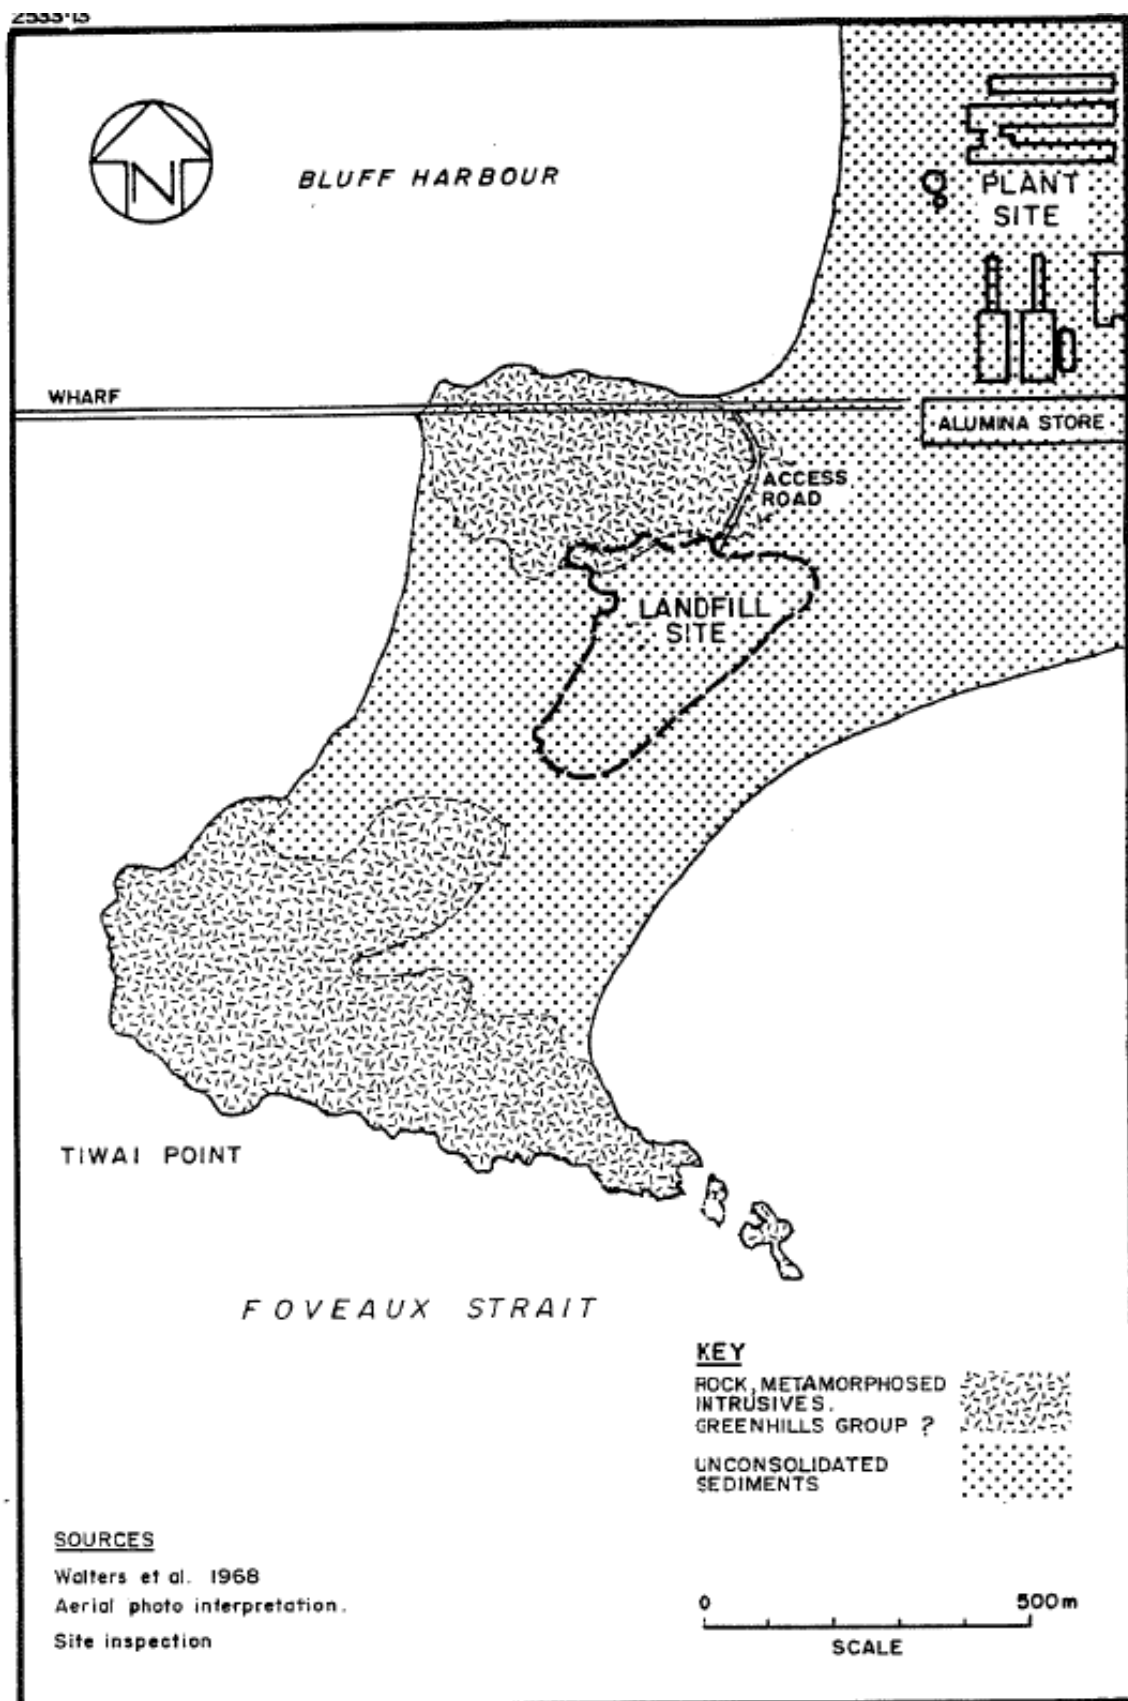
Figure 4-1 Landfill surficial geology

Unconsolidated sediments in the Landfill Domain are underlain by hard, dense fine-grained intermediate intrusive basement rocks belonging to the Greenhills Group (Figure 4-1).

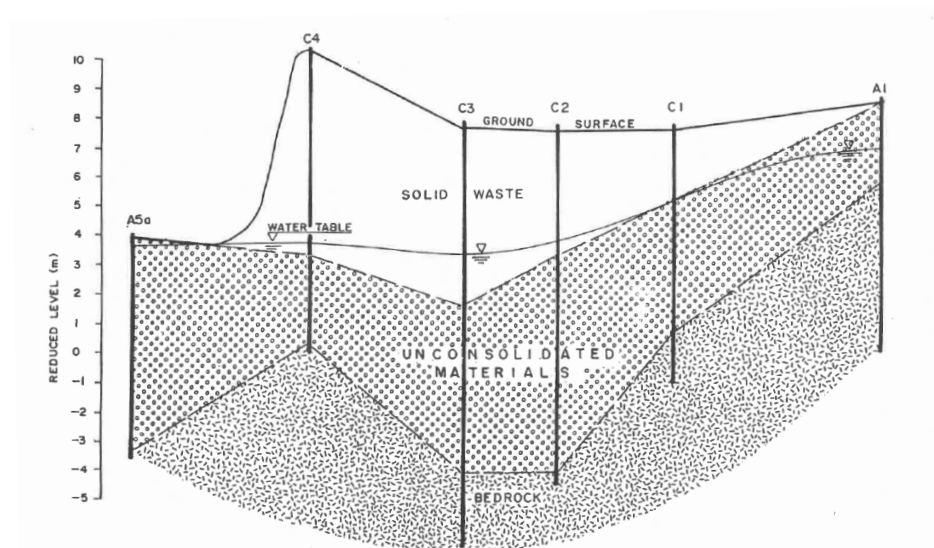
Figure 4-2 North (Bore A1) to south (Bore A5a) cross section through the Landfill Domain

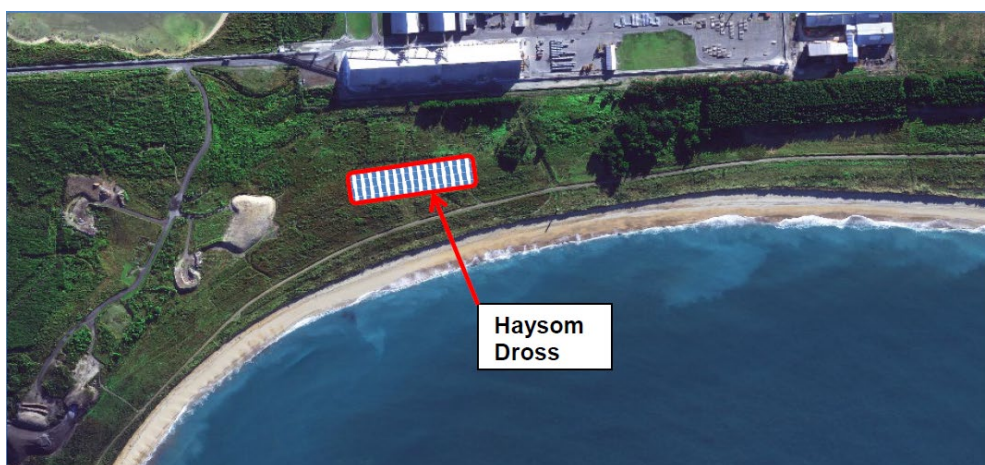
Figure 4-3 Location of Haysom Dross between the Landfill Domain to the west and Smelter Domain to the north

The eastern most part of the landfill contains the Haysom's dross area, where sediments are up to 13 m thick, consisting of sands and gravels overlying mudstone deposits. This area is south of the Smelter Domain near the southern coastline of Tiwai Peninsula (Figure 4-3). There is a transition with the appearance of sand at a depth of approximately 6 m bgl that has an associated decrease in conductivity from 1.0×10^{-4} m/s to 1.0×10^{-5} m/s (URS, 2003). Hydraulic gradients are variable, averaging 0.001 m/m (1V to 1000H).

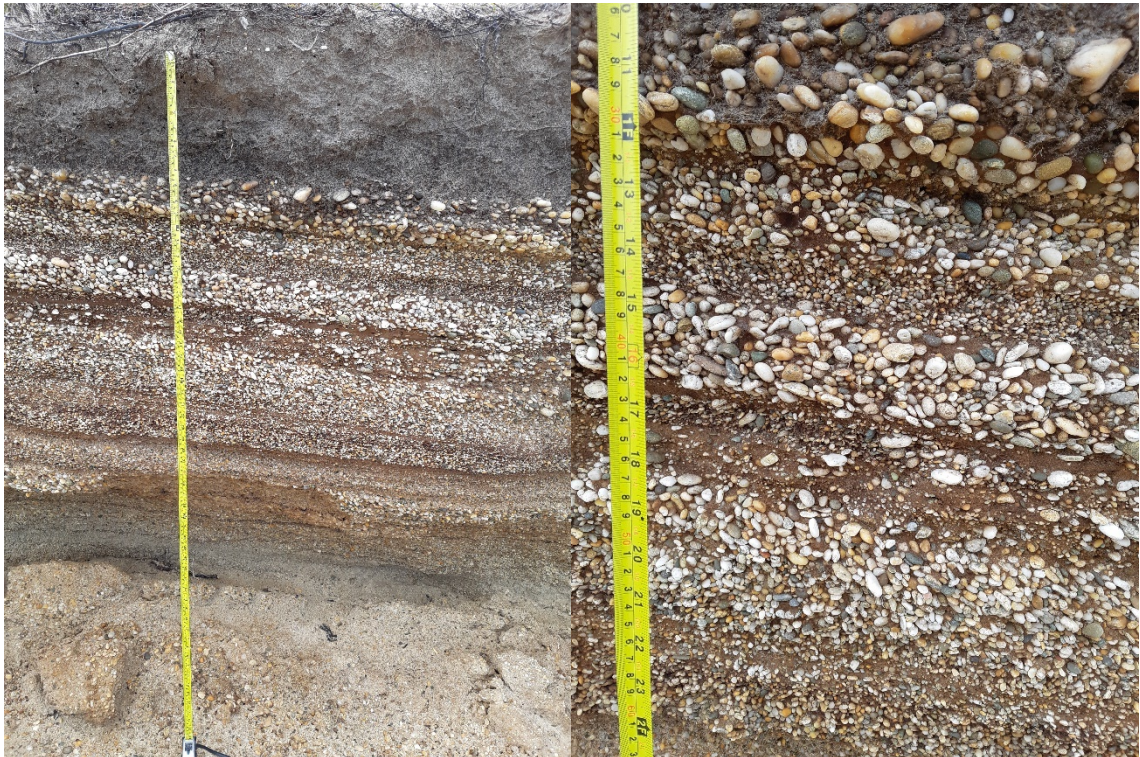
Figure 4-4 Excavation of near surface pea gravels at the coast north of the Tiwai Wharf, adjacent to the Smelter

Tape measure 1.5 m in the left photo

Woodward-Clyde (1994a) noted that the geology at the Smelter Domain is similar to that encountered at the SCL Storages Domain and the Leasehold Land Domains (unconsolidated sediments; Figure 4-4 and Figure 4-5). Woodward-Clyde suggested that the Smelter Domain geology is a transition zone from the gravel rich units in the Leasehold Land Domain to the sands of the Landfill Domain. Drill log data indicates a greater amount of sand is present in the shallow gravels at the Smelter Domain than those in Leased Land Domain (Woodward-Clyde 1994a). Exposed gravels along the coast, north of the Tiwai wharf, show layers that are gravel-rich and clast-supported, between layers that matrix-supported with the presence of fine sand (Figure 4-4).

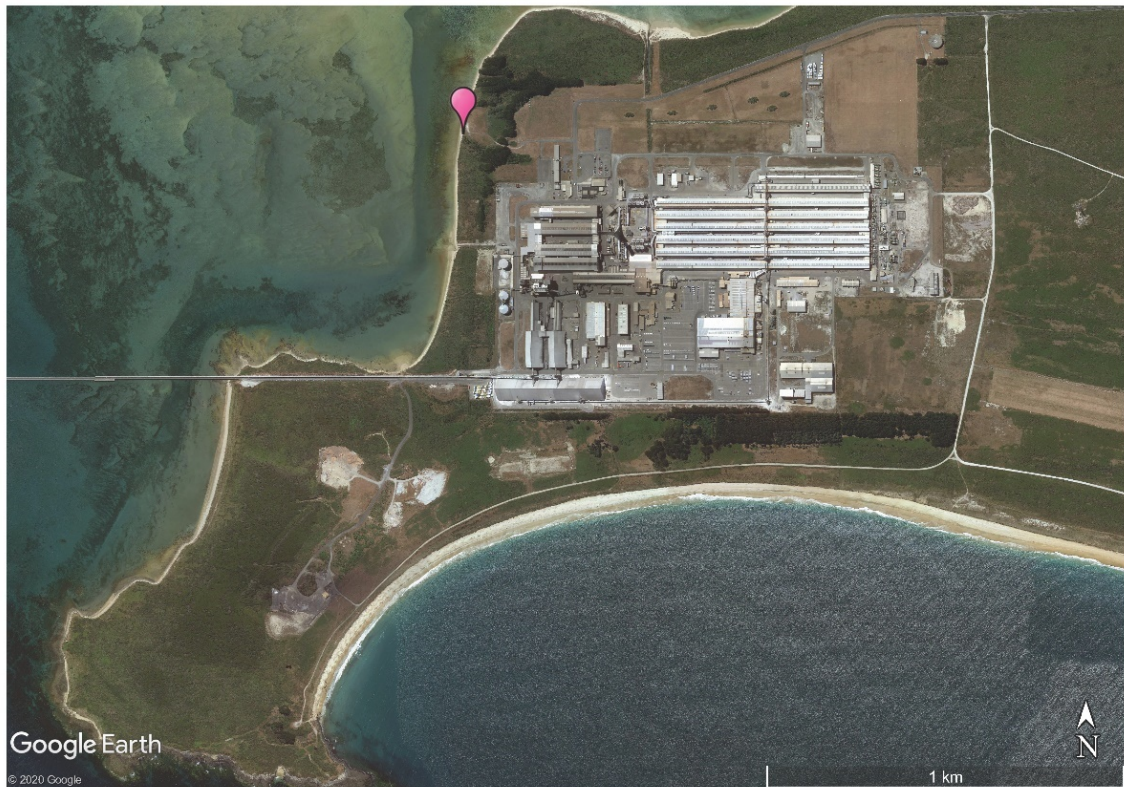
Figure 4-5 Location of pea gravel exposure at coast (Figure 4-4)

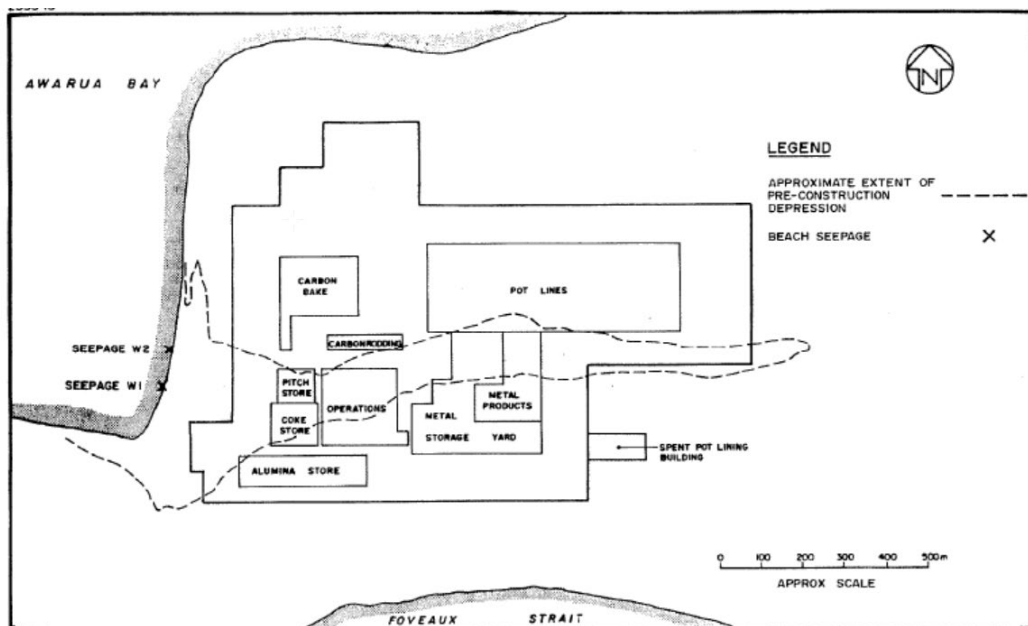
Figure 4-6 Location of pre-construction depression at the Smelter Domain

Disturbed ground beneath the Smelter Domain (Figure 4-6) represents a natural pre-construction depression that was infilled with surface materials, likely pea gravels and sand, to level the site. This infilled depression has an influence on groundwater flow (Woodward-Clyde, 1994a). Reviewing old aerial photos of the site (ca 1963) suggests that this depression was likely a partially naturally infilled lagoonal wetlands area with some surface water present (Figure 4-7).

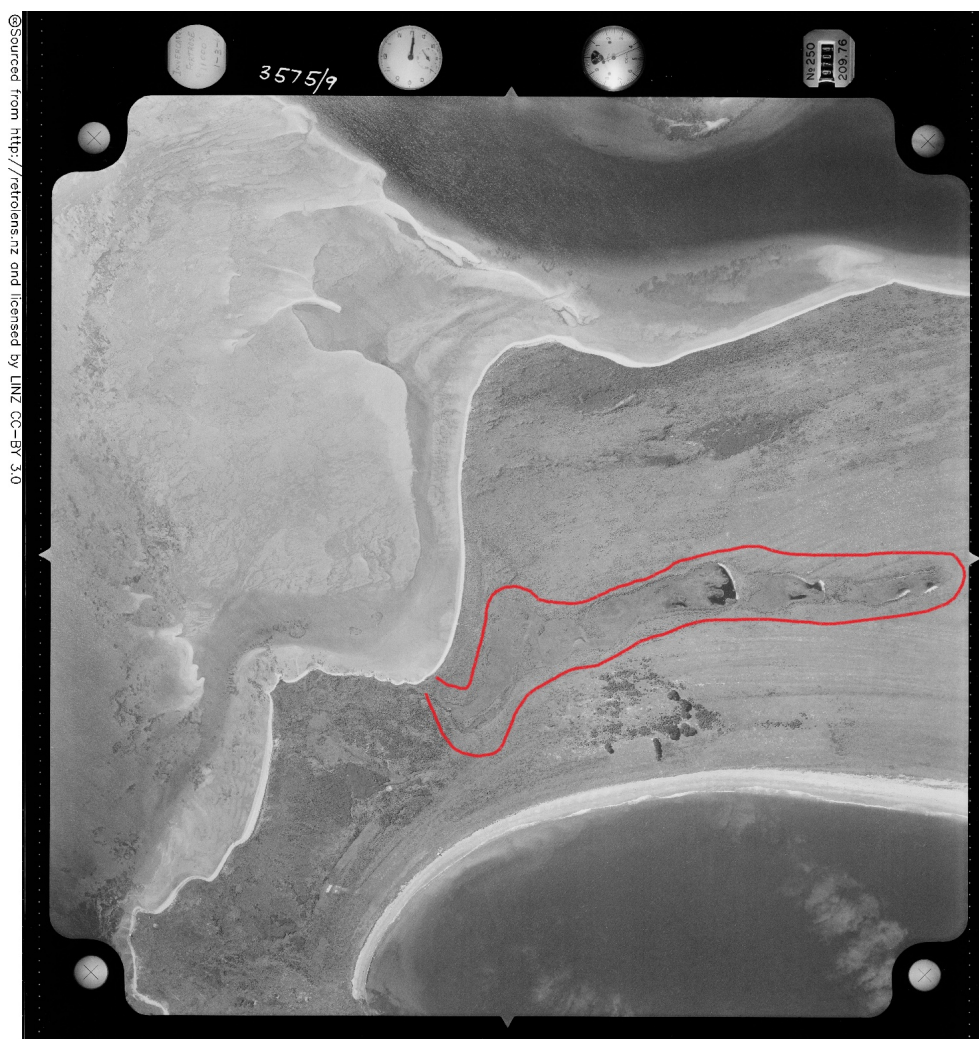
Figure 4-7 1962 aerial photo of the Smelter Domain illustrating the (wetlands) depression

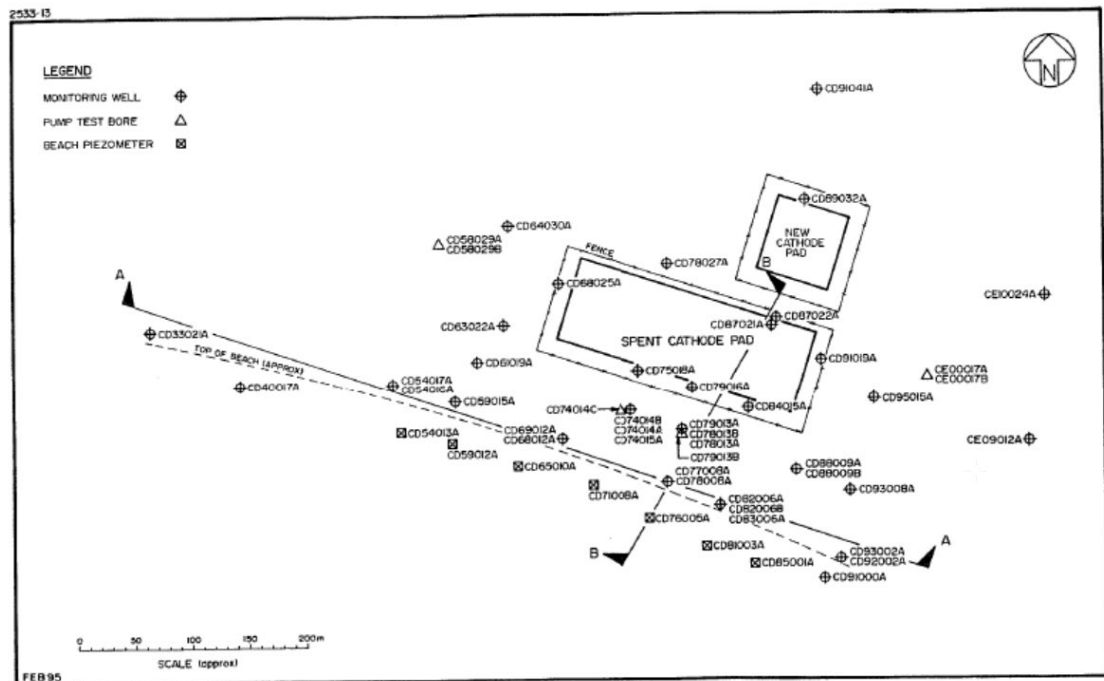
Figure 4-8 Location map of SCL Pad and Section A-A and B-B

Sedimentary units underlying and surround the SCL pad (Figure 4-8 and Figure 2-1) have been defined (Woodward-Clyde, 1994a; NZAS, 2005b) as follows:

Groundwater flow is noted to be greater in the pea gravel unit than the fine sands because of the higher permeability of the gravels (NZAS, 2005b). In the area south of the SCL (Figure 4-8) groundwater is 2 m bgl (Figure 4-9).

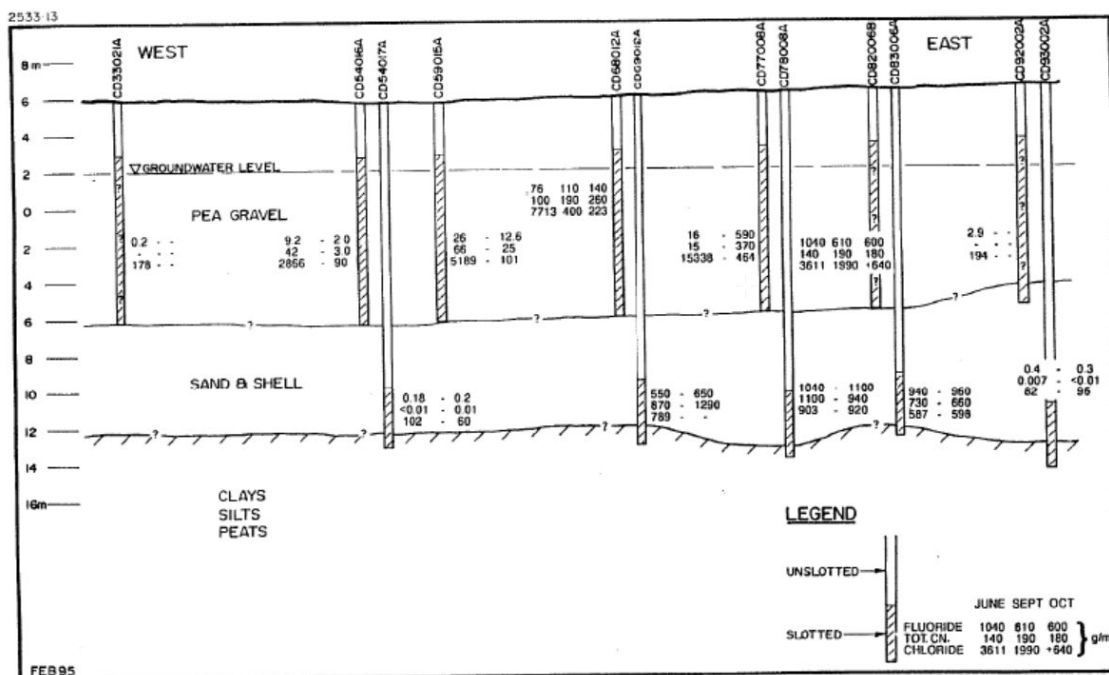
Figure 4-9 East-west cross section of the geology and groundwater level below the SCL Pad

- Pea gravel to a depth of 12-14 m (Figure 4-9 and Figure 4-10);
- Underlain by a fine sands and shell unit to a depth of 18-20 m; and
- Silt, clay and peat (lower permeability) which form an aquifer boundary at the base of the fine sands unit.

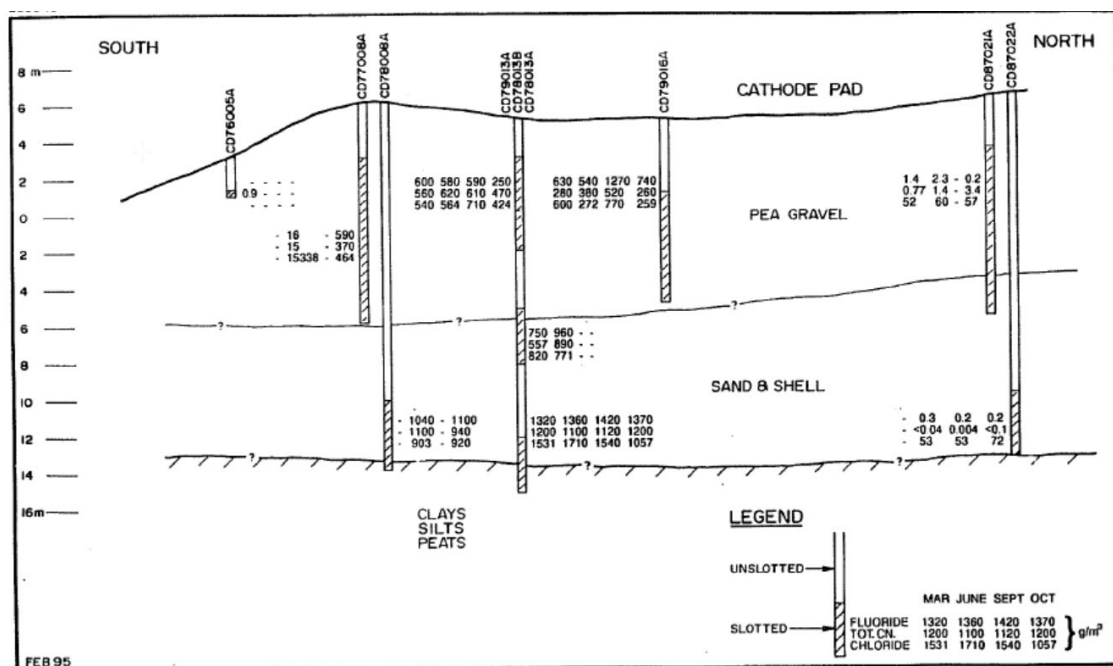
Figure 4-10 North-south cross section of the geology below the SCL Pad (Section B-B)

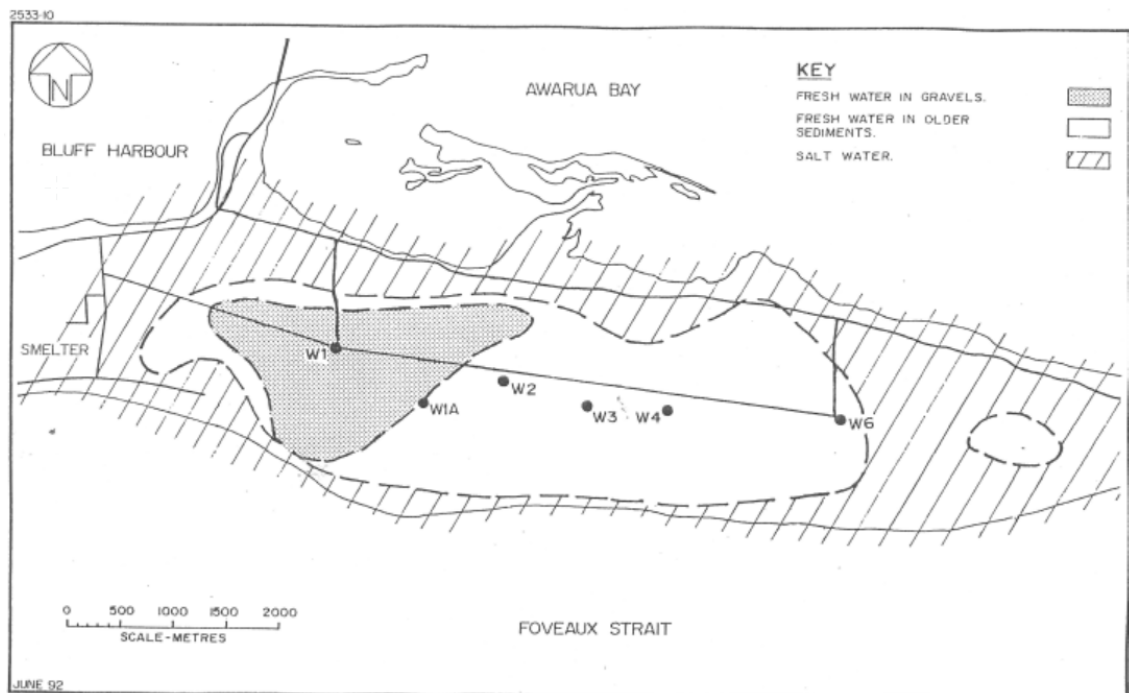
Figure 4-11 Location of bore field in the RT Leasehold Land Domain

The Leasehold Land Domain contains the borefield that supplies water to the Smelter Domain (Figure 4-11). Drill logs and resistivity logs for this borefield supply information on the sub-surface geology of the Tiwai Peninsula. The Leasehold Land Domain is comprised of an extensive beach (pea) gravel and sand deposits developed into well-defined ridges that are orientated in an east-west direction (Figure 3-3). On the surface, the area is dominated by pea gravels with one area of surficial sand deposit noted during the site visit along the northernmost track that transverses the peninsula and adjacent elevated dune (Figure 4-12 and Figure 4-13). Older sediments comprising clays, sandy mudstones, muddy sandstones, sandstones and lignites occur 20 to 30 m bgl beneath the sands and gravels forming a less permeable layer (Figure 4-14 and Figure 4-15; GCNZ, 1990). Hard basement rock was intersected by deep test bores at 60- 65 m bgl, underlying less permeable multiple muddy sandstones and lignite units (GCNZ, 1990). The exact location of these deeper test bore collars is not known.

Nearby wells in the Leasehold Land Domain (Well 1/1A; Figure 4-11) and in the SCL Storages Domain indicate that pea gravels in this area may be at least 10 m thick before grading into more sand dominated units. However, the only known well on the freehold land domain is Well 15(w), excluding the SCL Domain. Well 15 is a decommissioned water well to the east of the Smelter Domain (Figure 4-16). Well 15 was used to supply the site with water during the initial construction phase, so was likely drilled in the early 1970s (NZAS, 2006). The bore logs for this well could not be located so the subsurface geology in the Freehold Land Domain is poorly understood (excluding the SCL Domain).

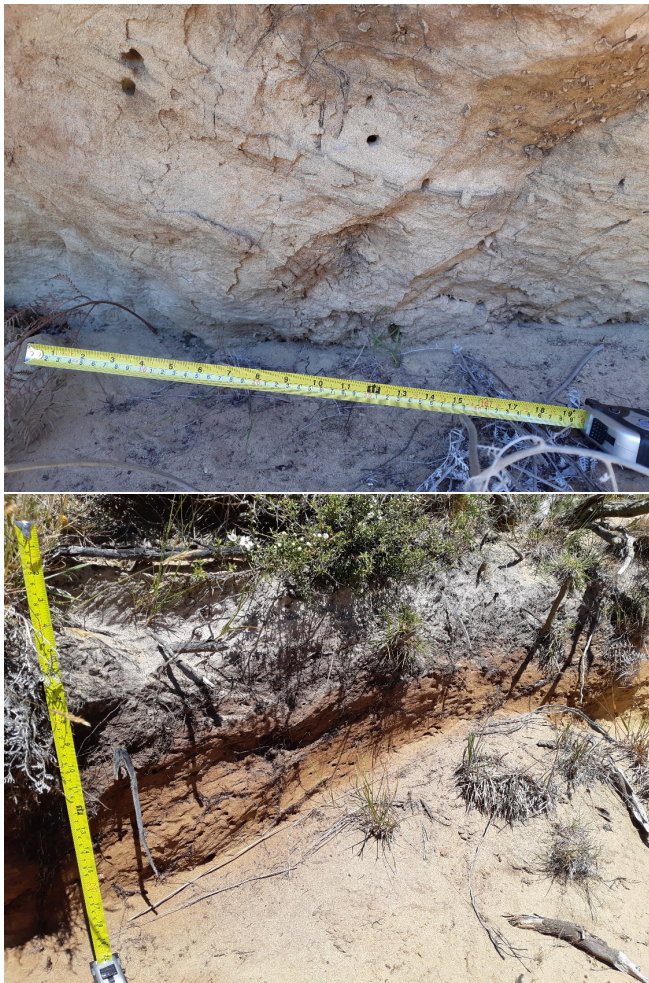
Figure 4-12 Cross bedding in fine sand (top) and cementing of fine sand along the road track (bottom)

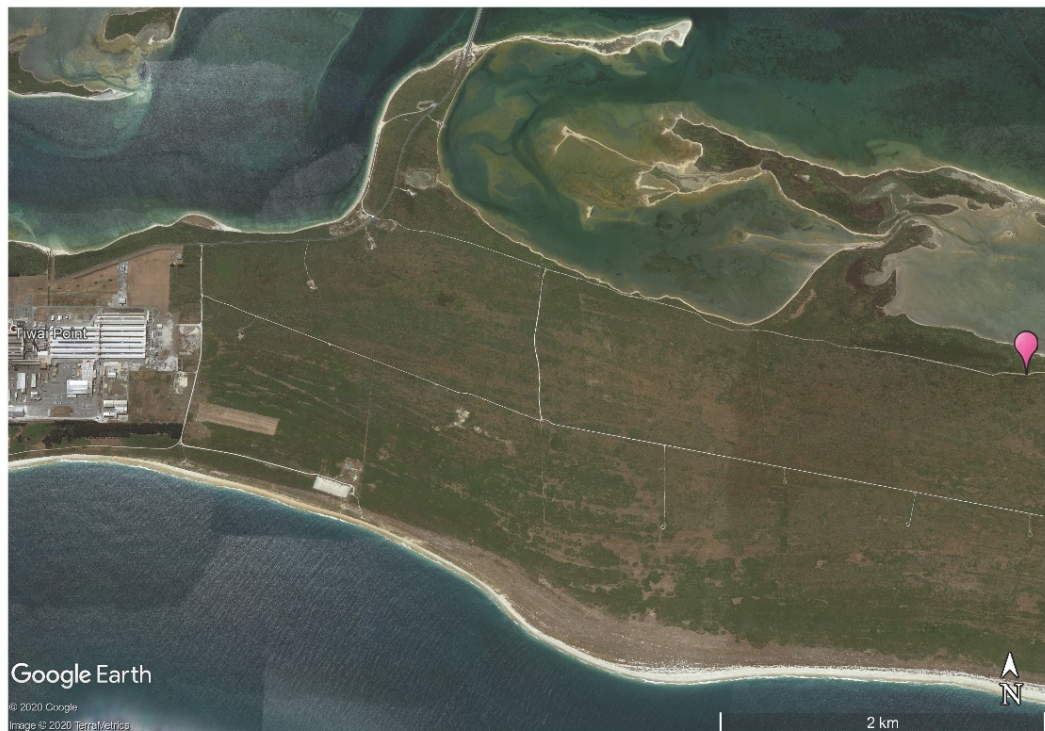
Figure 4-13 Location of sand deposit (Figure 4-12)

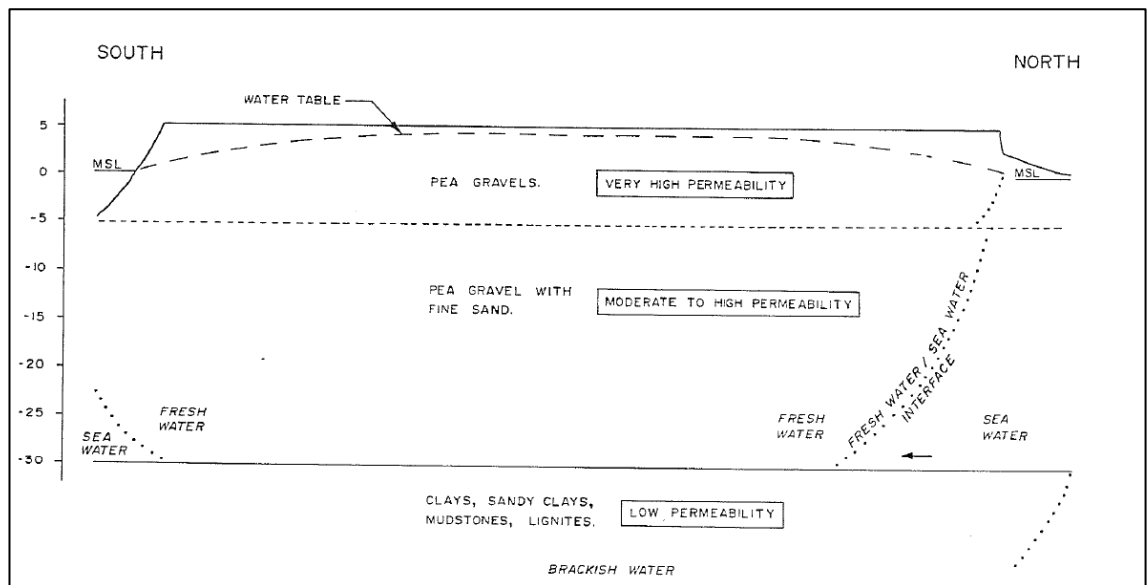
Figure 4-14 Generalised N-S cross section of the RT Leasehold Land Domain

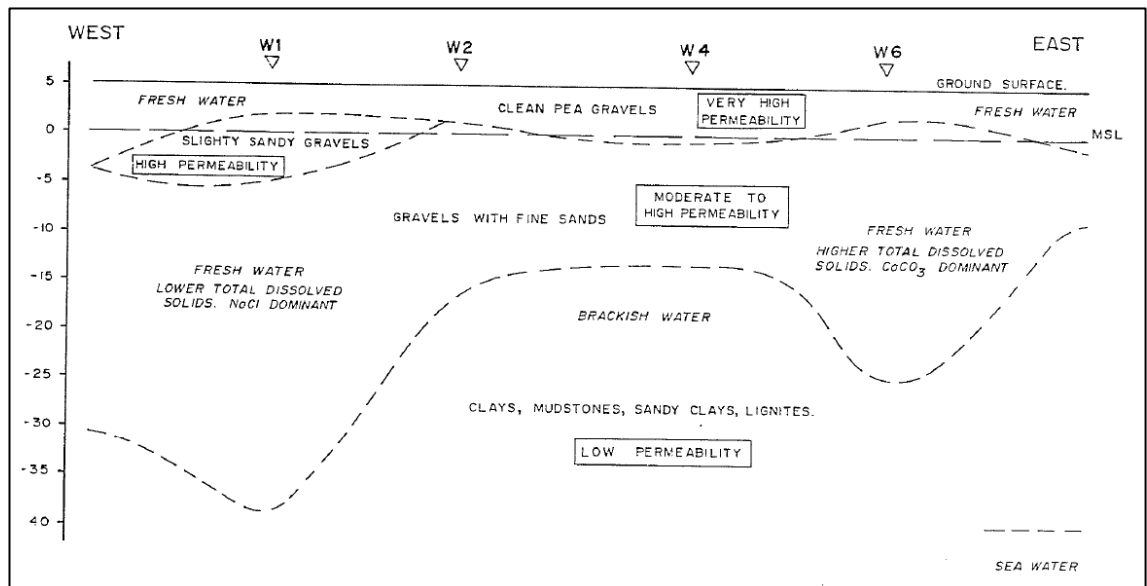
Figure 4-15 Generalised W-E cross section of the RT Leasehold Land Domain with water bores

The depth to the older, less permeable sediments (clays, silts) varies, deepest at W1 in the west, highest under W2 and W4 and dropping again at W6 in the east (Figure 4-15). Changes in depth of the older sediments were interpreted by GCNZ (1990) as paleochannels cut into older sediments prior to the formation of the peninsula sands and pea gravels.
