NEW ZEALAND
ALUMINIUM SMELTERS LIMITED

**REPORT TO THE INTERDEPARTMENTAL COMMITTEE
ON ENVIRONMENTAL EFFECTS OF THE TIWAI ALUMINIUM SMELTER
FOR THE YEAR ENDED 31 DECEMBER 1992**

MEETING AT TIWAI
20th APRIL, 1993

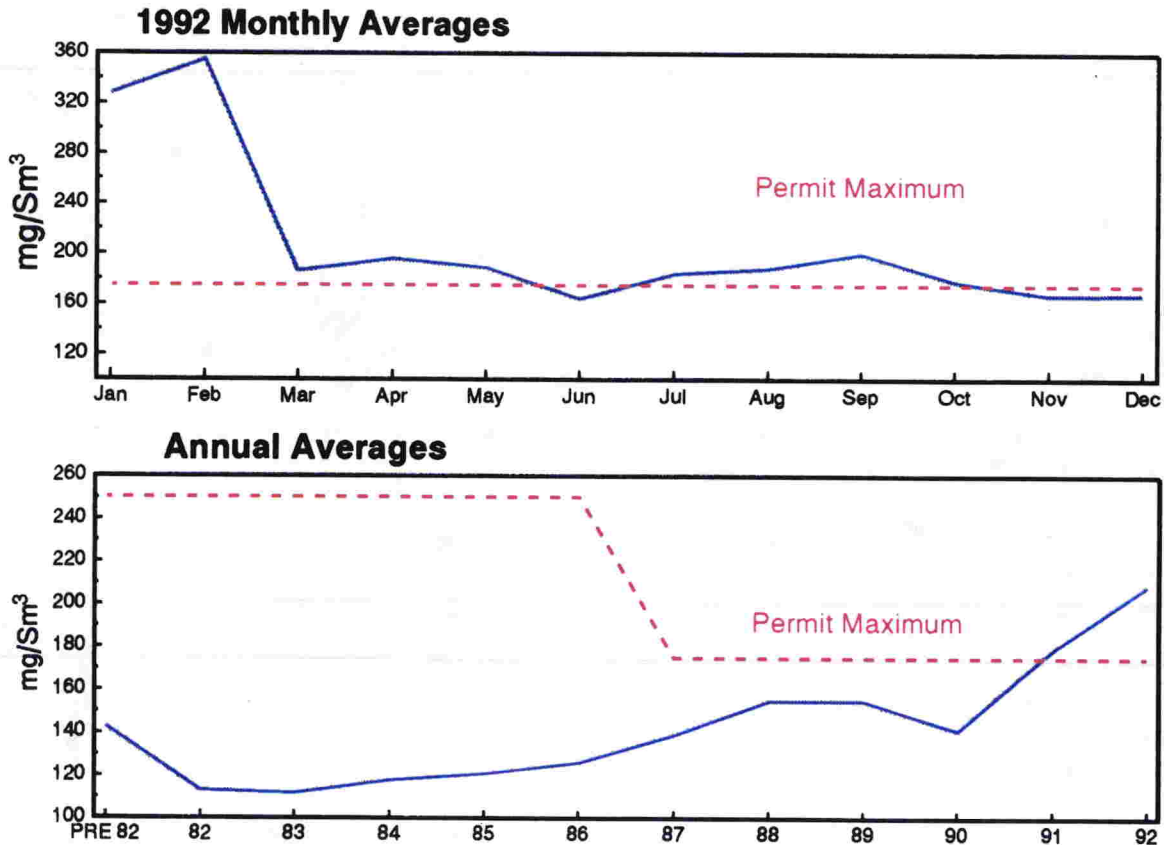
2.1.1 Total Particulate Concentrations

The 1992 average stack total particulate concentration was 206mg/Sm³ exceeding the permit condition maximum of 175mg/Sm³. However, as work progressed on the replacement of the multicyclone paraclones during the year from March 1992, the average total particulate concentration reduced. For the ten months from March 1992 the average particulate concentration was 182mg/Sm³.

It was recognised that to continue the use of alumina injection to control HF gaseous emission and reduce wear on the new paraclones, an additional pre-collection system was required. The first system was installed in Potroom 3A ducting during the third quarter 1992 and optimisation trials completed. While this pre-collector has achieved the expected recovery of injected alumina, the reversion to the original secondary air system to allow collection of the pre-collector material by the Bag House, has caused an increase in fines carry over.

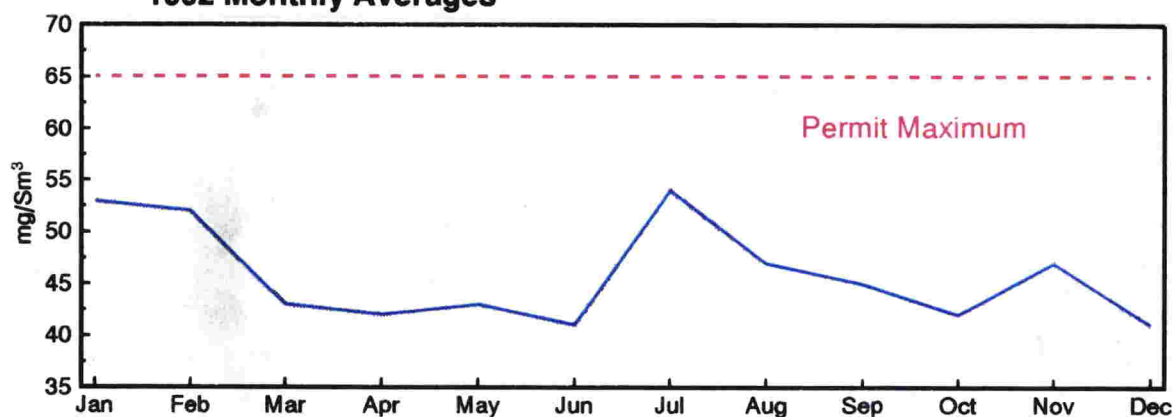
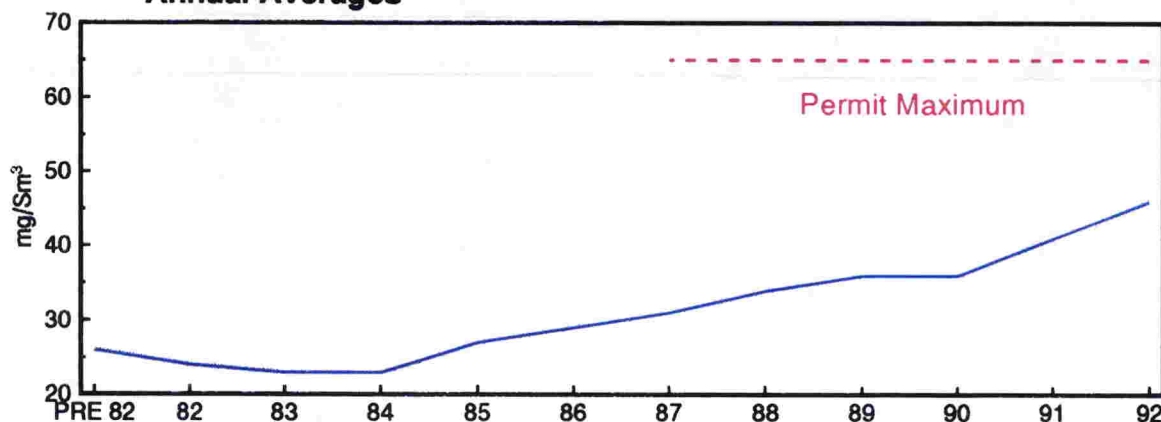
2.1.2 Particulate Fluoride Concentration

The 1992 average stack particulate fluoride concentration was 46mg/Sm.³

Additional comment is made in Section 2.1.1 relating to some fines carry over.

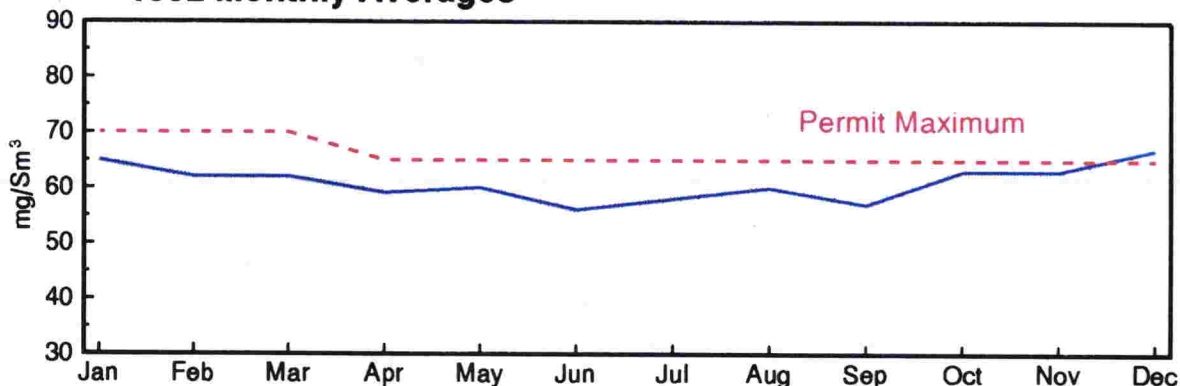
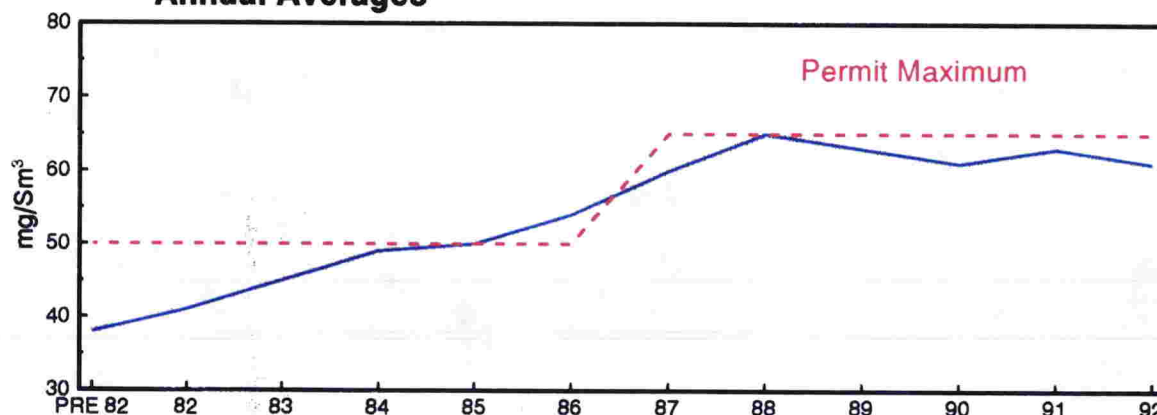
2.1.3 Gaseous Fluoride Concentrations

The 1992 average stack gaseous fluoride concentration of 61 mg/Sm³ was slightly lower than the 1991 average concentration of 63 mg/Sm³. The decrease reflecting improved control of the alumina injection system.

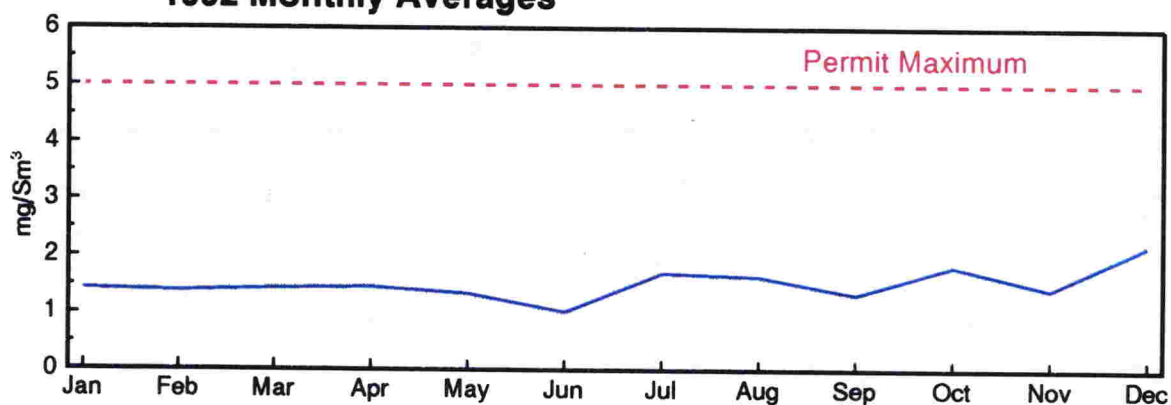
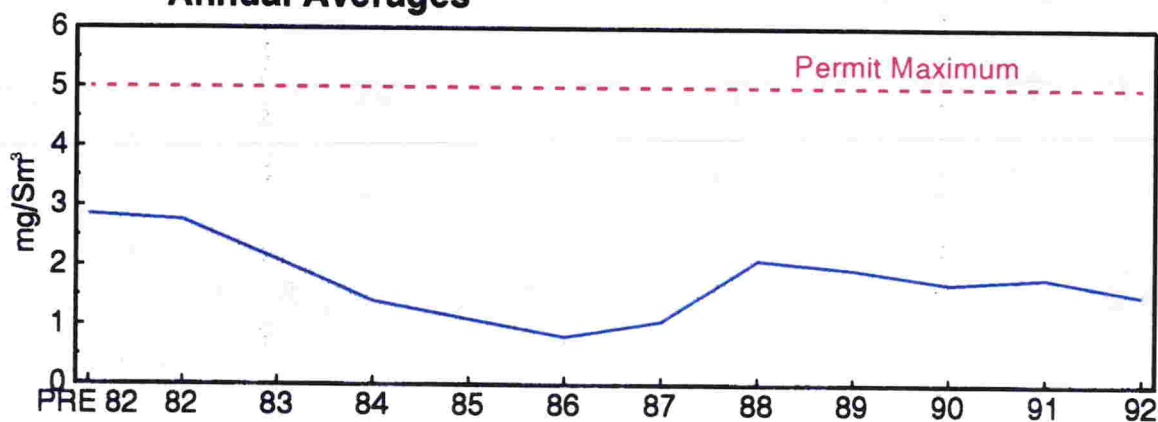
2.2.1 Total Particulate Concentrations

The 1992 average Potroom roof louvre total particulate concentration was 1.51mg/Sm³ . There is no trend evident.

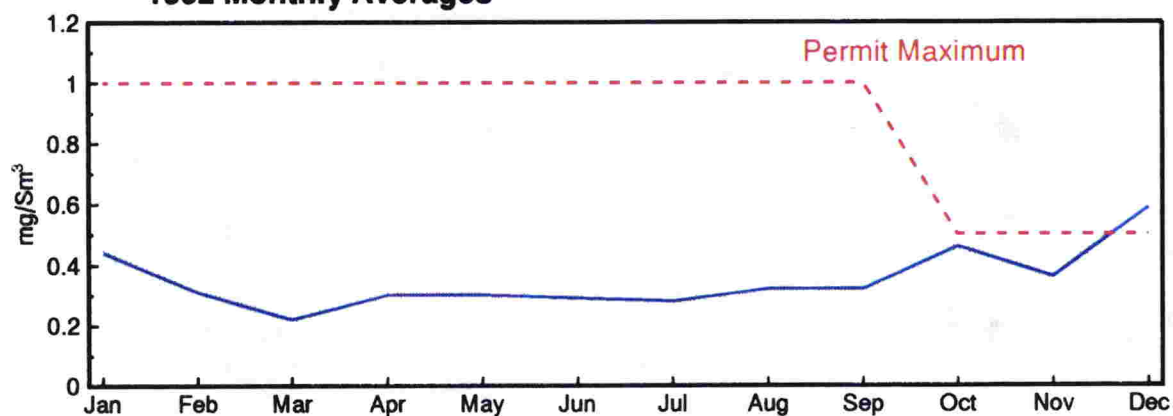
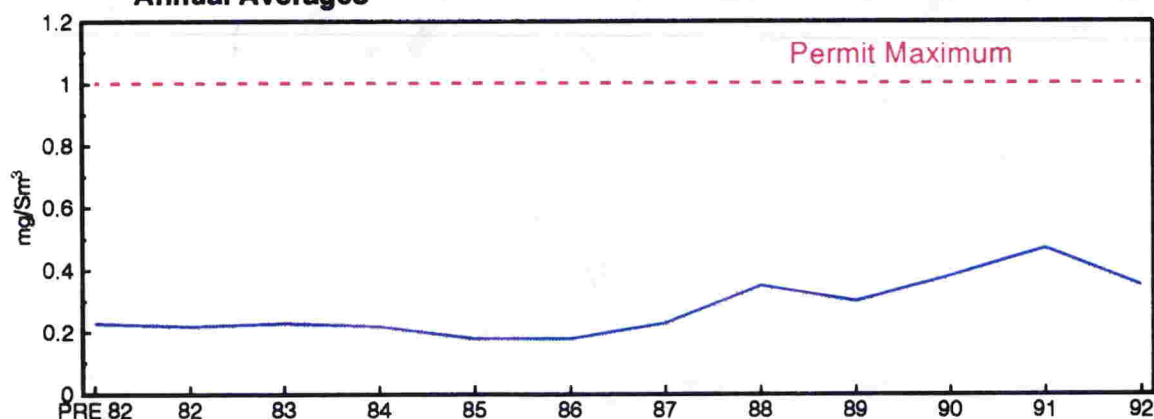
2.2.3 Gaseous Fluoride Concentrations

The 1992 average Potroom roof louvre gaseous fluoride concentration was 0.35 mg/Sm^3 .

The gaseous fluoride measurement exceeded the permit condition in December. The Line 2 start-up operation led to a higher than predicted level of roof emissions during this period.

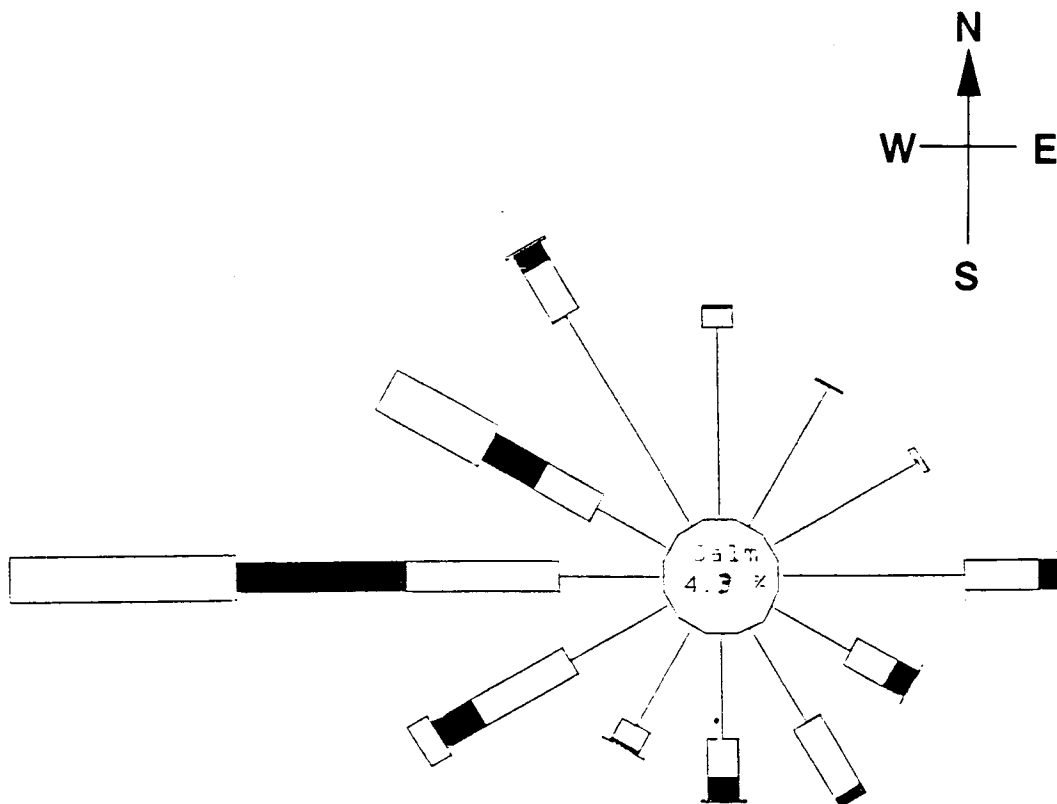
TIWAI POINT
MEAN WIND FREQUENCY (%) OF SURFACE WIND DIRECTIONS
FOR THE YEAR 1992

The mean wind frequency diagram shown on the following page indicates the near typical Tiwai wind pattern which is dominated by westerly winds. Again, as in 1991, there was a reduction in south-westerly and a slight increase in north-westerly winds when compared to previous years.

The Tiwai meteorological station was not operational during the last two months of the year due to equipment failure that required off-shore servicing. Data from the Invercargill meteorological station was used to complete the mean wind frequency diagram.

Calm	4.3
1-10 Knots	52.0
11-16 Knots	20.8
17-21 Knots	11.6
>21 Knots	11.6

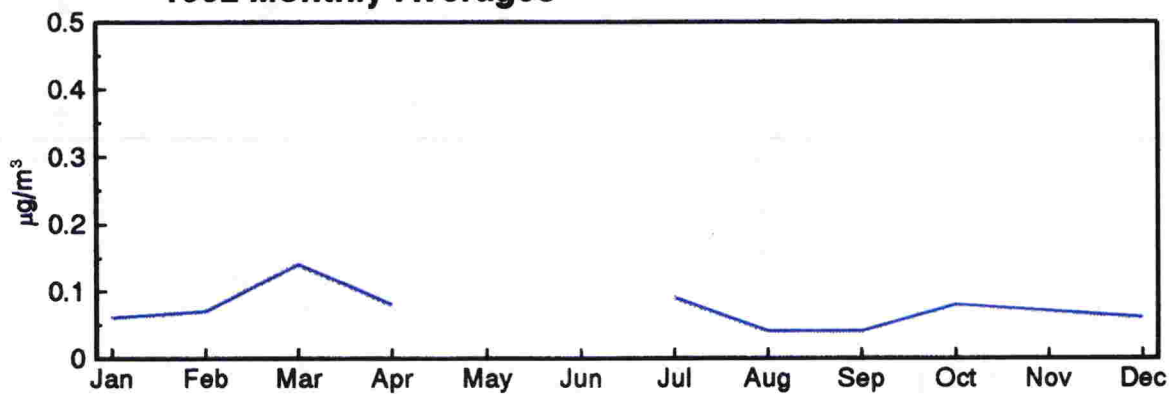
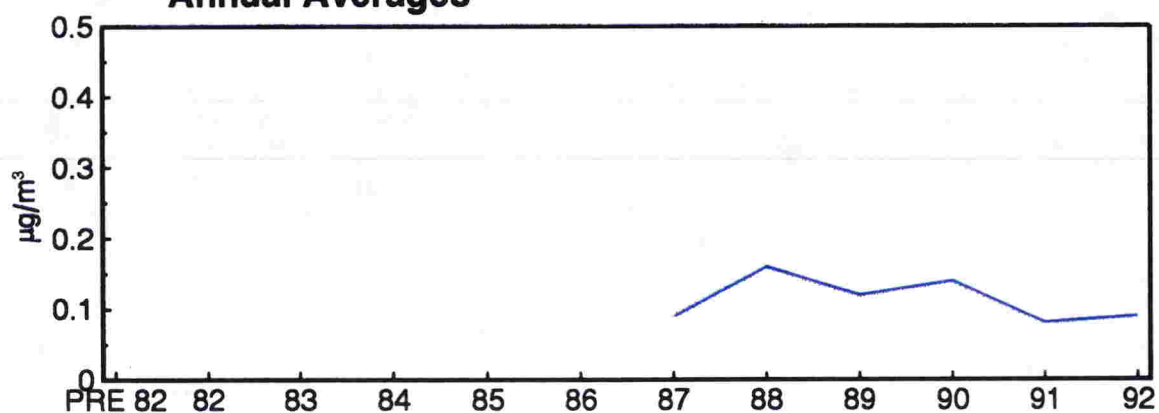
3.2.1 1 km Hut

The 1992 mean gaseous fluoride concentration at the 1 km hut was $0.09 \mu\text{g}/\text{m}^3$.

Malfunctions of the continuous analyser at the 1 km hut resulted in no data being available for May and June.

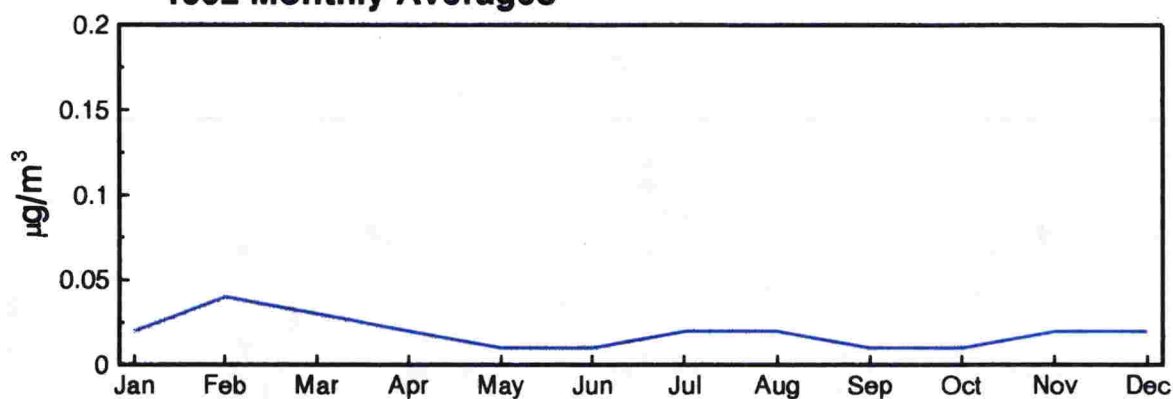
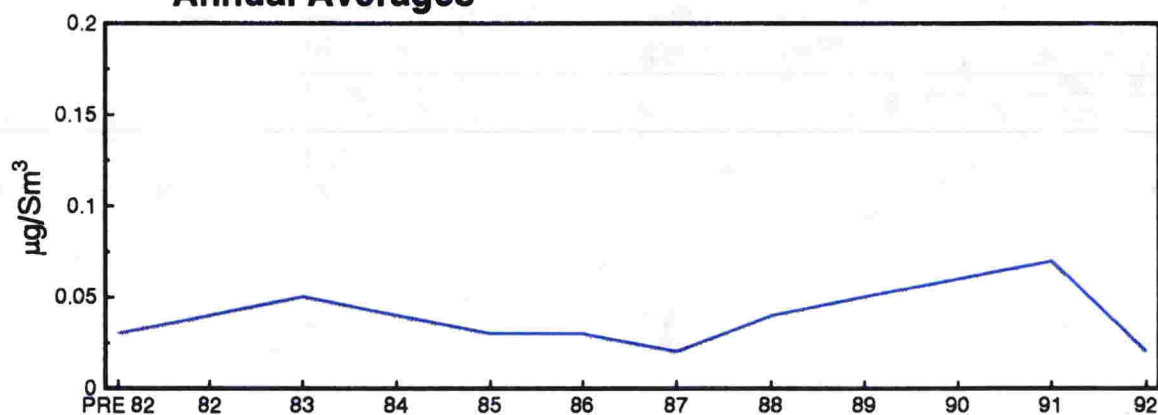
3.2.2 No 1 Bore

The lower gaseous fluoride concentrations that were evident at the end of 1991 were sustained through out 1992 resulting in a mean gaseous fluoride concentration of $0.02\mu\text{g}/\text{m}^3$. This is markedly lower than the 1991 mean of $0.07\mu\text{g}/\text{m}^3$.

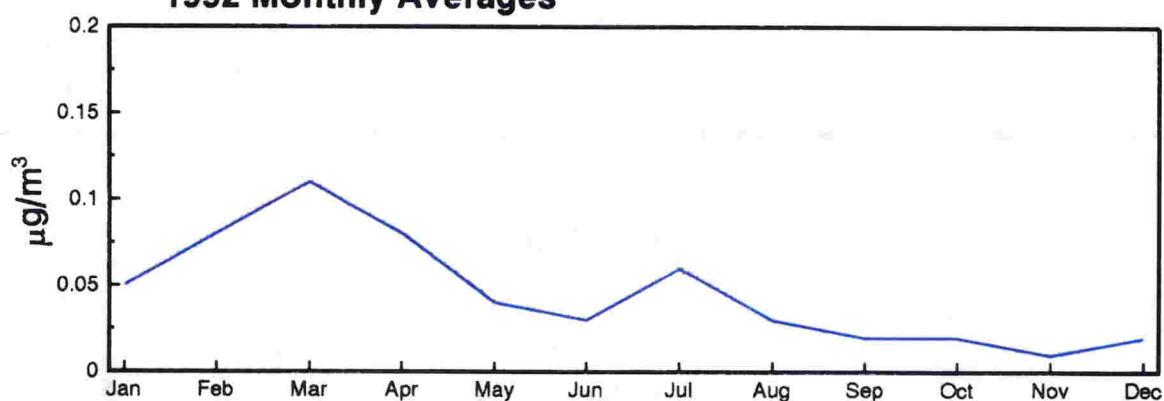
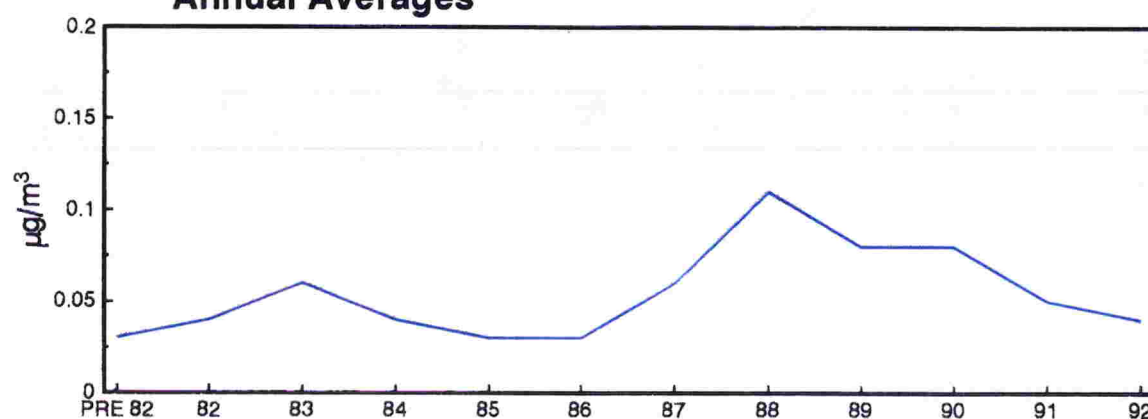
3.2.3 No 6 Bore**1992 Monthly Averages**

The 1992 mean gaseous fluoride concentration was $0.04\mu\text{g}/\text{m}^3$, a reduction from the 1991 figure of $0.05\mu\text{g}/\text{m}^3$. As with previous years, periods of elevated gaseous fluoride concentrations correspond to periods of strong westerly winds. The 1992 mean gaseous fluoride concentration continued the downward trend from the peak recorded in 1988.

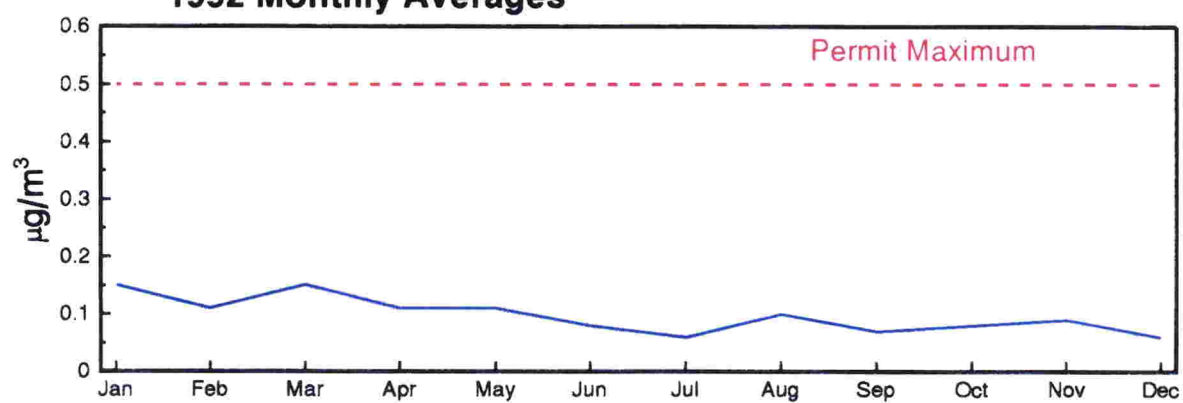
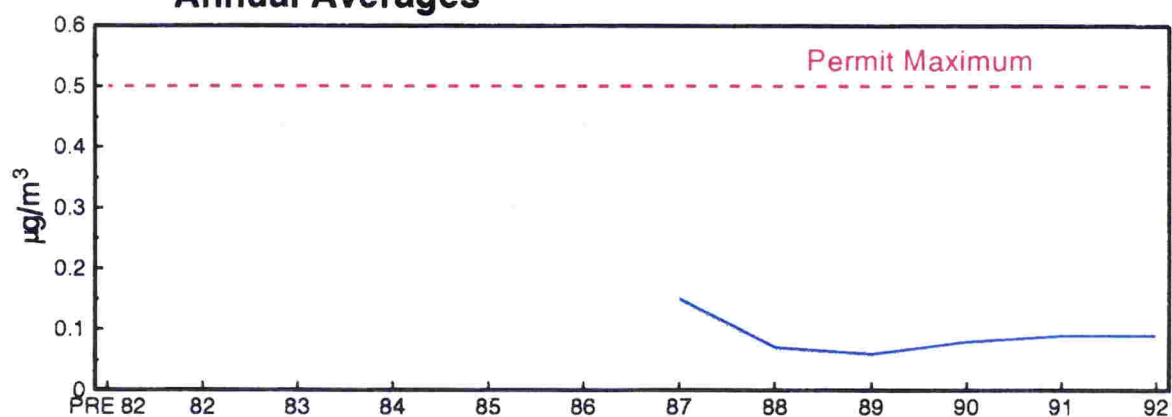
3.2.4 Buddle Road

The 1992 mean gaseous fluoride concentration of $0.09\mu\text{g}/\text{m}^3$ which is similar to previous years mean values.

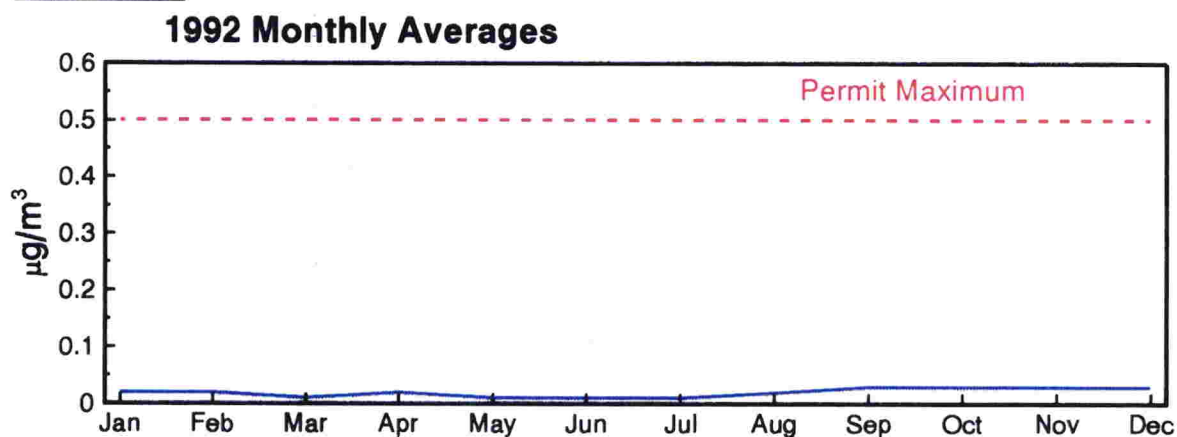
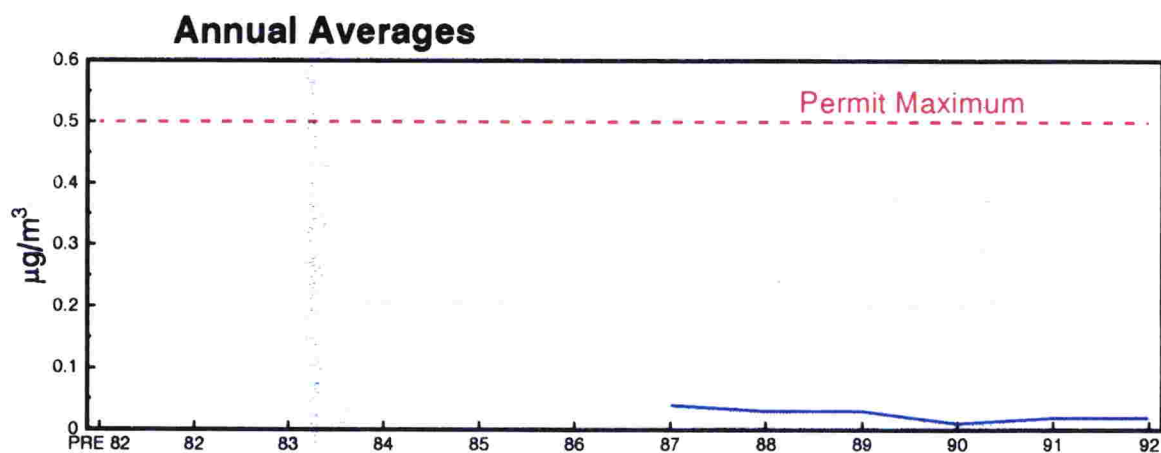
3.2.5 Bluff

The 1992 mean gaseous fluoride concentration of $0.02\mu\text{g}/\text{m}^3$ indicates a continuation of the very low concentrations at Bluff. It is interesting to note that there was no noticeable variation during July, a month dominated by easterly winds.

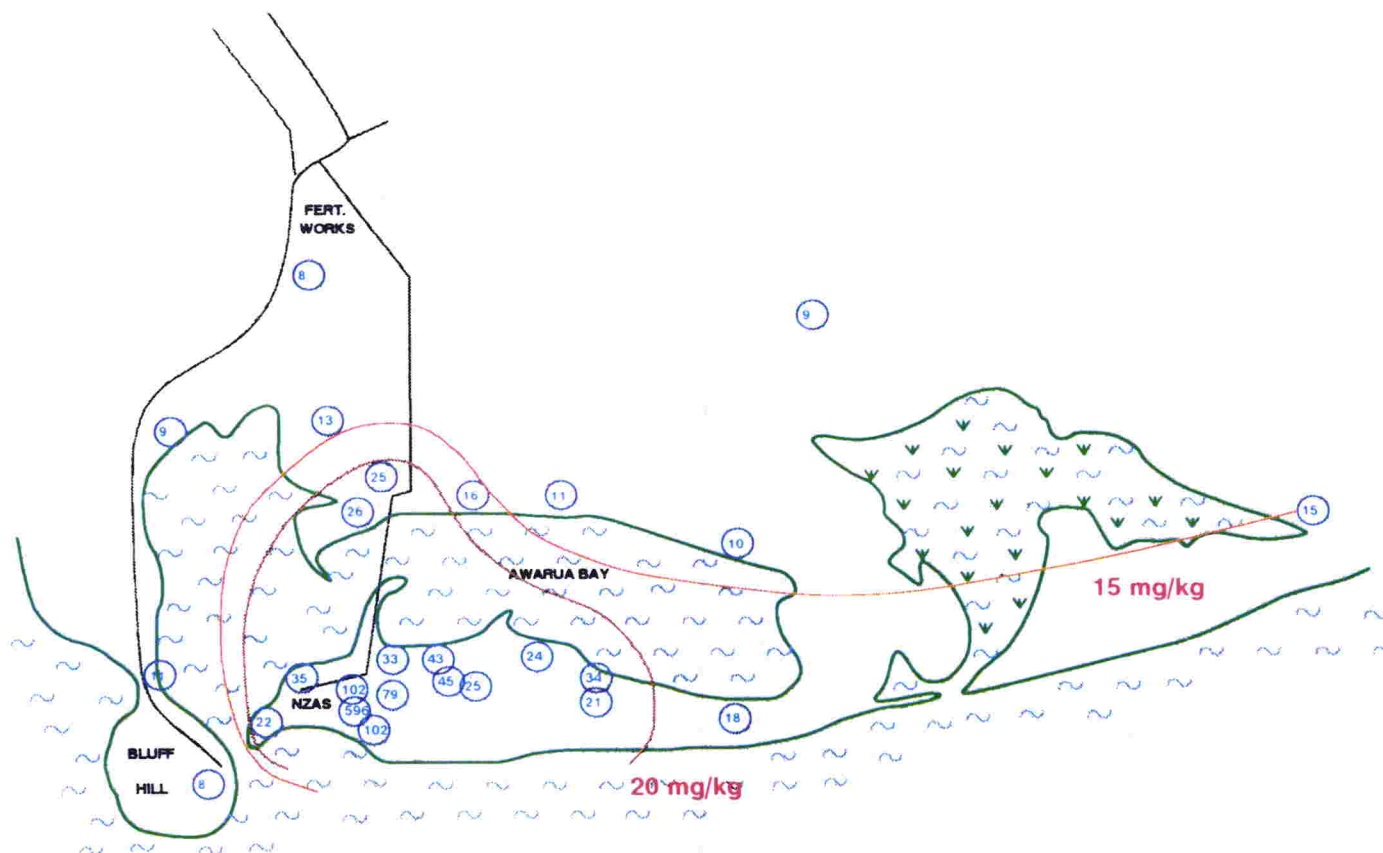
UNGRAZED GRASS FLUORIDE CONCENTRATIONS

The ungrazed grasses 1992 mean concentrations are shown on the map on the following page. Comparison with the 1991 mean concentrations indicates similar results in most locations. The exceptions being the higher mean concentrations reported for the sites on the northern shore of Awarua Bay.

Key: (10) mg/kg fluoride - unwashed dry weight basis

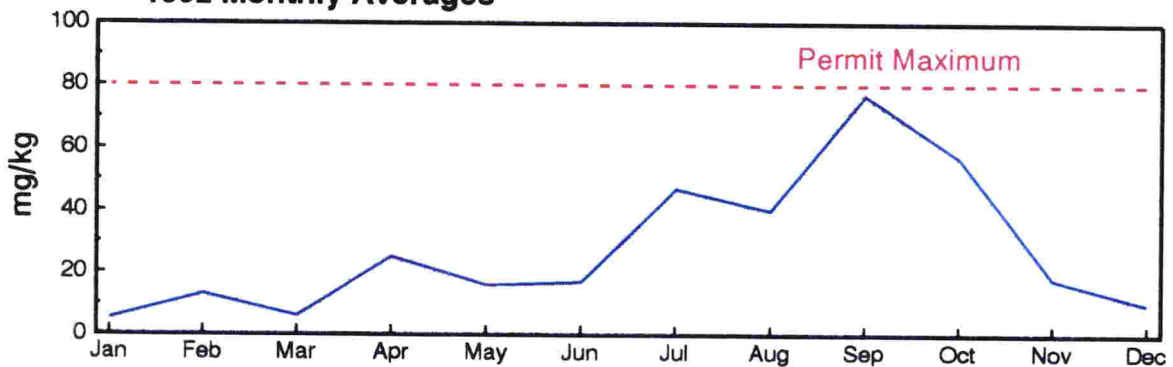
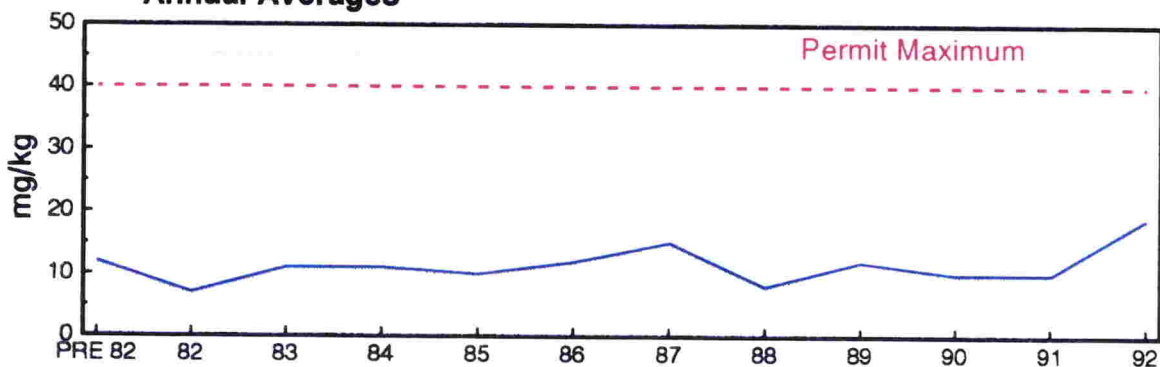
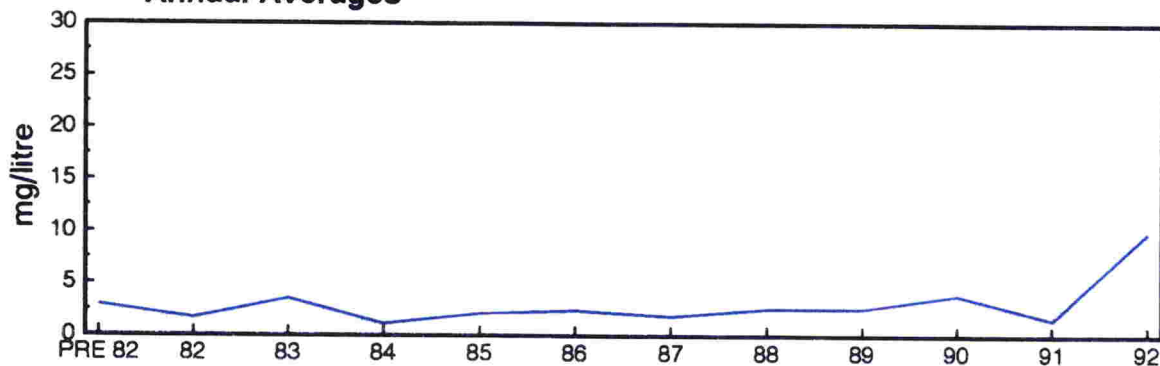
3.4.1 Farm No 1

This farm is to the west of the smelter at Green Point.

Of the 4 months that correspond to the period of elevated pasture fluoride concentrations only the results for July and October are supported by the nearby ungrazed grass monitoring. In both cases a period of easterly winds preceeded the sample collections. This would indicate that the pasture fluoride concentrations had been affected by smelter emissions. In comparison the September result is totally unsupported by both the ungrazed grass monitoring at nearby sites and the meteorological data collected prior to the sample date. The two nearest monitoring sites returned results of 11 mg/kg and 8 mg/kg and as there was an almost total absence of easterly wind leading up to the samples being collected the smelter is unlikely to be the source of the fluoride. With reportedly no top dressing on the farm this result remains unexplained.

The mean cattle urinary fluoride concentration for 1992 was 10.0 mg/litre. The samples were collected in May when the pasture fluoride concentrations were normal. This result should be considered to be demonstrating part of the natural variation of this parameter on this farm.

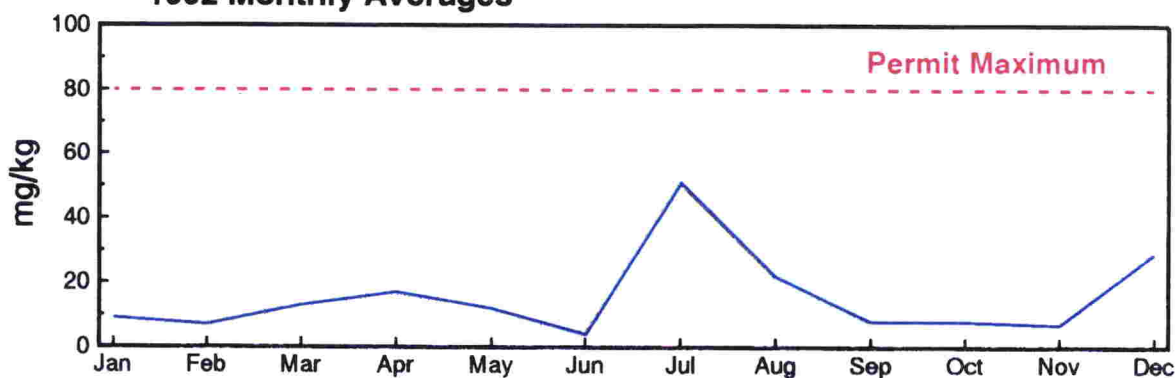
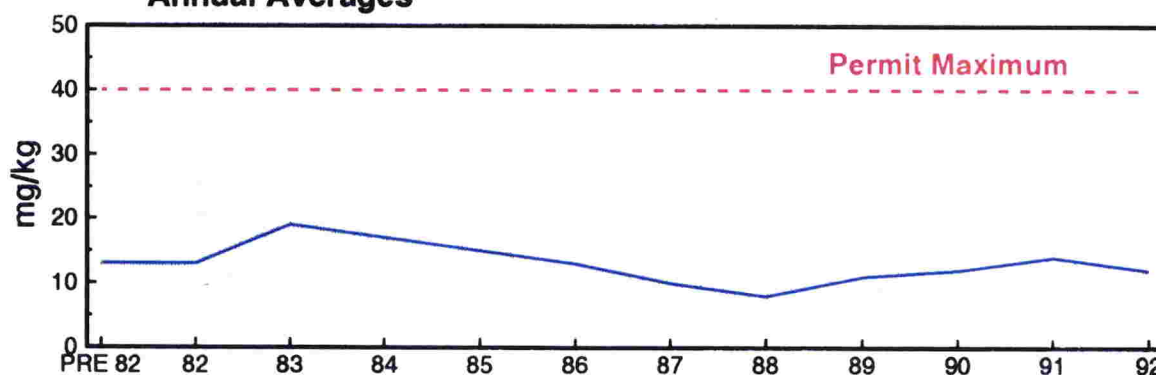
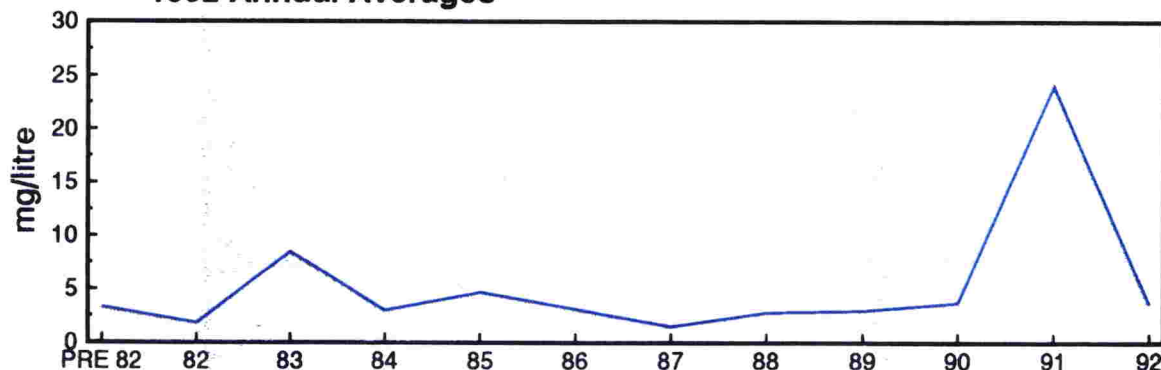
3.4.2 Farm No 2

This farm is 6 km north of the smelter. The elevated pasture fluoride concentration in July is not reflected in either the nearby deposit gauge or the ungrazed grass monitoring. As there were effectively no southerly winds for the whole of July it is unlikely that this result is due to smelter emissions. No top dressing was reported.

The mean fluoride concentration in the cattle urine samples collected was 3.6 mg/litre. This is similar to the results recorded in all years other than 1991.

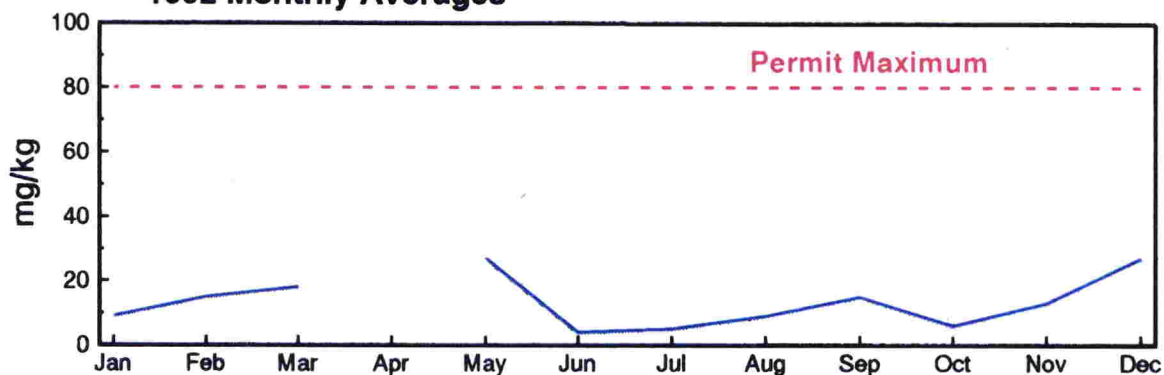
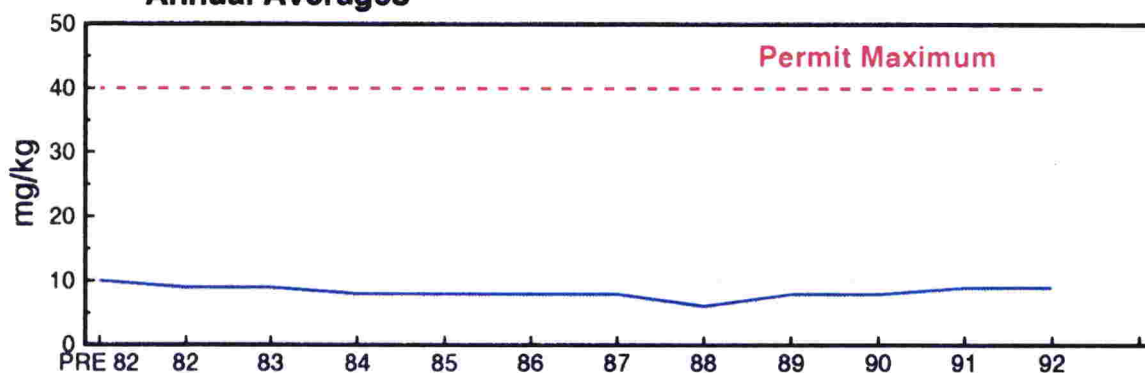
3.4.3 Farm No 3

This farm is 18 km north east of the smelter . The pasture fluoride concentrations on this farm continue to be low. A sampling error in April resulted in the loss of that months data.

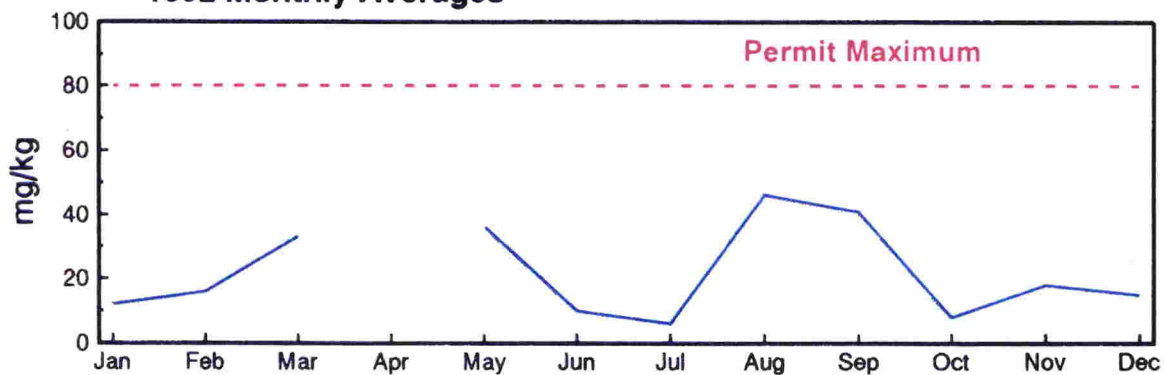
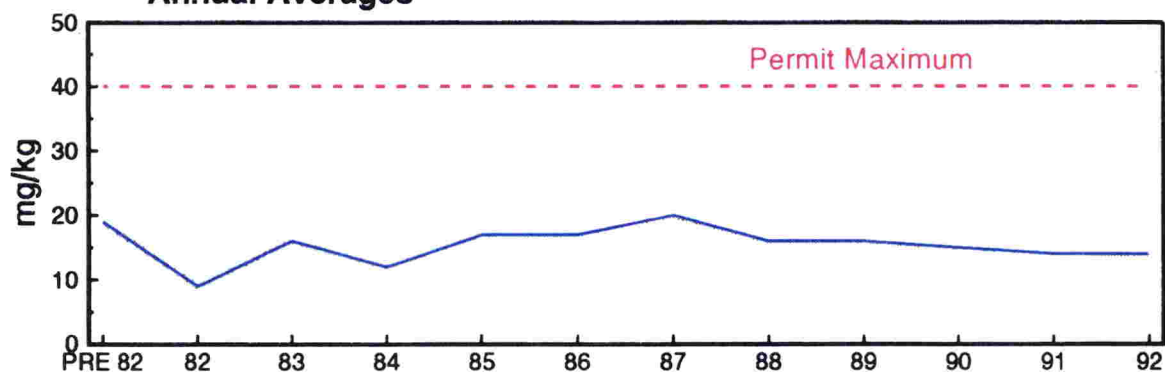
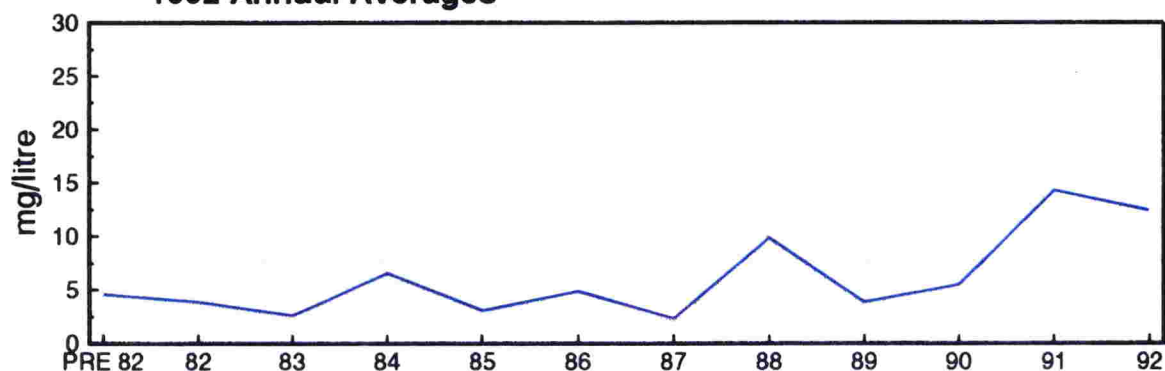
3.4.4 Farm No 4

This farm is on the northern shore of Awarua Bay, north-east of the smelter. Because of its proximity to the smelter and its position relative to the prevailing winds this farm is periodically affected by the smelter's emissions. Although there was marked variation in the pasture fluoride concentration during the year the levels remained well below the permitted maximum. To some extent the nearby deposit gauge and ungrazed grass monitoring sites show the same variation in fluoride concentration. A sampling error in April resulted in the loss of that months data.

The cattle urine samples collected in March had higher than normal fluoride concentrations. This is likely to be linked to the high pasture fluoride concentration that was recorded at the same time. Bone biopsies were performed with the fluoride concentrations very similar to the 1991 results and in the normal range for this farm. The NZAS veterinary consultant noted some wear and tooth staining but the actual tooth scores were similar to those in 1991.

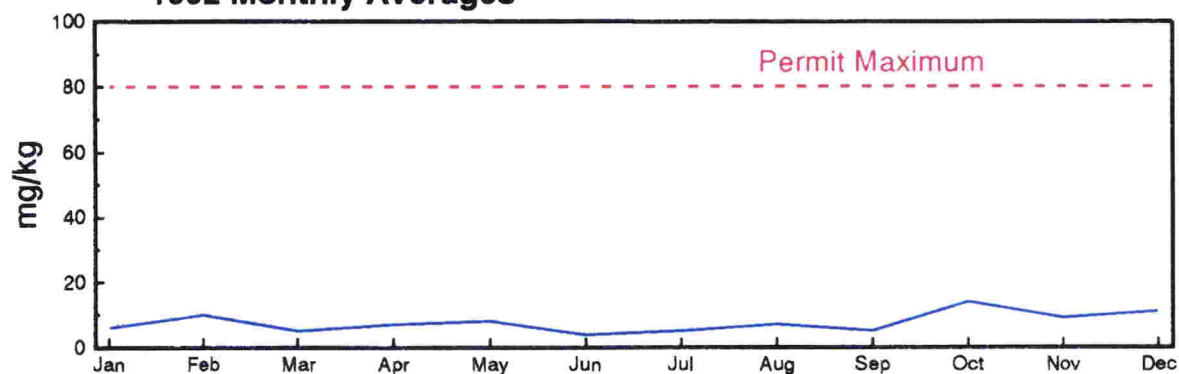
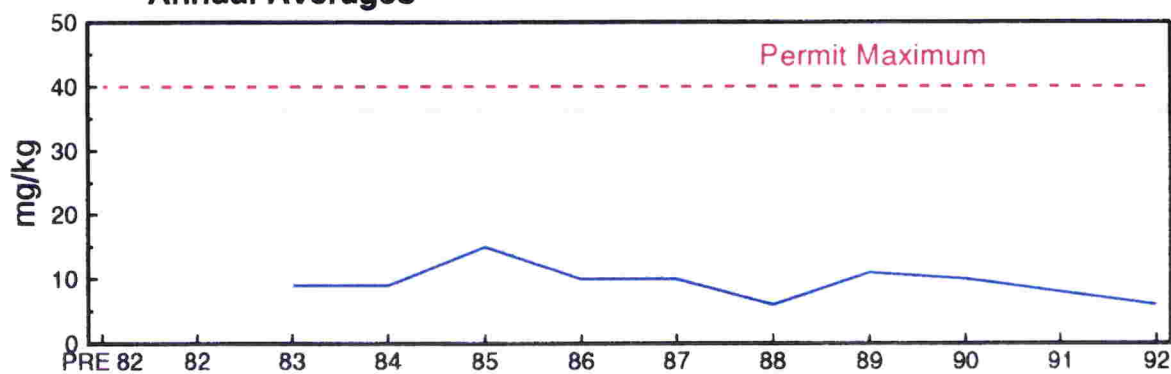
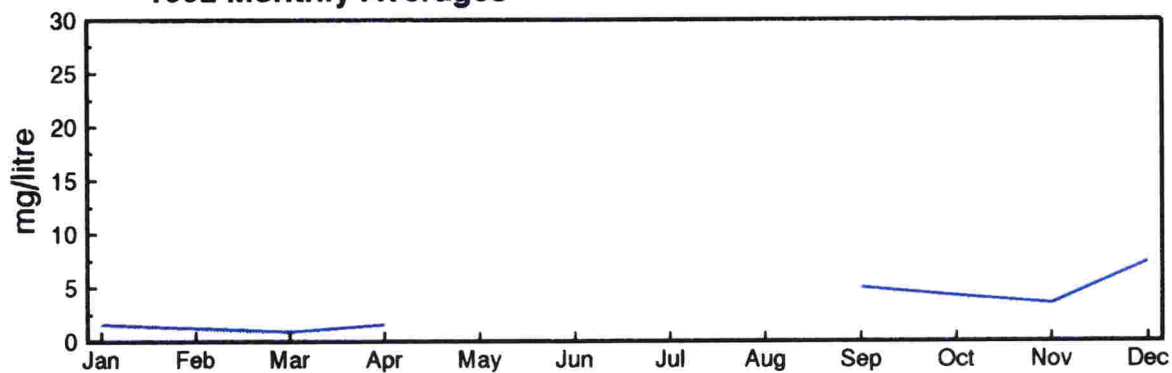
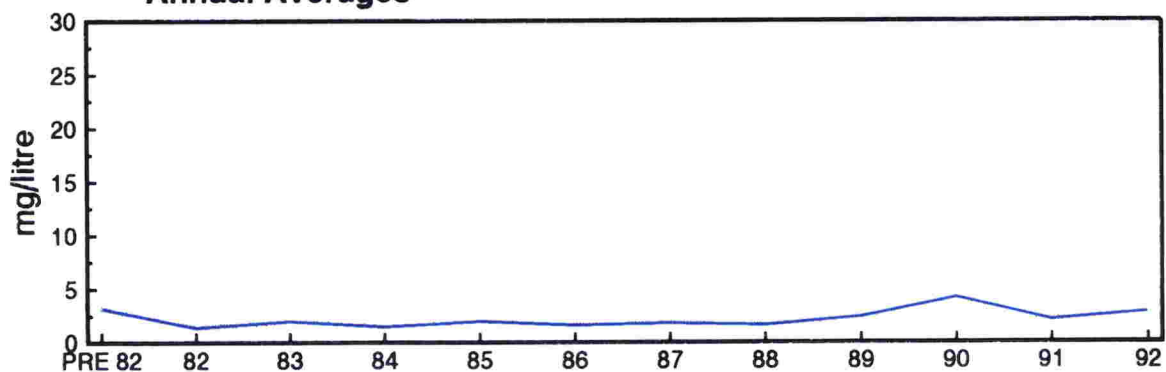
3.4.6 Farm No 8**Pasture Fluoride Concentrations****1992 Monthly Averages**

This farm is 13 km north of the smelter and is unlikely to be affected by the emissions. The pasture and cattle urinary fluoride concentrations continue to be low.

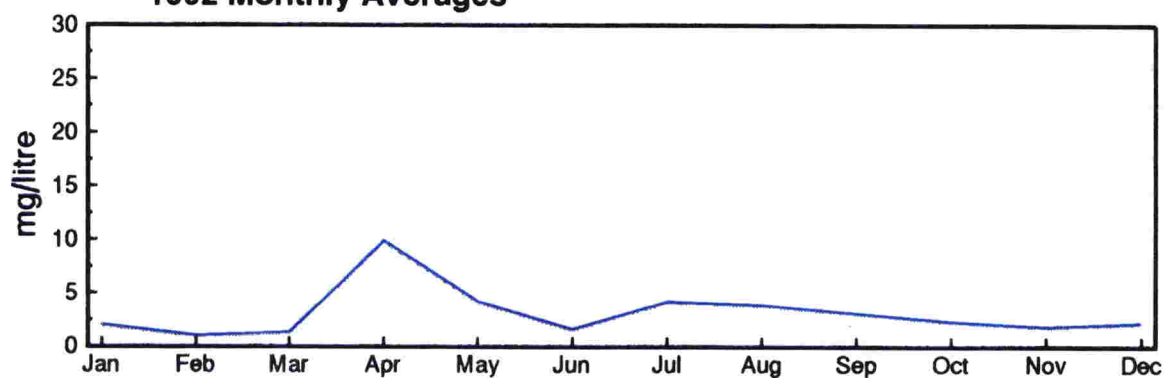
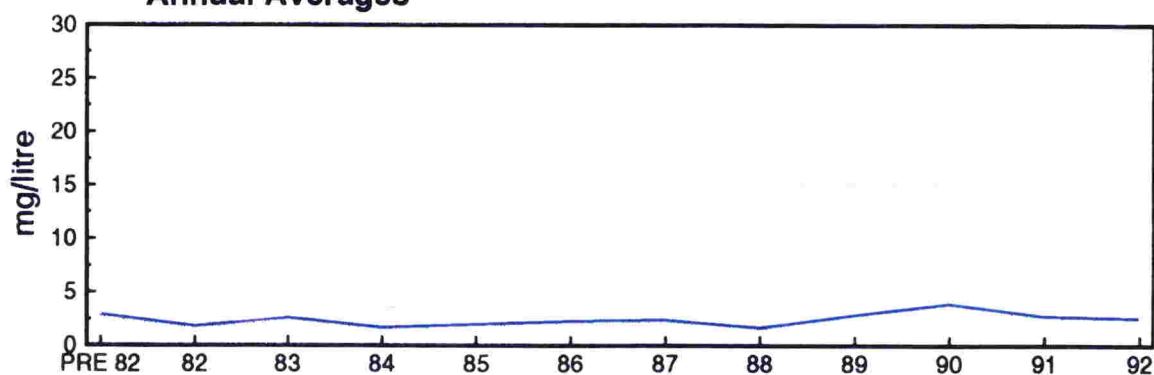
3.4.7 Farm No 9**Cattle Urinary Fluoride****1992 Monthly Averages**

This farm is 15.5 km north-west of the smelter and is unlikely to be affected by the smelter's emissions. The cattle urinary fluoride concentrations remain low.

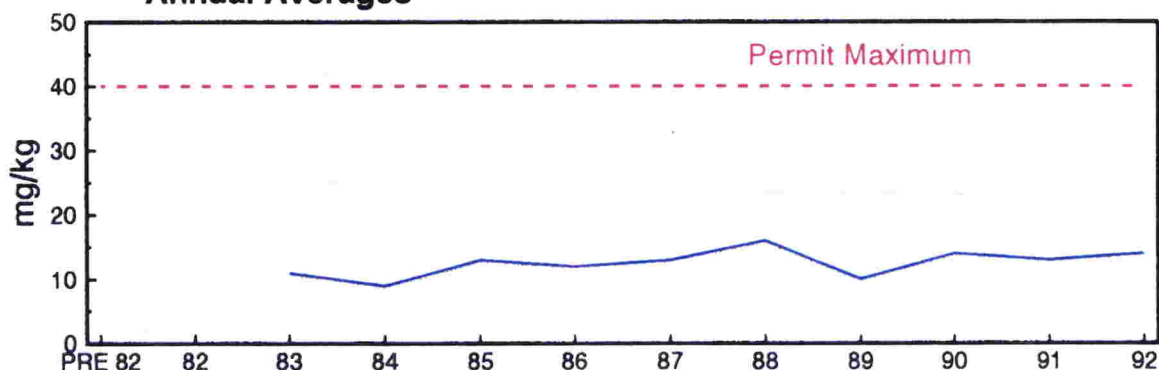
**Pasture Fluoride Concentrations
Annual Averages**

This farm is 25 km east-north-east of the smelter. The 1992 pasture fluoride concentrations were normal. The mean fluoride concentration of 14 mg/kg is very similar to the previous years results. The mean ungrazed grass fluoride concentration for samples collected in the same area was 15 mg/kg, again a very similar result to previous years as was the result from the nearby deposit gauge.

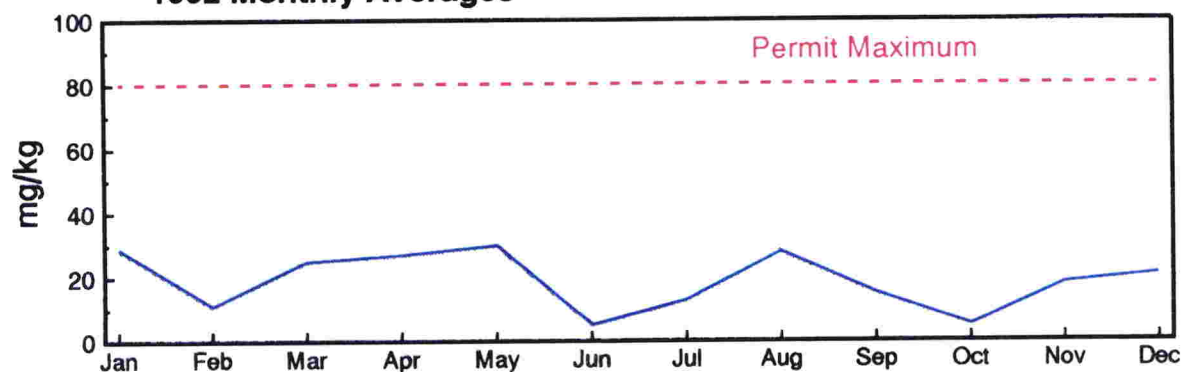
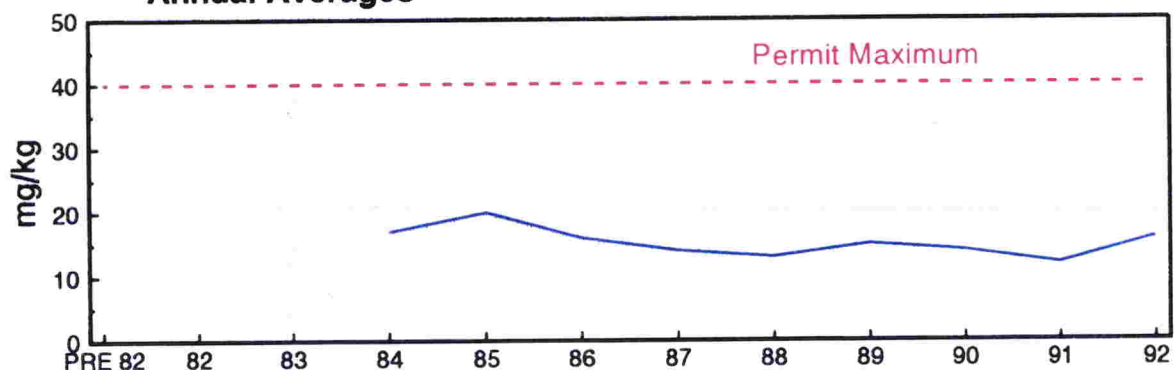
3.4.9 Farm No 11**Pasture Fluoride Concentrations
1992 Monthly Averages**

This farm is 5 km north-north-east of the smelter. The 1992 pasture fluoride concentrations demonstrated greater variation than previous years but the annual mean was unaffected with the 1992 result within the normal distribution of results for this farm.
