NEW ZEALAND
ALUMINIUM SMELTERS LIMITED

**REPORT TO THE INTERDEPARTMENTAL COMMITTEE
ON ENVIRONMENTAL EFFECTS OF THE TIWAI ALUMINIUM SMELTER
FOR THE YEAR ENDED 31 DECEMBER 1992**

MEETING AT TIWAI
20th APRIL, 1993

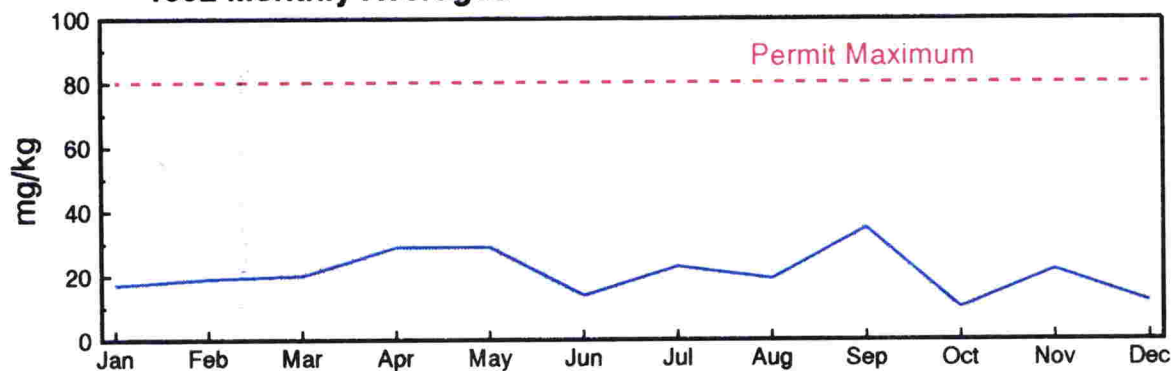
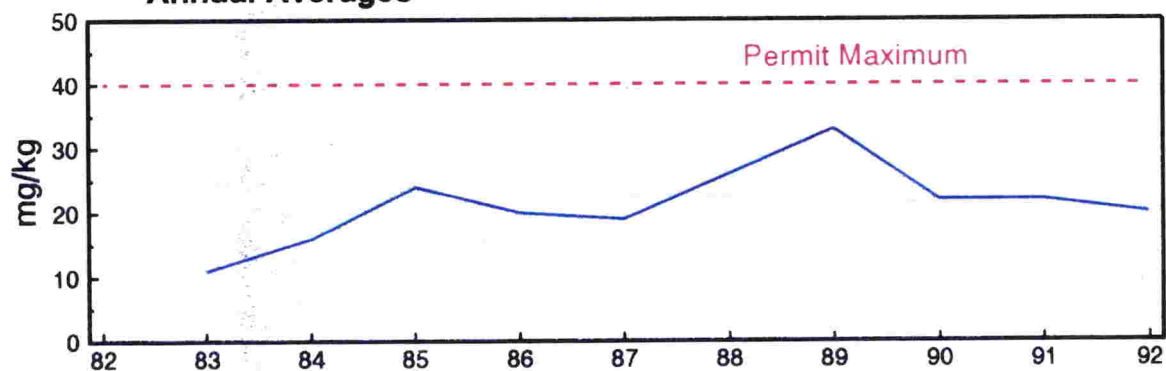
3.4.10 Farm No 12**Pasture Fluoride Concentrations
1992 Monthly Averages**

This farm is on the northern shore of Awarua Bay, 9.5 km east-north-east of the smelter. The 1992 pasture fluoride concentrations were generally lower and were without the large variation which has characterized previous years monitoring results.

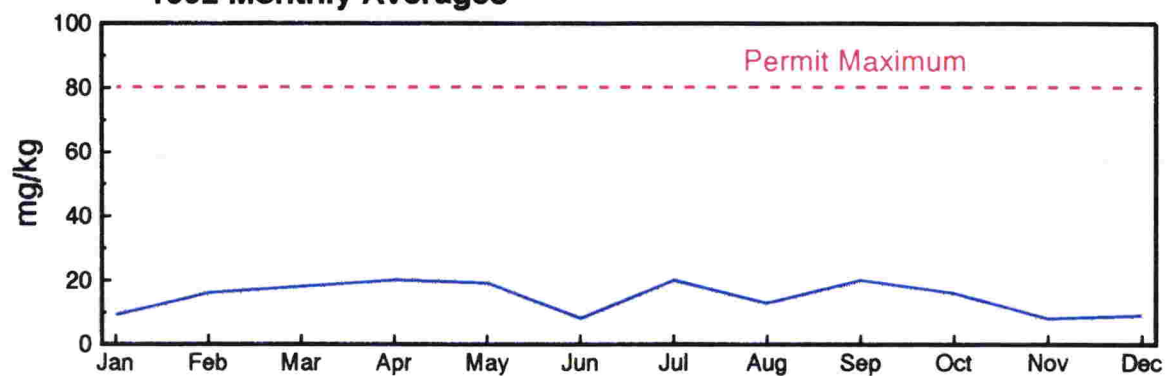
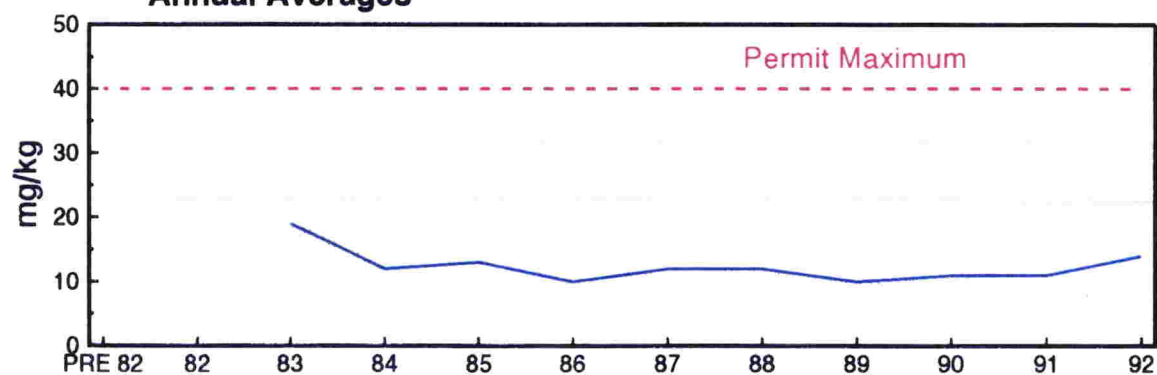
3.4.11 Farm No 13**Pasture Fluoride Concentrations
1992 Monthly Averages**

This farm is 15 km east-north-east of the smelter. No trends are apparent.

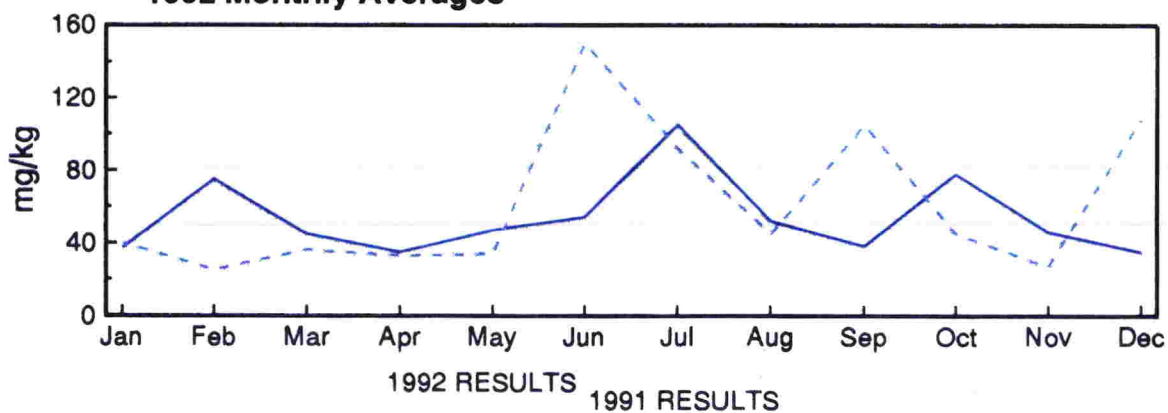
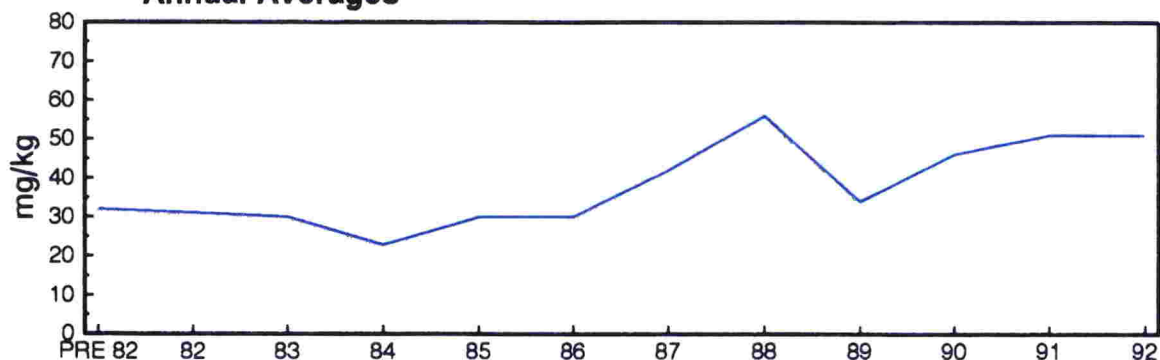
Pasture Fluoride Concentrations

The amount of variation in the monthly pasture fluoride concentrations is similar to previous years. There has been no consistent trend in the annual mean values, with the 1992 results within the normal distribution of previous years values. The monthly pasture fluoride concentration data presented for this farm in the 1991 report was incorrect. This oversight has been corrected in this report.

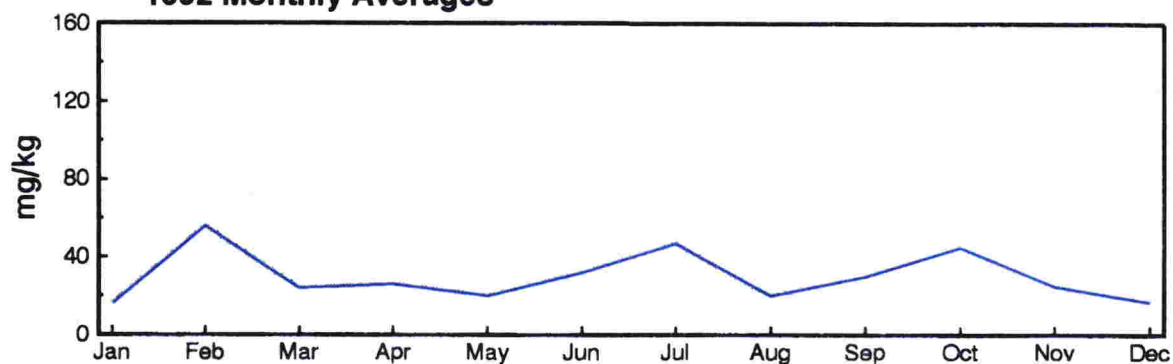
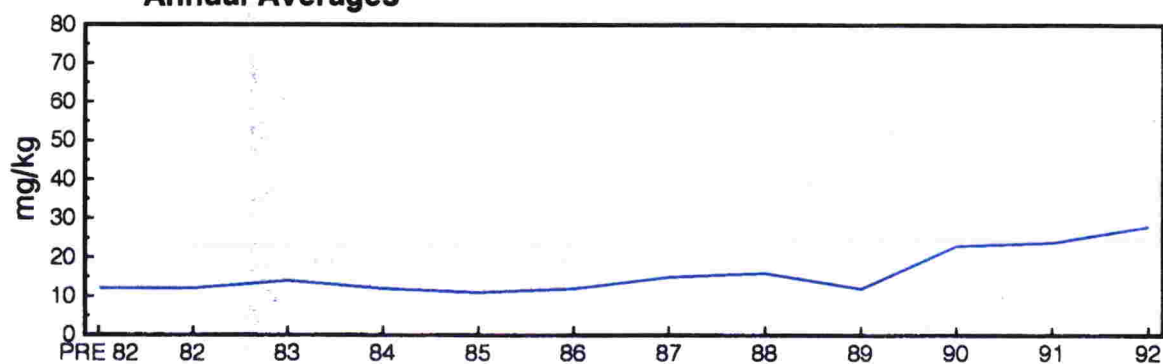
3.5.2 Farm No 2**Pasture Fluoride Concentrations
1992 Monthly Averages**

The 1992 pasture fluoride concentrations follow the same pattern of monthly variation as Farm No. 1 although the magnitude of change is not as great. This, along with annual mean pasture fluoride concentrations, illustrates the scale of the reduction in the effects of the smelter's emissions with increasing distance from the smelter.

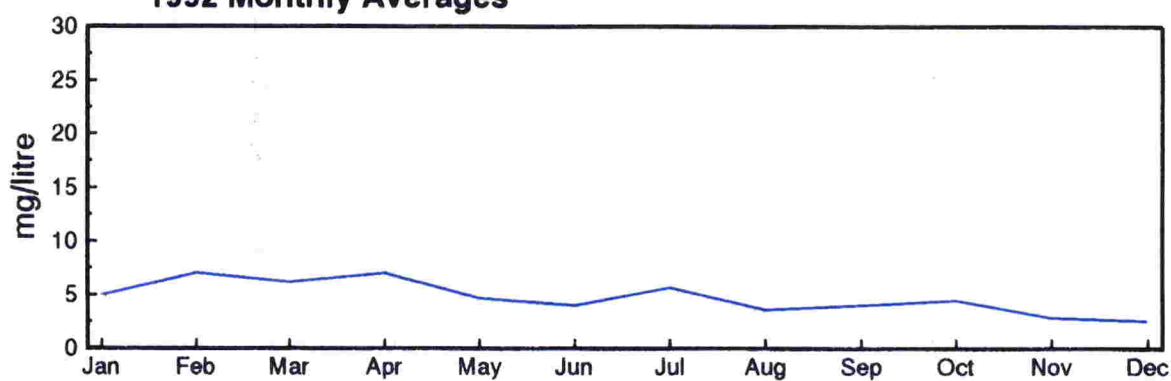
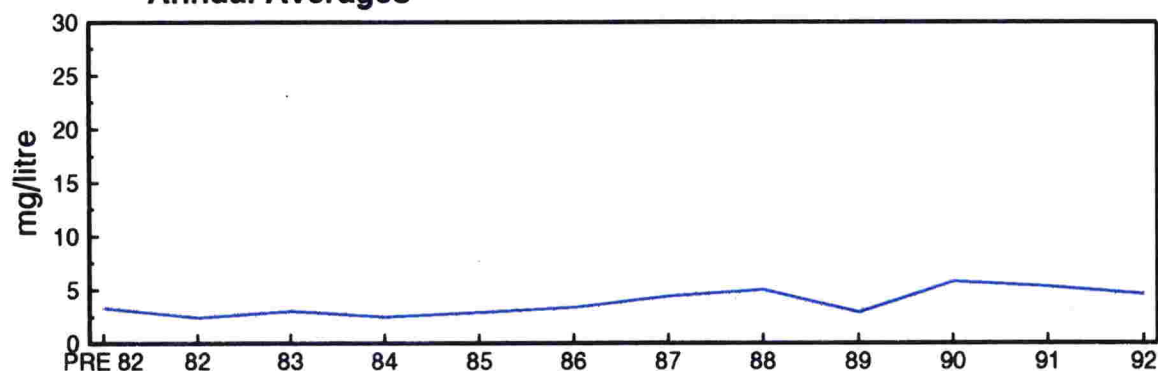
**Lamb Urinary Fluoride
1992 Monthly Averages**

There was little variation in the lamb urinary fluoride and no trend is evident in the annual mean concentration which remains low.

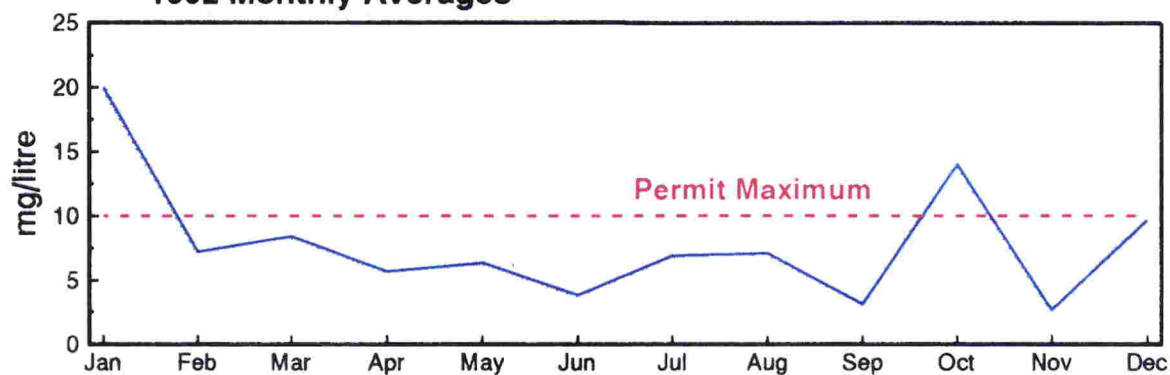
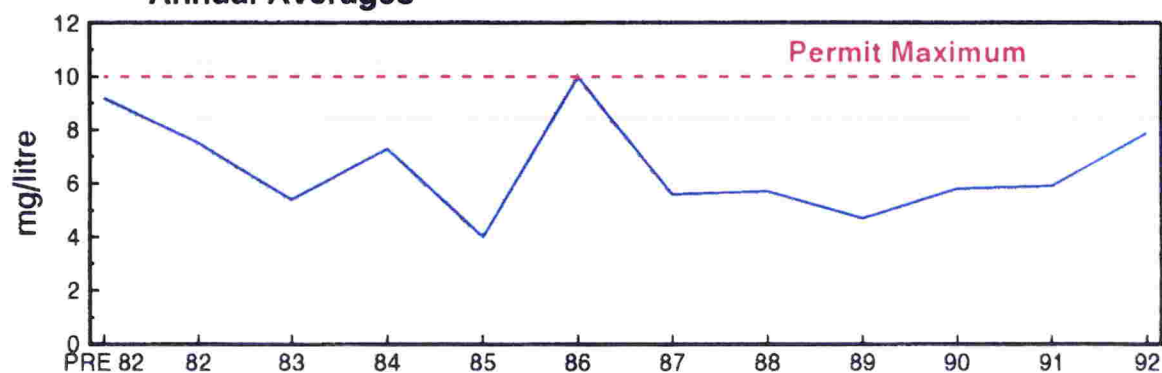
Discharge Fluoride Concentrations

The 1992 north drain discharge fluoride concentrations demonstrated similar variation to previous years. An investigation has determined that the major source of this fluoride is the low level roof louvre emissions from Potrooms which have historically been within permit conditions. A number of remedial options are now under review.

The 1992 annual mean drain discharge fluoride concentration of 7.9 mg/litre is an increase on the 1991 figure. This result is within the normal distribution of this data and does not indicate a trend.

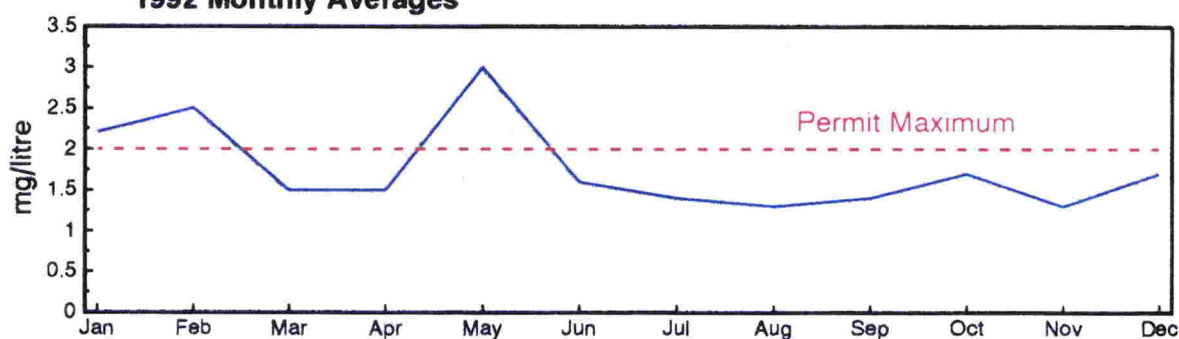
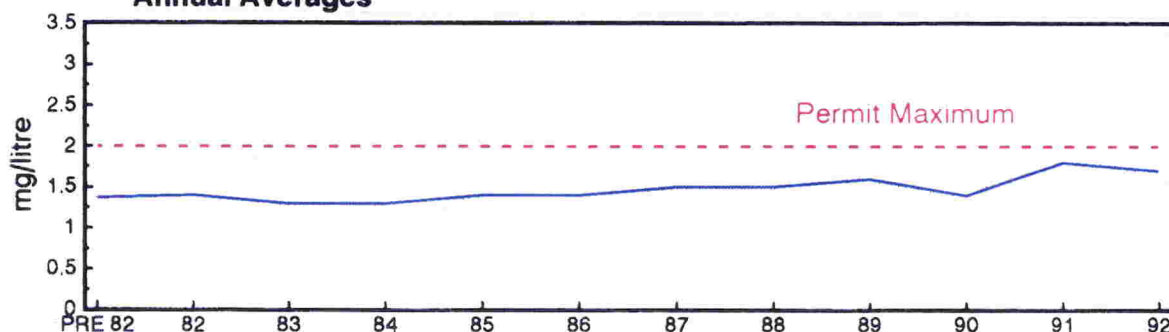
Receiving Water Fluoride Concentrations 1992 Monthly Averages

The lack of effective dispersion in the receiving seawater resulted in elevated levels of fluoride outside the mixing zone. This has been highlighted in previous reports and is being taken into consideration in developing a final remedial solution for the north drain.

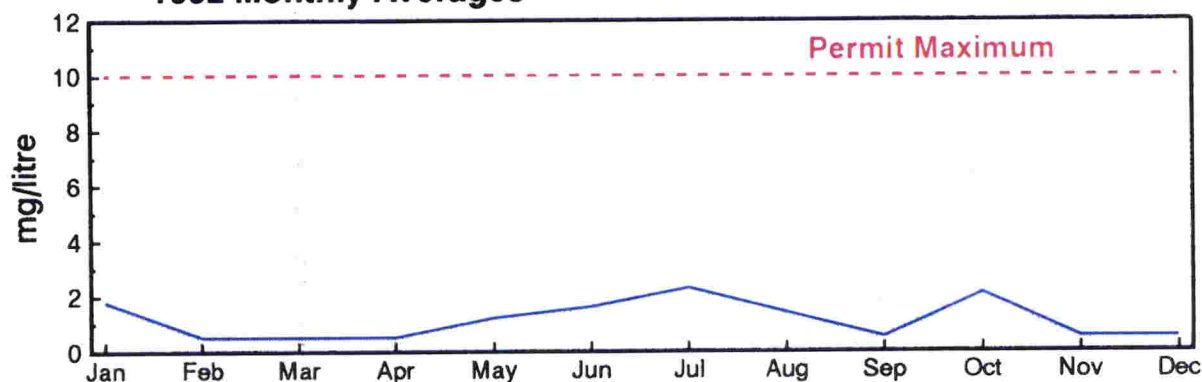
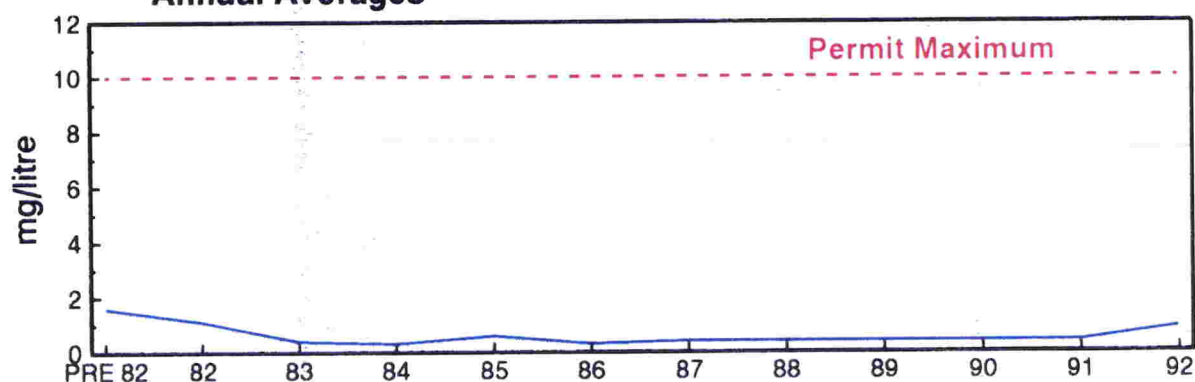
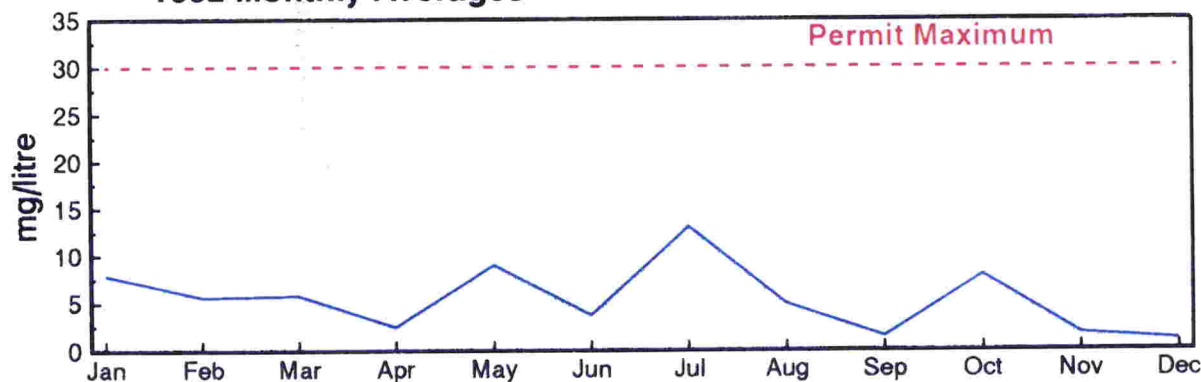
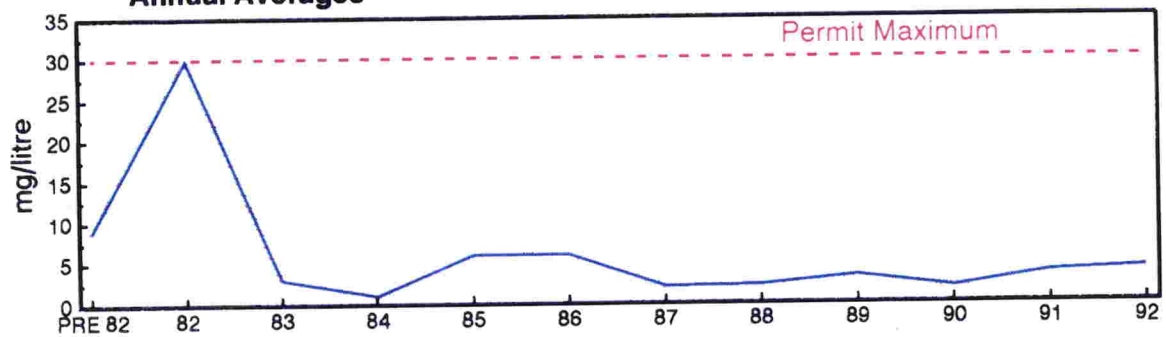
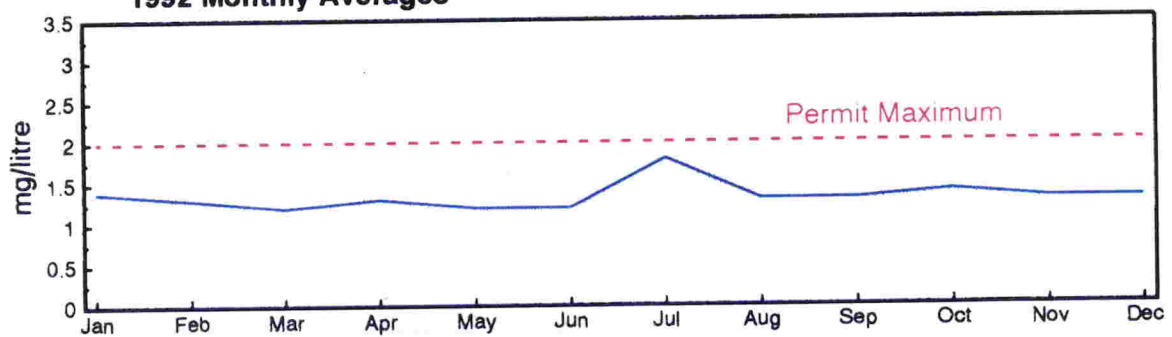
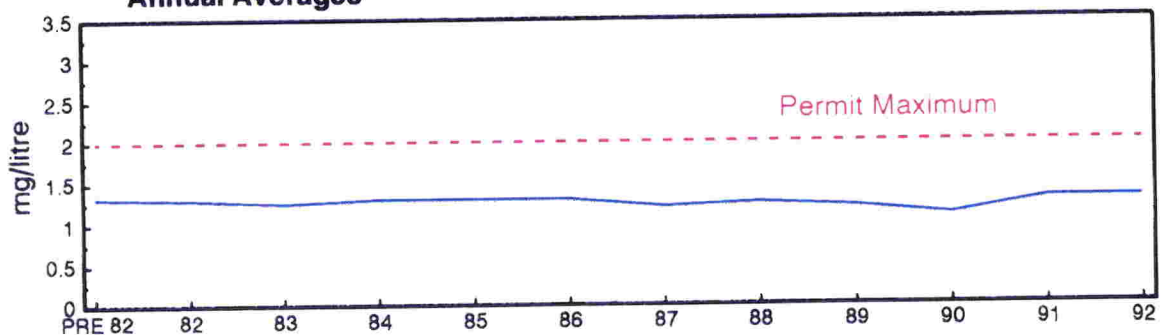
No trends are evident in the west drain discharge or receiving water data. All levels are well within permit conditions.

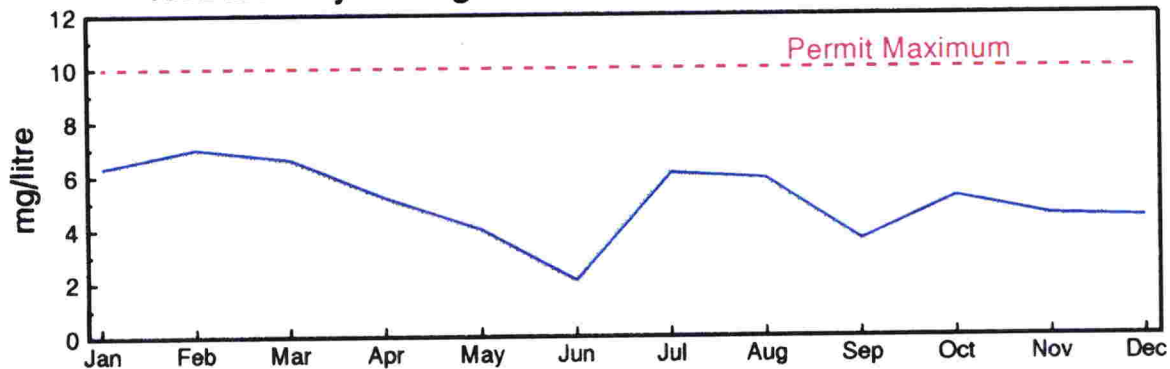
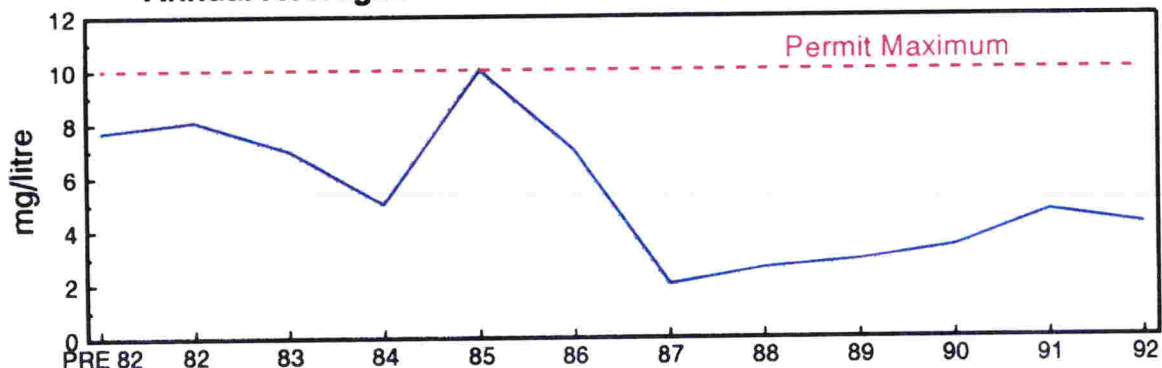
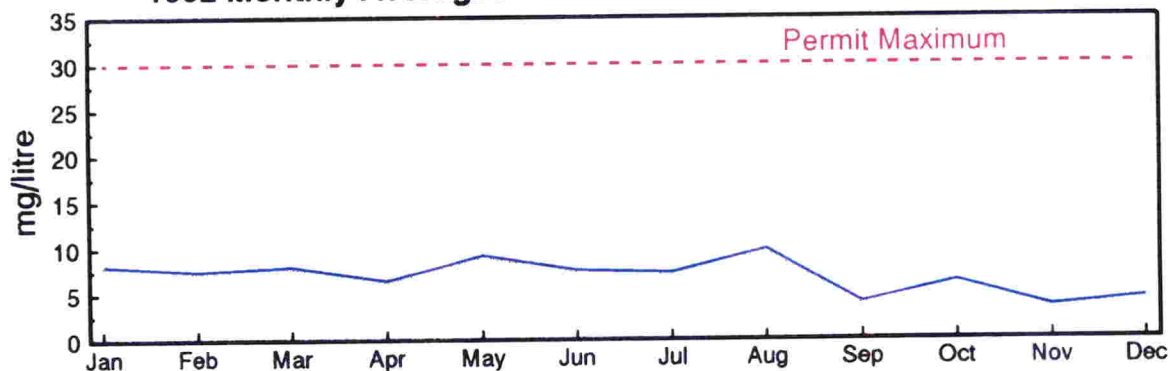
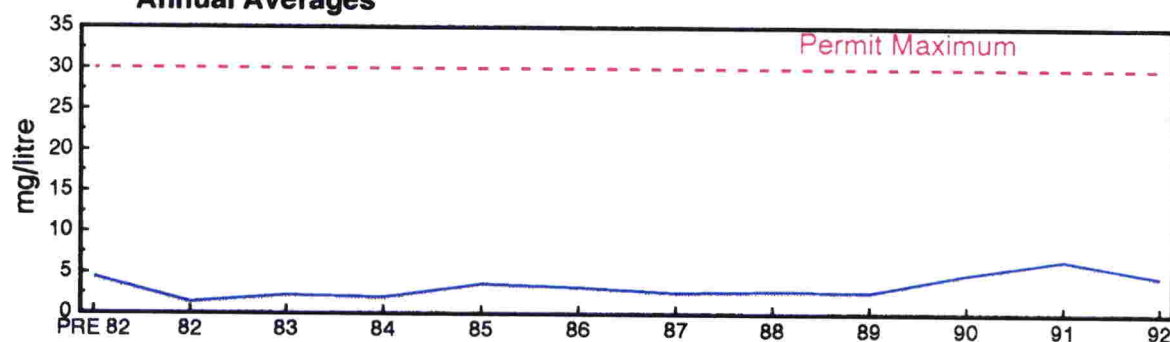
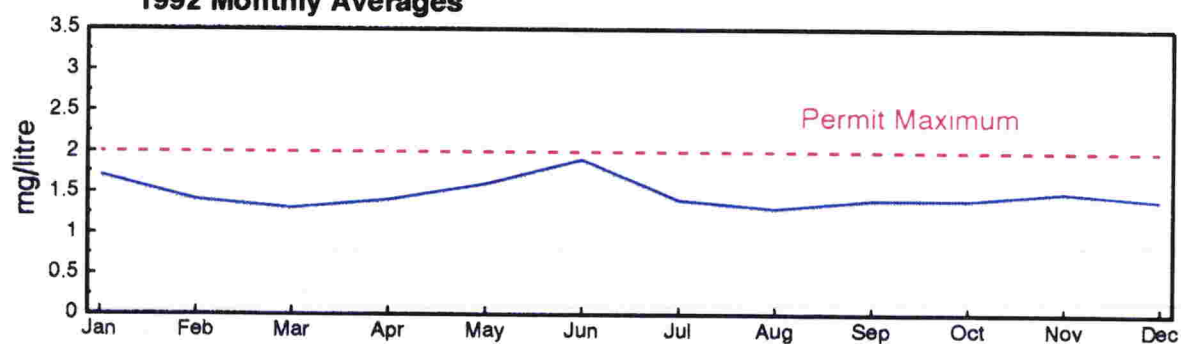
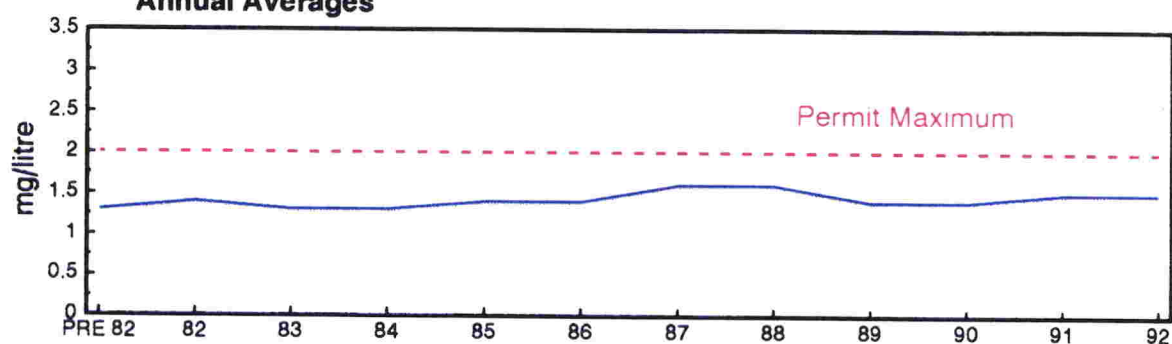
No trends are evident in the south drain discharge or receiving water data. All levels are well within permit conditions.

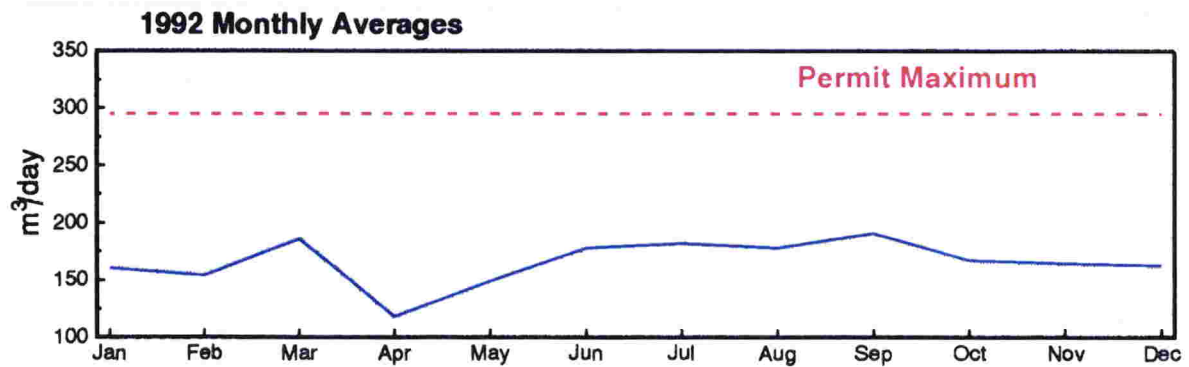
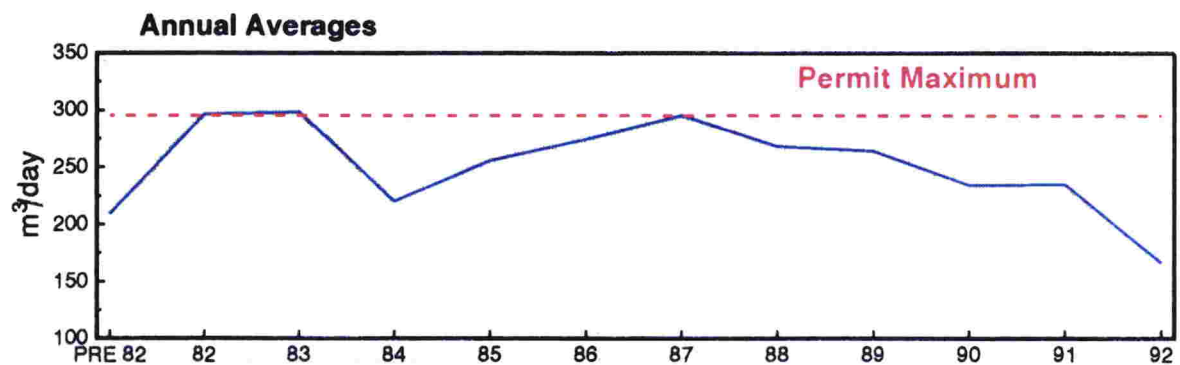
Flow Rates

As a result of improvement work to the sewage system and the elimination of storm water ingress into the system the mean flow was reduced from 235 m³/day in 1991 to 166 m³/day in 1992.

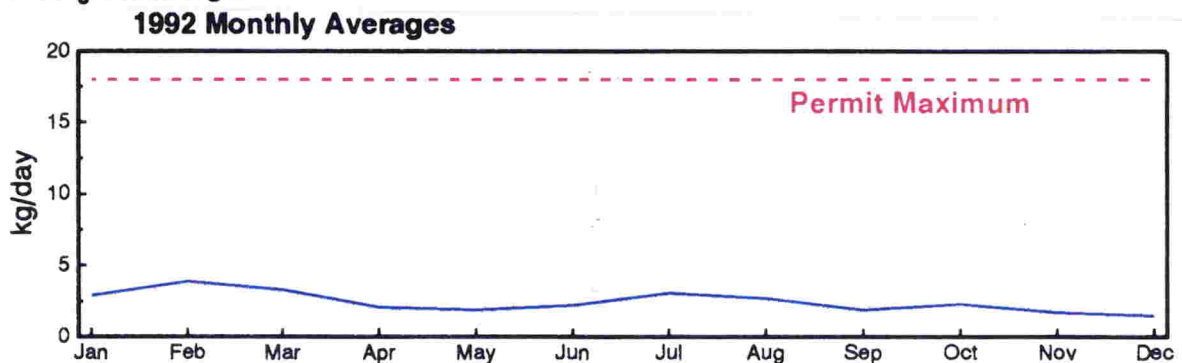
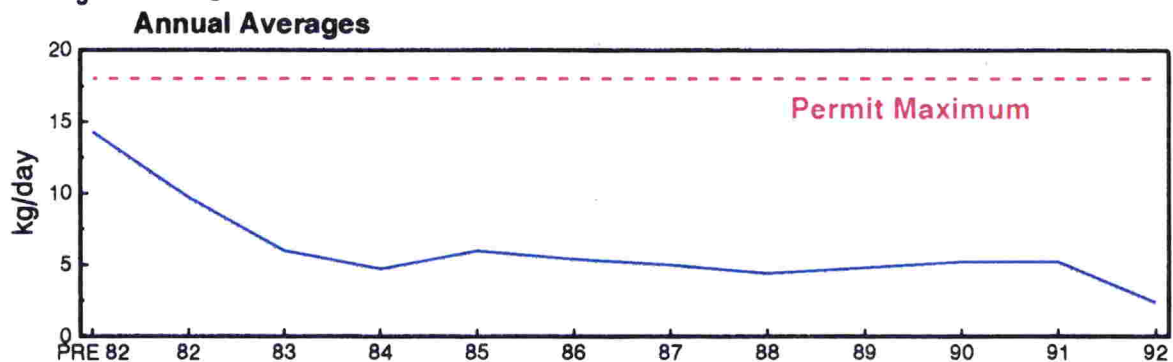
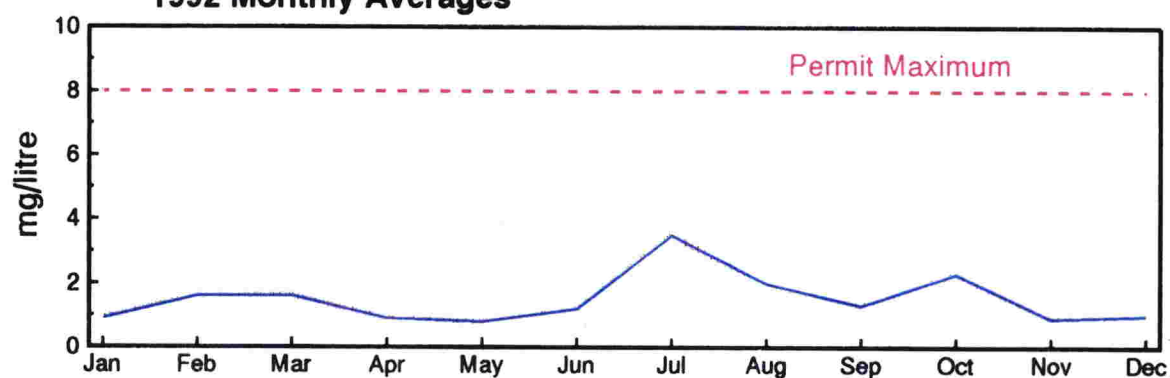
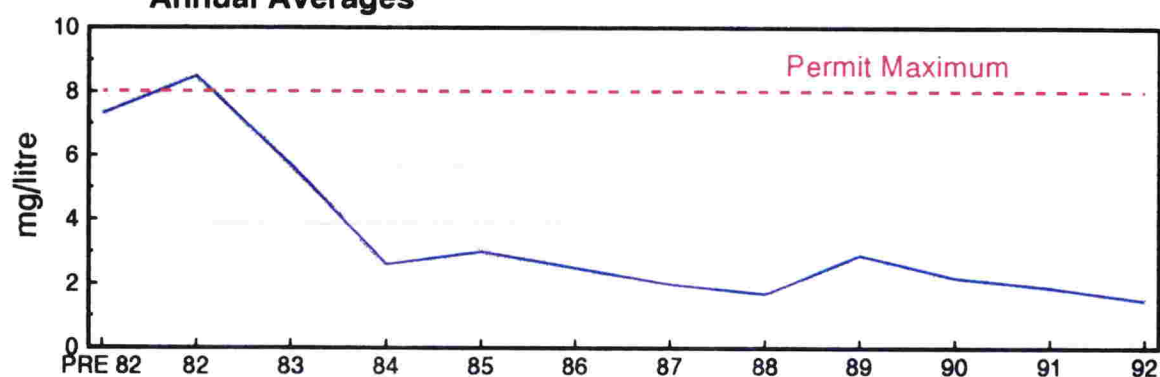
The resulting increased residence time in the contactor and clarifier reduced the BOD₅ count and the suspended solids concentration.

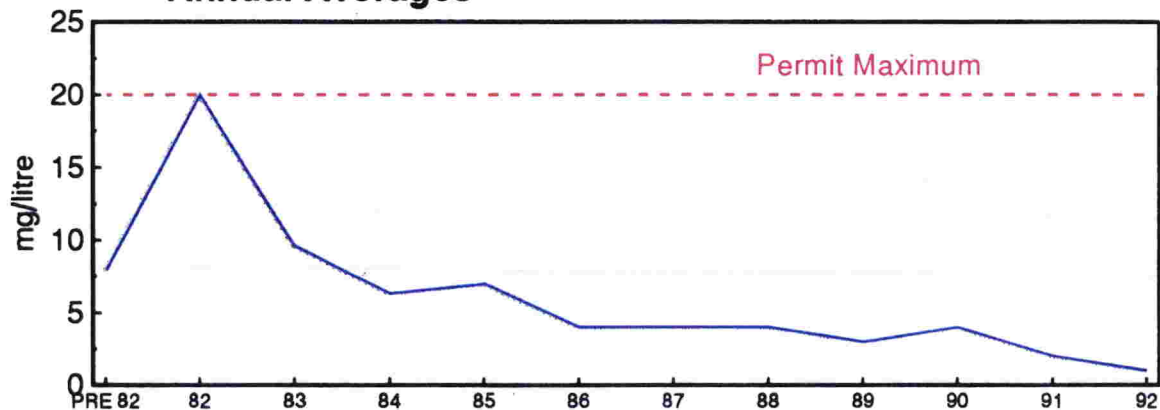
Annual Averages

The discharge free cyanide concentration remains low with the annual mean concentration for 1992 of 1mg/litre continuing the downward trend evident since 1982.

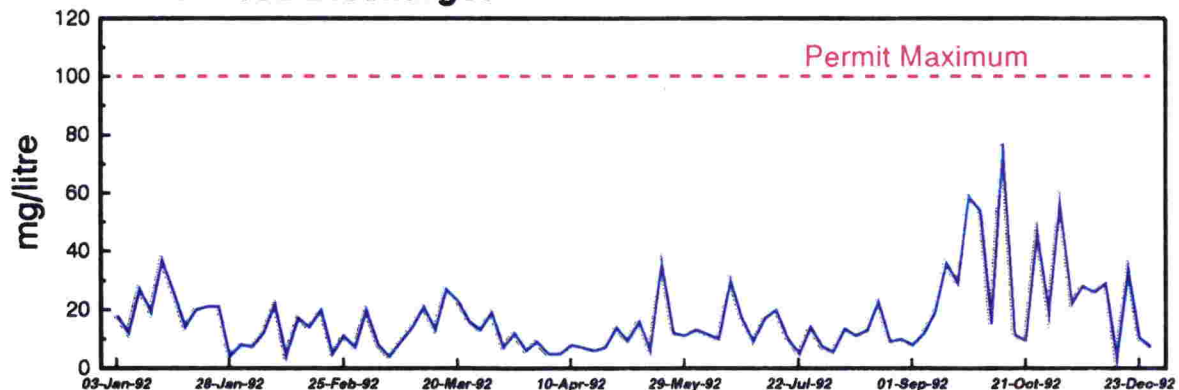
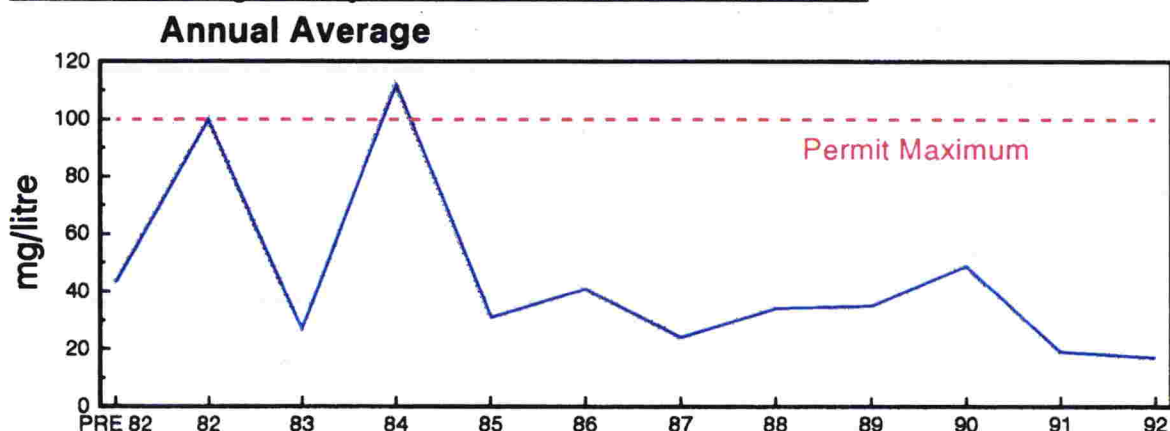
4.5.2 Discharge Suspended Solids Concentrations

The period of large variation in the suspended solids concentration is related to the capping of the south cathode storage pad which resulted in a reduction in the total volume of effluent. The storm water run off from the north pad made up a greater percentage of this effluent and it was observed to have a high concentration of very fine solids. Compliance with the permit condition was maintained.

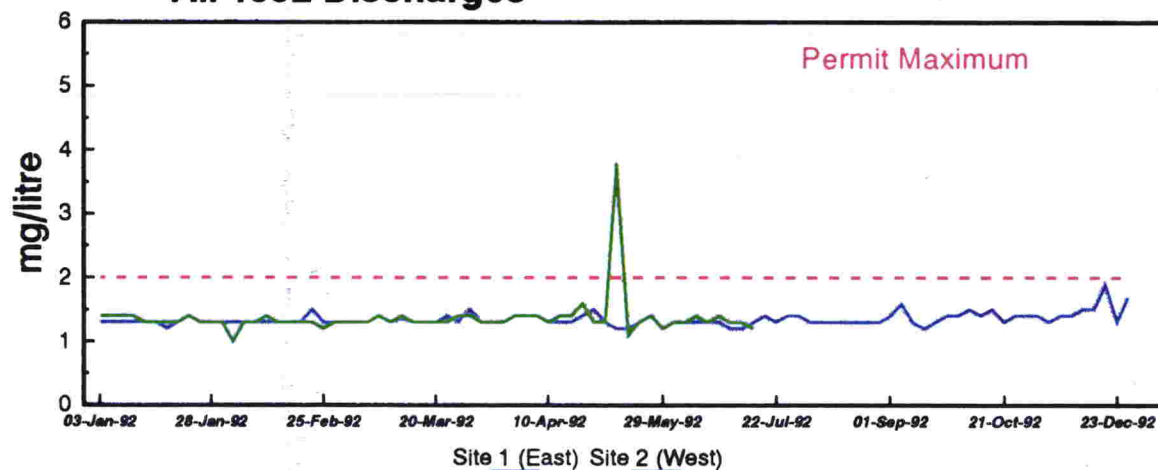
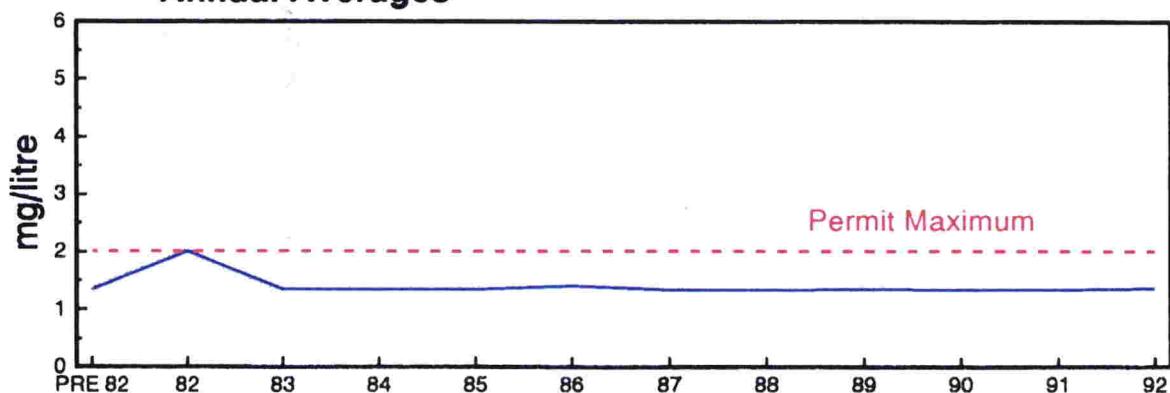
4.5.3 Receiving Water Fluoride Concentrations

There are no trends evident in the receiving water fluoride concentrations. In mid-July the discharge procedure was changed, on the basis of consultants advice, so that treated cathode effluent was discharged to coincide with optimum dispersion characteristics in the receiving seawater. This occurs during the rising tide when there is a strong tidal flow west to east along the coast. The west sample point was discontinued when the change was made because it is now up current from the point of discharge.

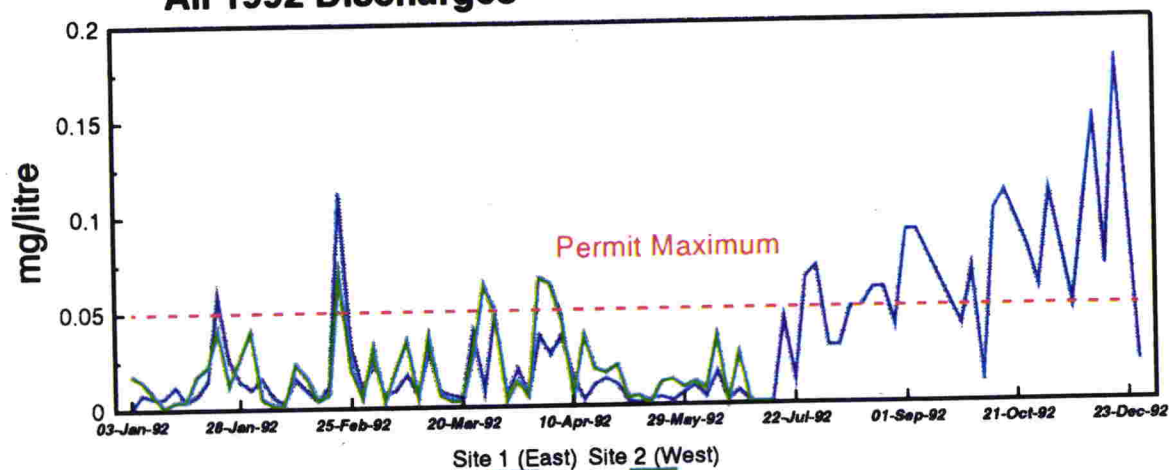
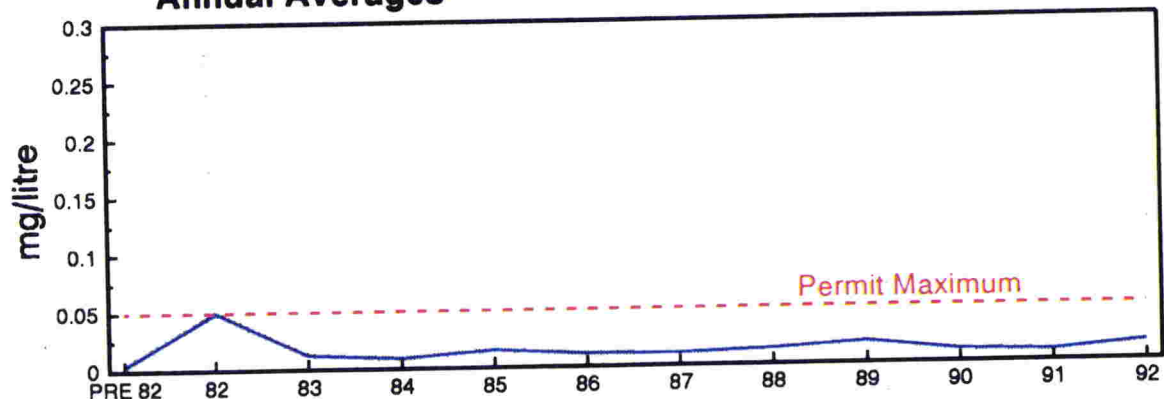
4.5.4 Receiving Water Total Cyanide Concentrations

As mentioned in section 4.5.3, mid-July saw a change in the discharge procedure. This was accompanied with a change in the time that the receiving seawater sample is taken. Previously this sample was taken at high tide, approximately the middle of the discharge. As of mid-July the sample is taken shortly after low tide when the receiving seawater effluent concentration is at its predicted maximum. Work completed during the year indicates that the most likely source of the detected total cyanide is contaminated groundwater. The concentrations measured are very dependent on the stage of the tide the sample is collected. The marked change in the reported receiving seawater total cyanide after July does not indicate a sudden change in the effect on the environment but a change in the way it is measured.
