New Zealand Aluminium Smelters Limited

Annual Environmental Monitoring Report 2016

Report to Environment Southland on consent monitoring and environmental effects of the Tiwai Aluminium Smelter for the year ending 31 December 2016

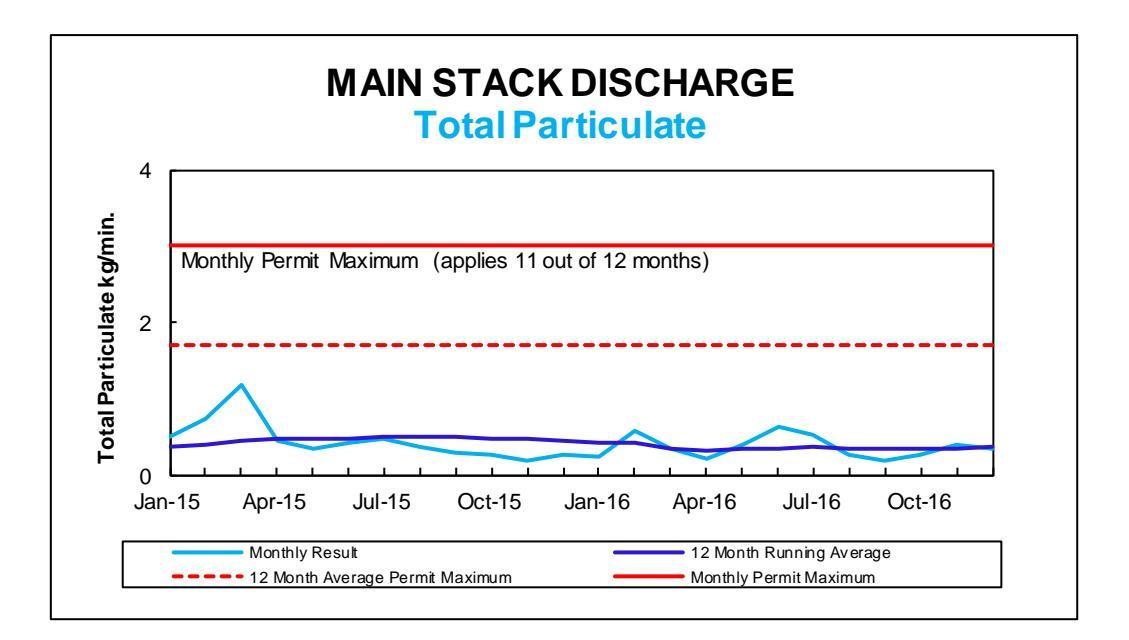
The following graph shows both the average monthly and 12 monthly running average main stack total particulate discharge during 2015 and 2016.

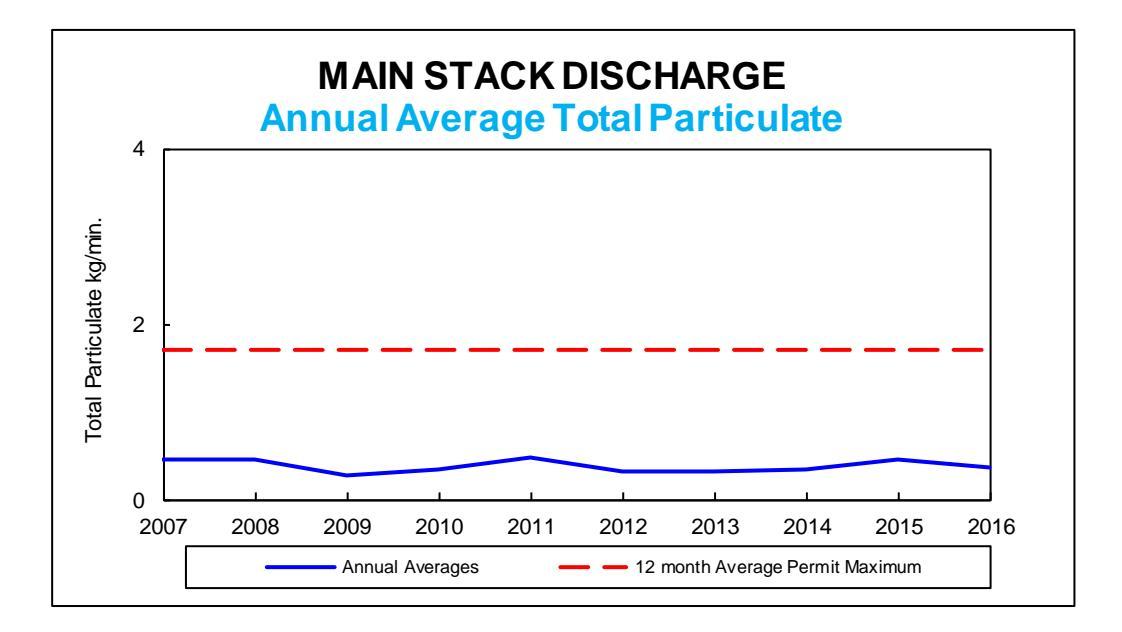
The following graph shows the annual average main stack total particulate discharge.

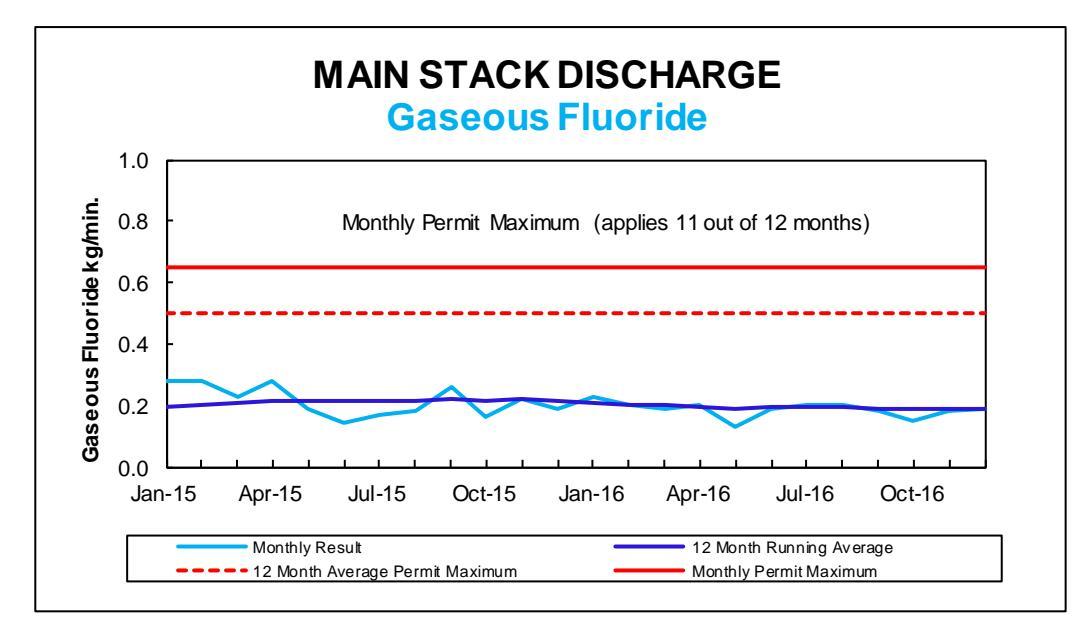
Permit: 12 month running average not to exceed 0.5 kg/min.

The following graph shows both the average monthly and 12 monthly running average main stack gaseous fluoride discharge during 2015 and 2016.

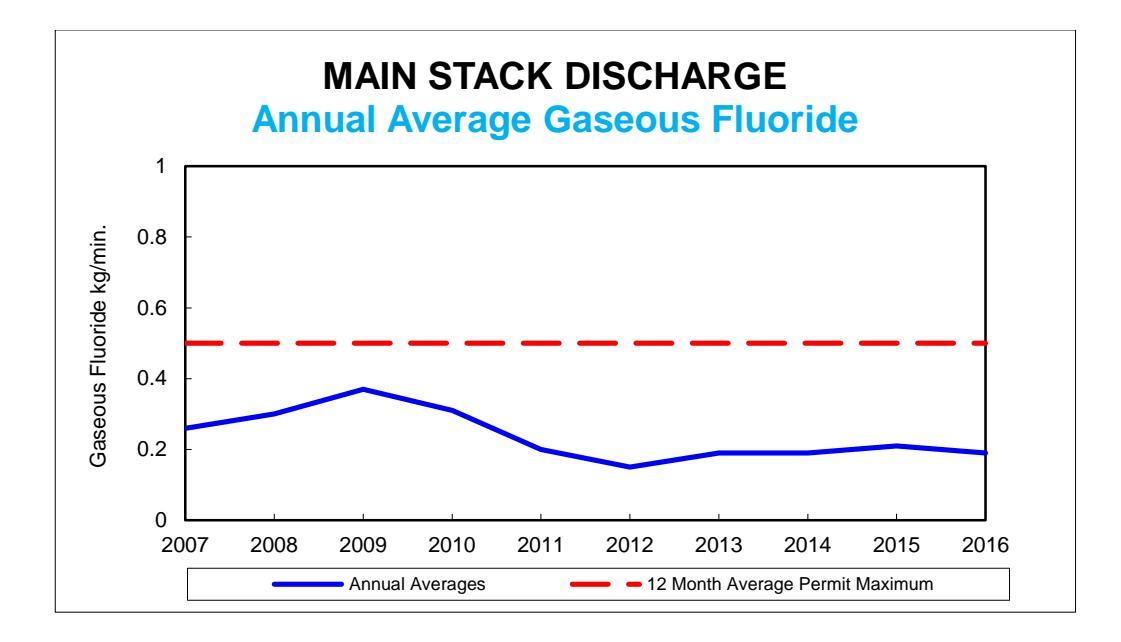
The following graph shows the annual average main stack gaseous fluoride discharge.

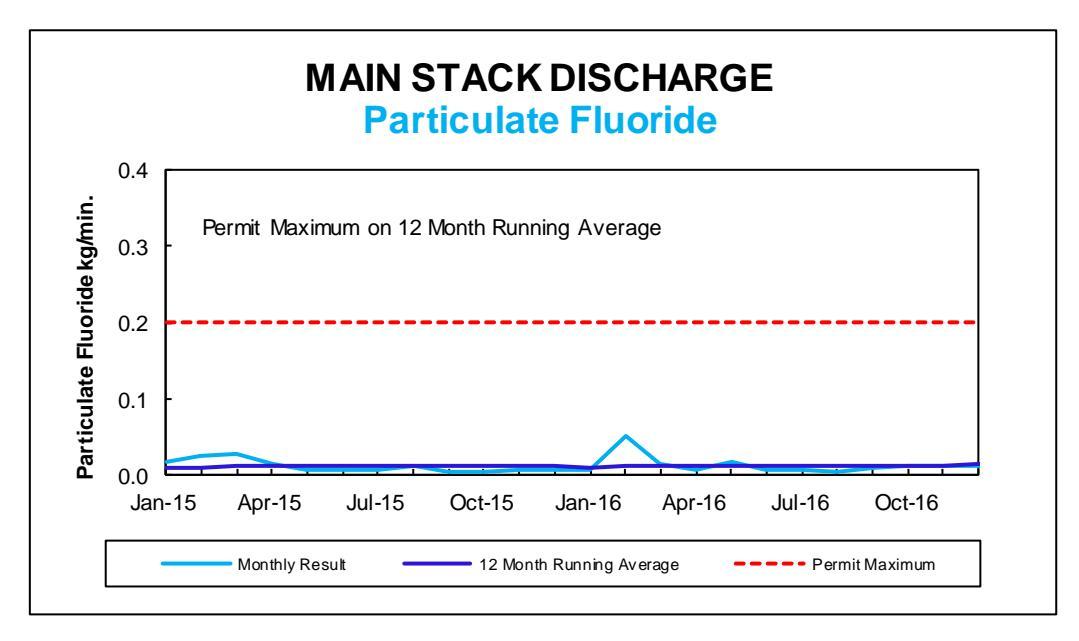
Permit: 12 month running average not to exceed 0.2 kg/min.

The following graph shows both the average monthly and the 12 monthly running average main stack particulate fluoride discharge during 2015 and 2016.

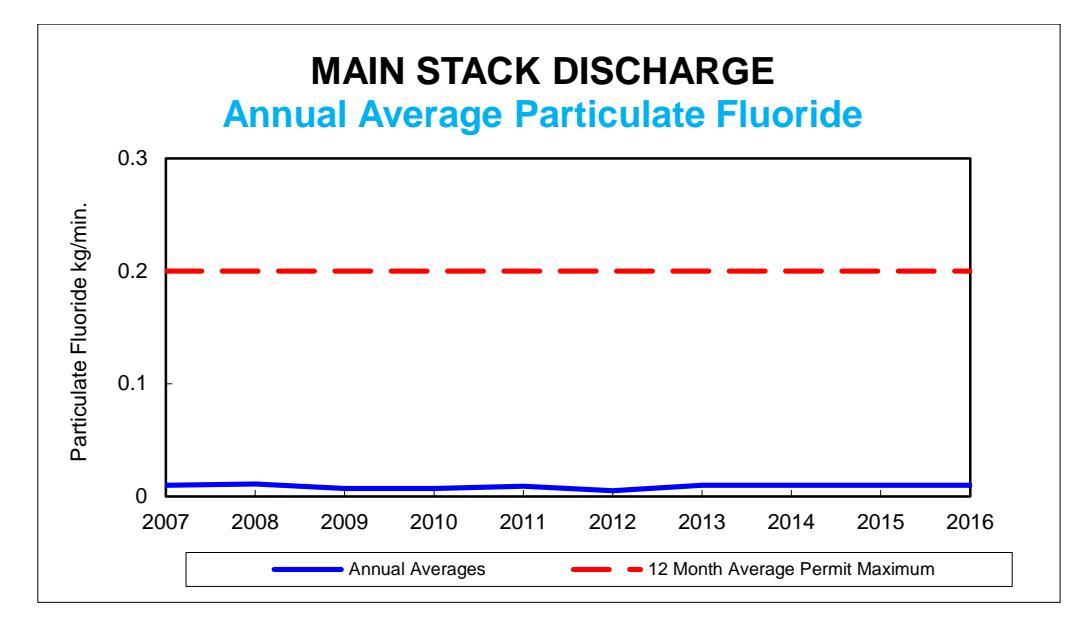
The following graph shows the annual average main stack particulate fluoride discharge.

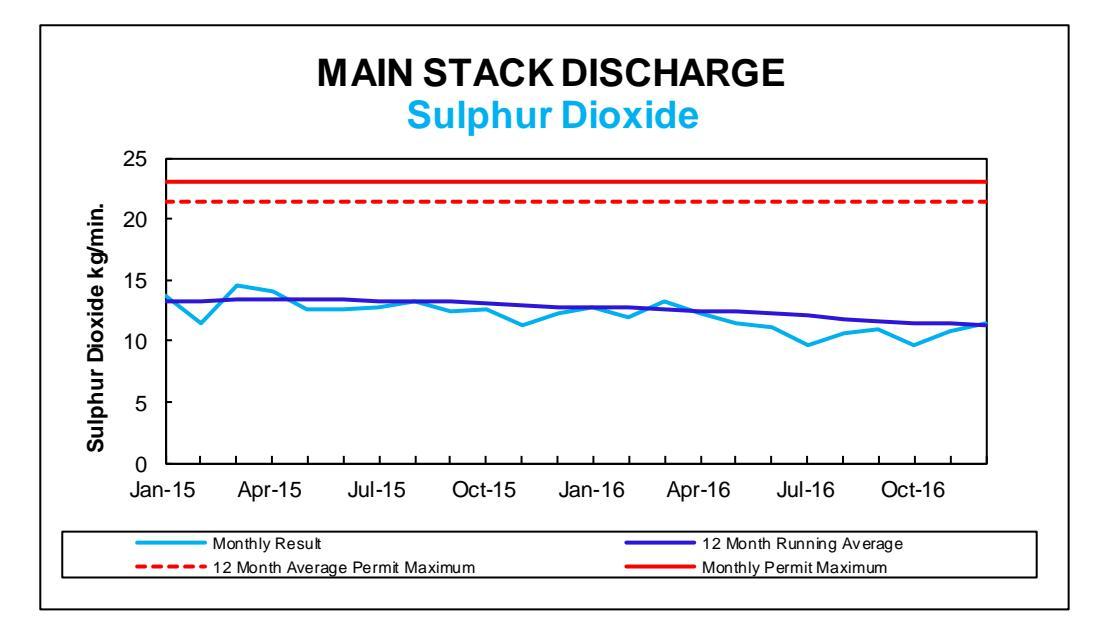
Permit: 12 month running average not to exceed 21.4 kg/min.

The following graph shows both the average monthly and 12 monthly running average main stack sulphur dioxide discharge during 2015 and 2016.

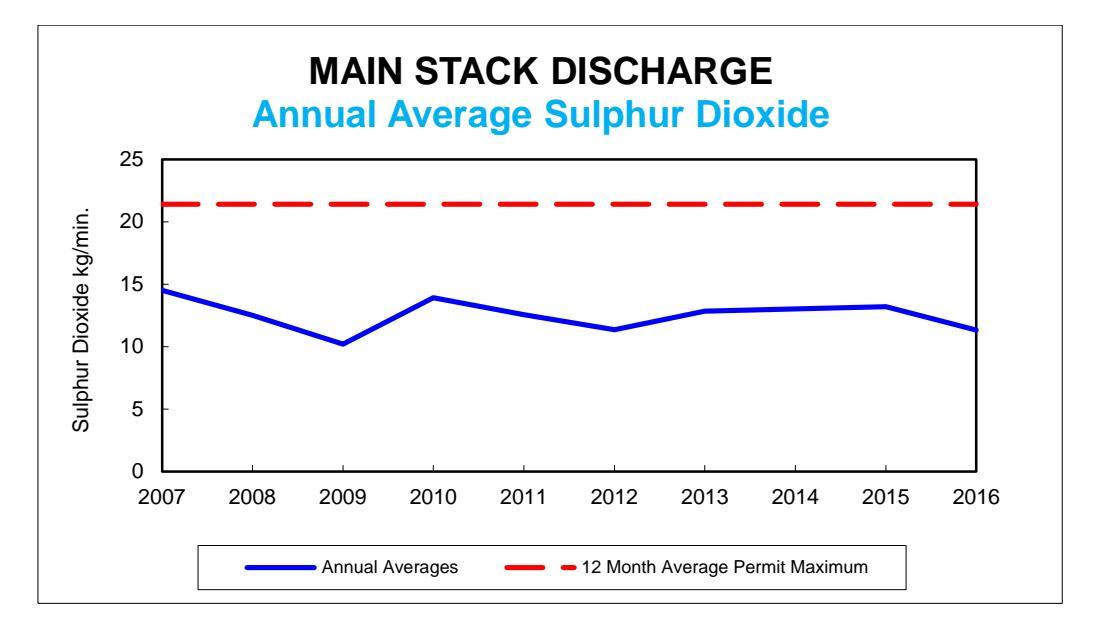
The following graph shows the annual average main stack sulphur dioxide discharge.

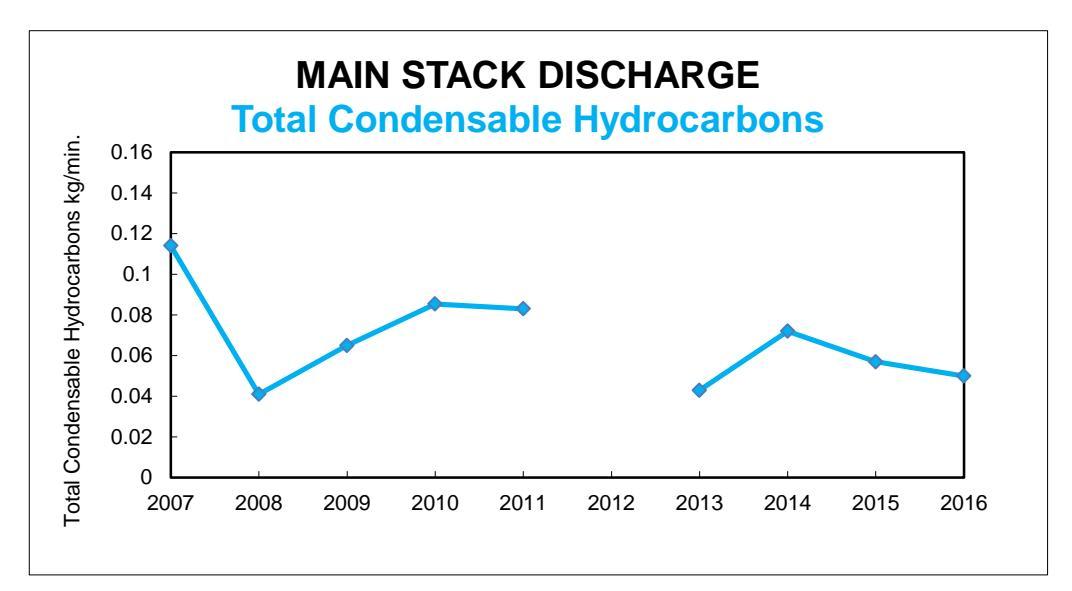
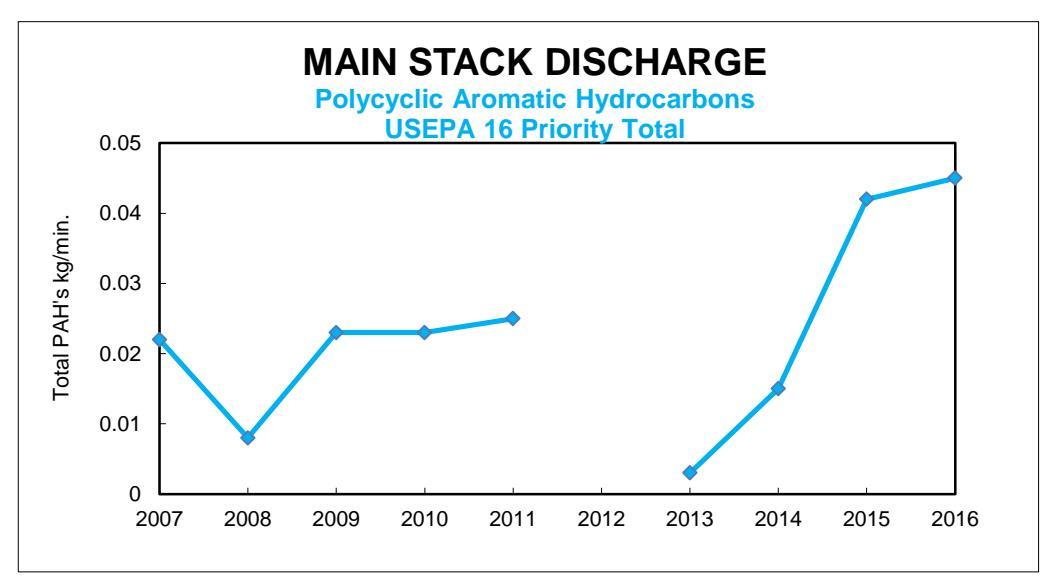
The annual analysis for total condensable hydrocarbons (TCH) and 16 USEPA priority PAH's was carried out in April 2016. The following graphs shows the annual TCH discharges and the 16 USEPA priority PAH's.

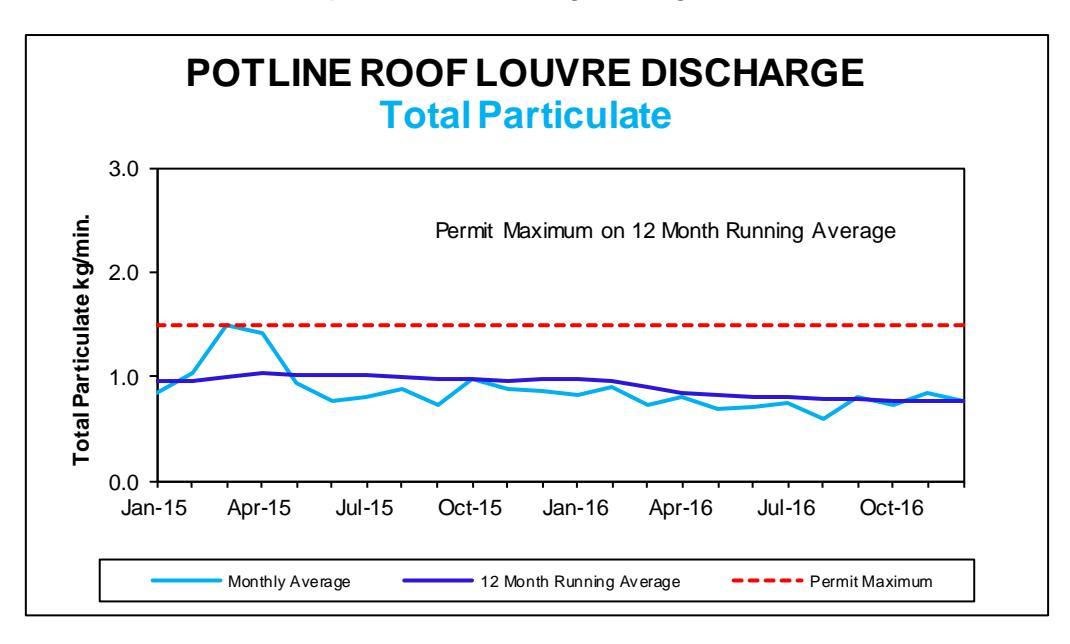
The following graph shows both the average monthly and 12 month running average Potline roof louvre total particulate discharge during 2015 and 2016.

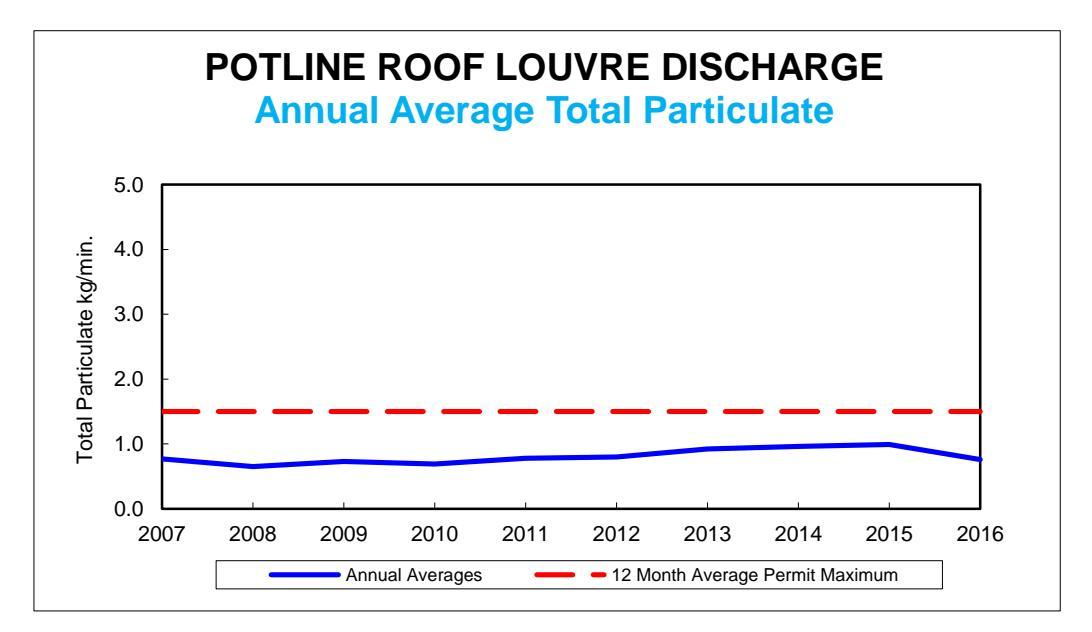
The following graph shows the annual average Potline roof louvre total particulate discharge.

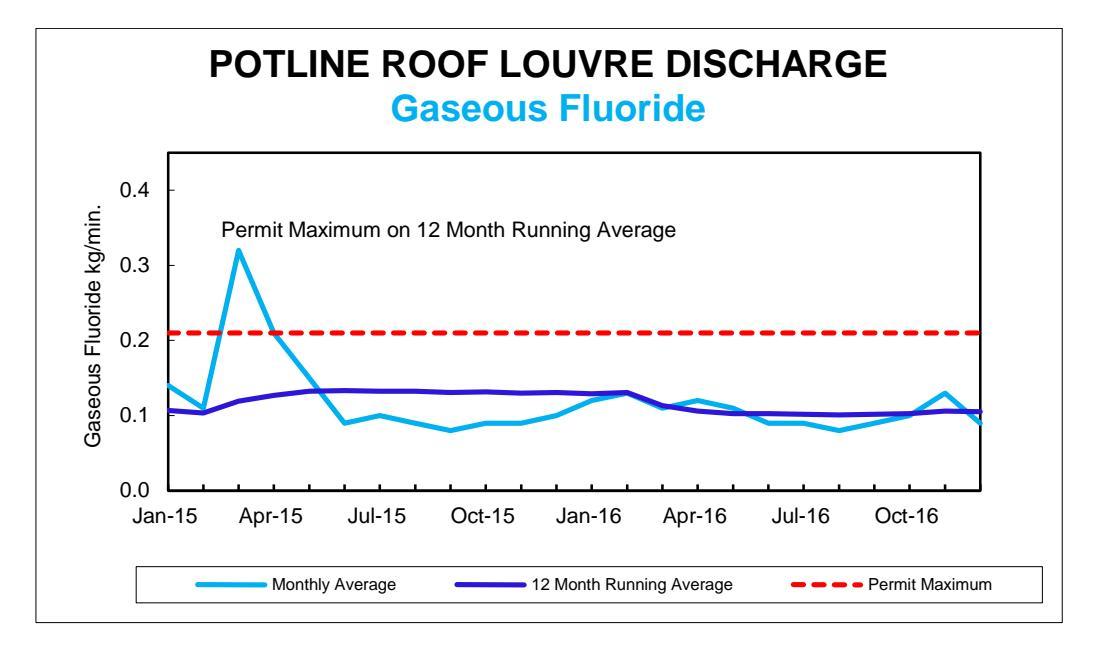
Permit: 12 month running average not to exceed 0.21 kg/min.

The following graph shows both the average monthly and 12 month running average Potline roof louvre gaseous fluoride discharge during 2015 and 2016.

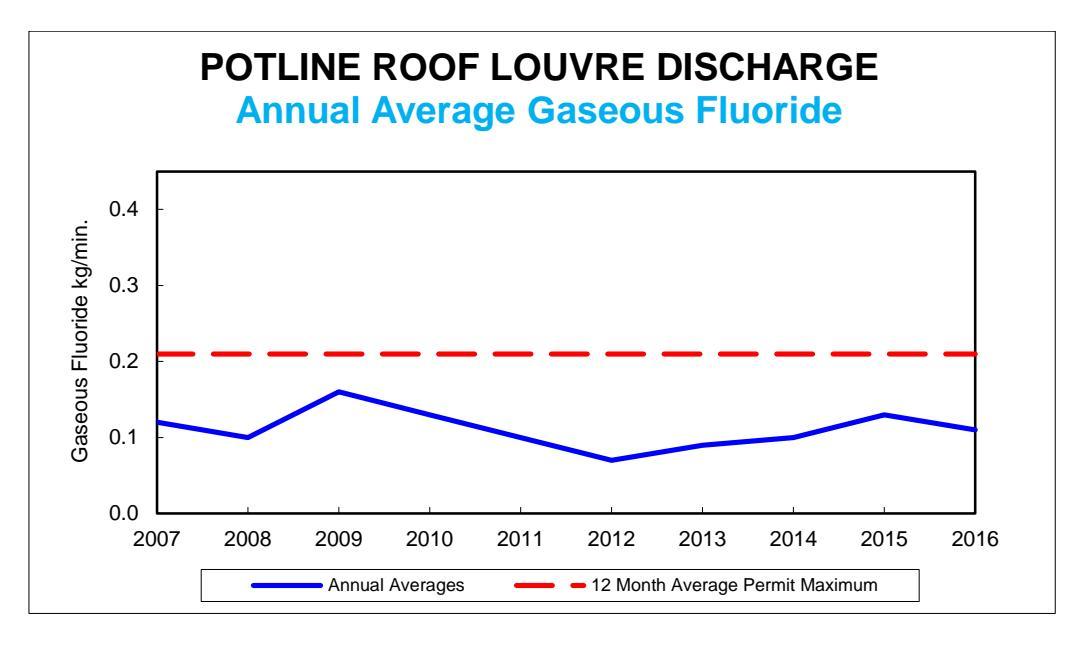
The following graph shows the annual average Potline roof louvre gaseous fluoride discharge.

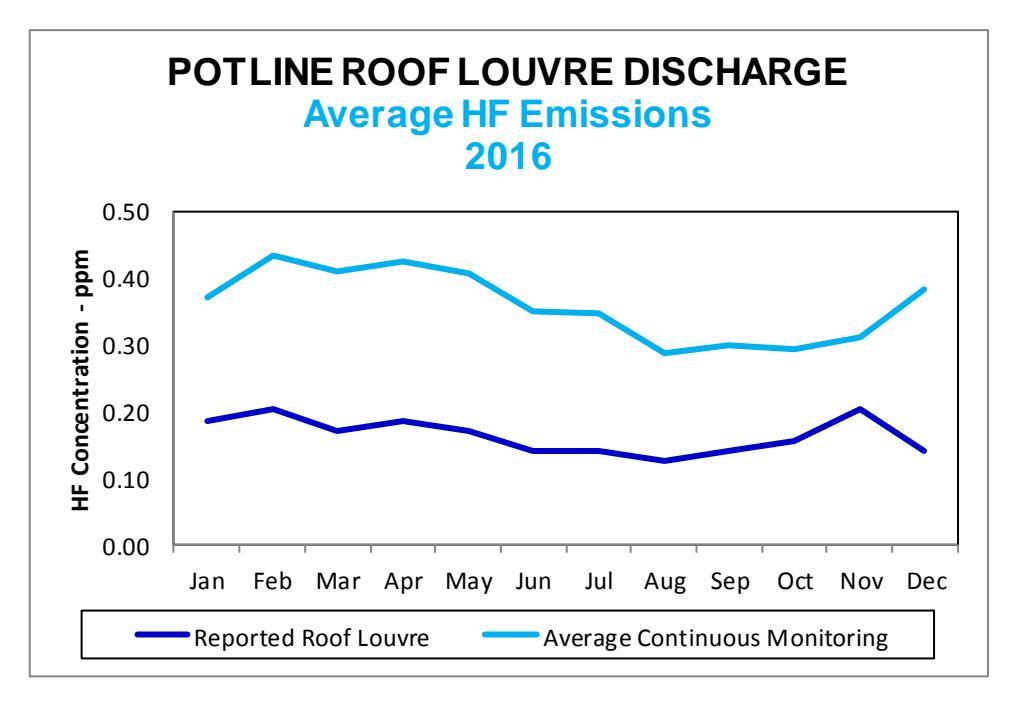
The following graph shows the reported Potline Roof Louvre gaseous fluoride emissions in comparison to the Boreal continuous monitoring results.

The Boreal instruments used for continuous monitoring of HF in Potlines were removed for repair and servicing. One instrument was out of service between February and August and the other between September and November. The fault was identical in both instruments.

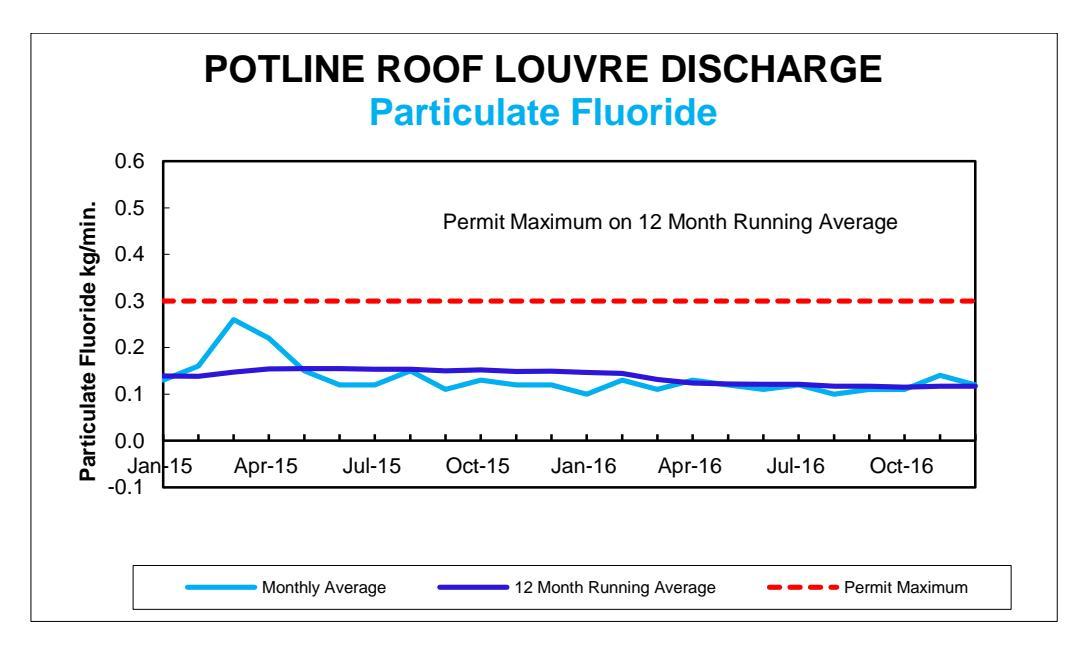
The following graph shows both the average monthly and 12 month running Potline roof louvre particulate fluoride discharge during 2015 and 2016.

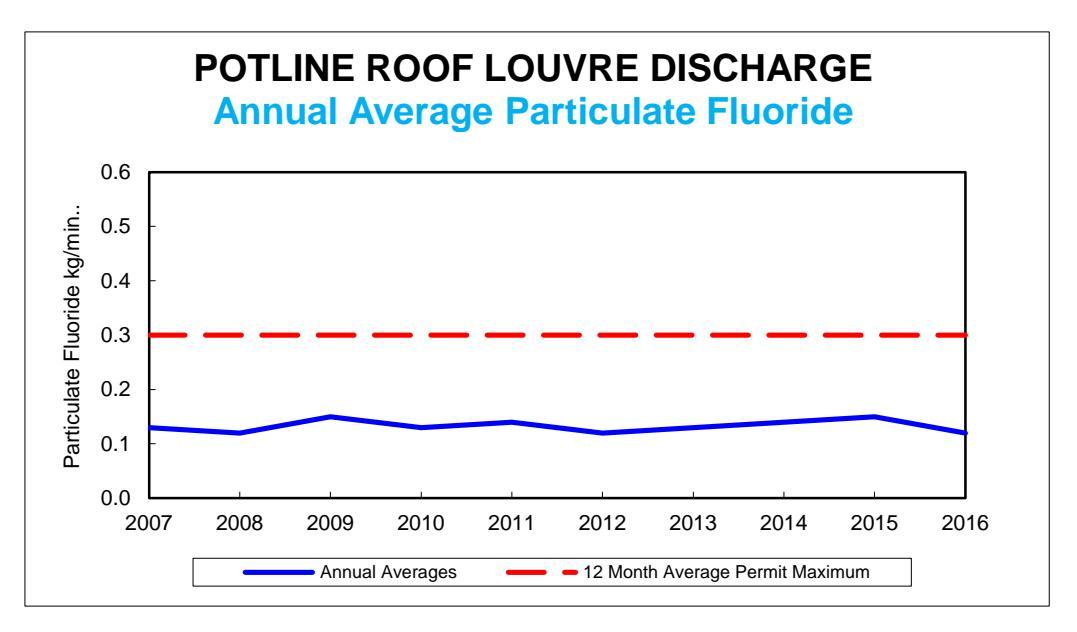
The following graph shows the annual average data for Potline roof louvre particulate fluoride discharge.

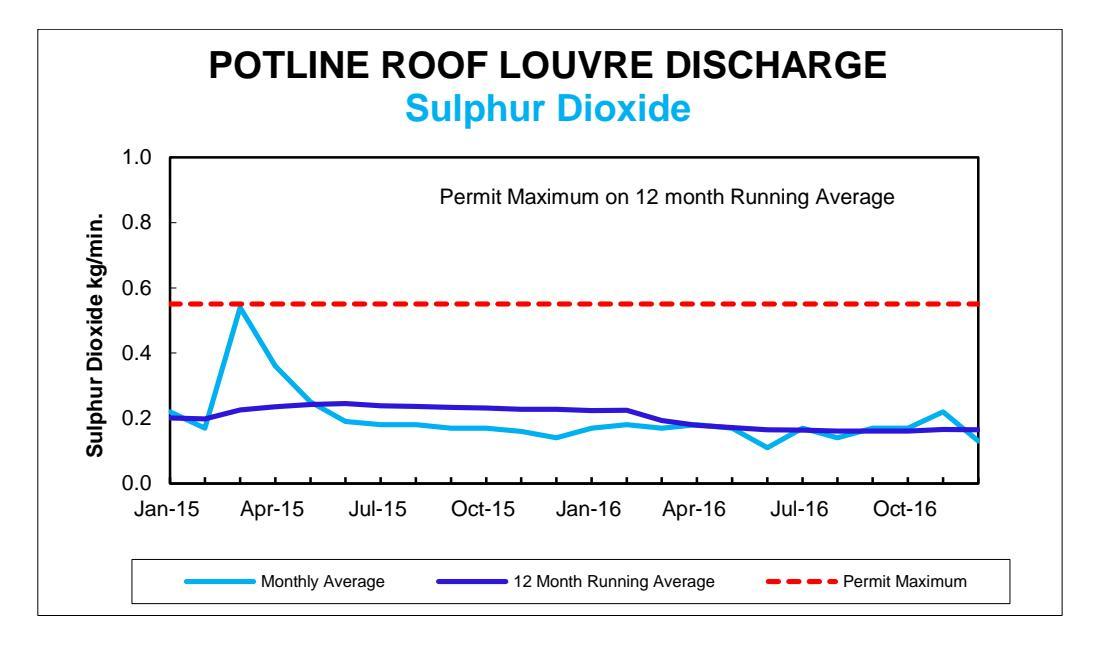
The following graph shows both the average monthly and 12 month running Potline roof louvre sulphur dioxide discharge during 2015 and 2016.

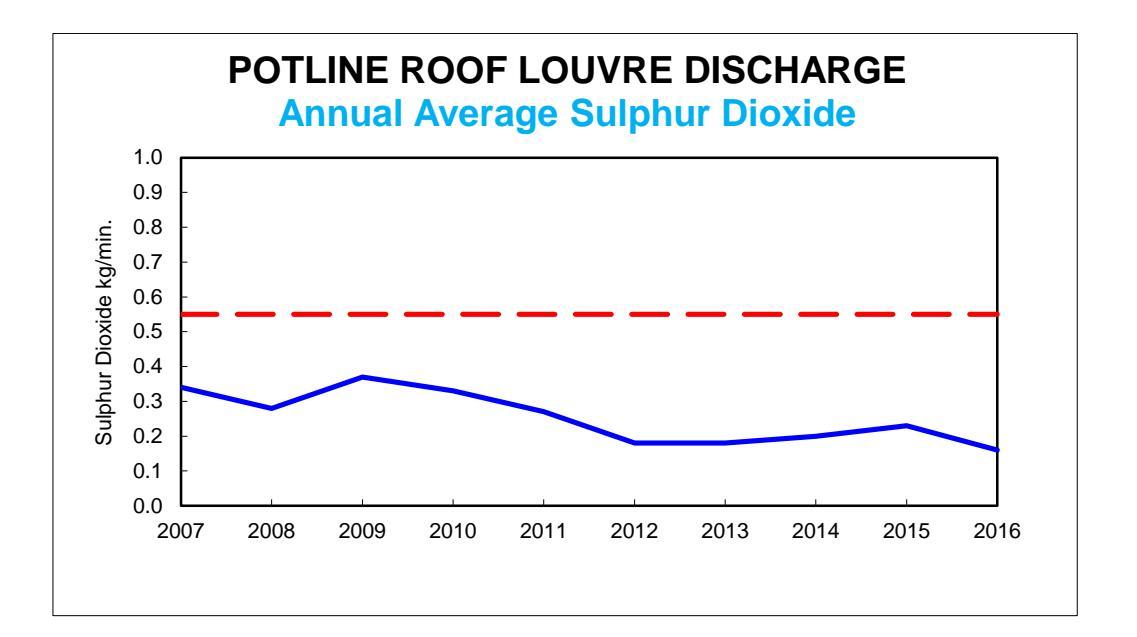
The following graph shows the annual average Potline roof louvre sulphur dioxide discharge.

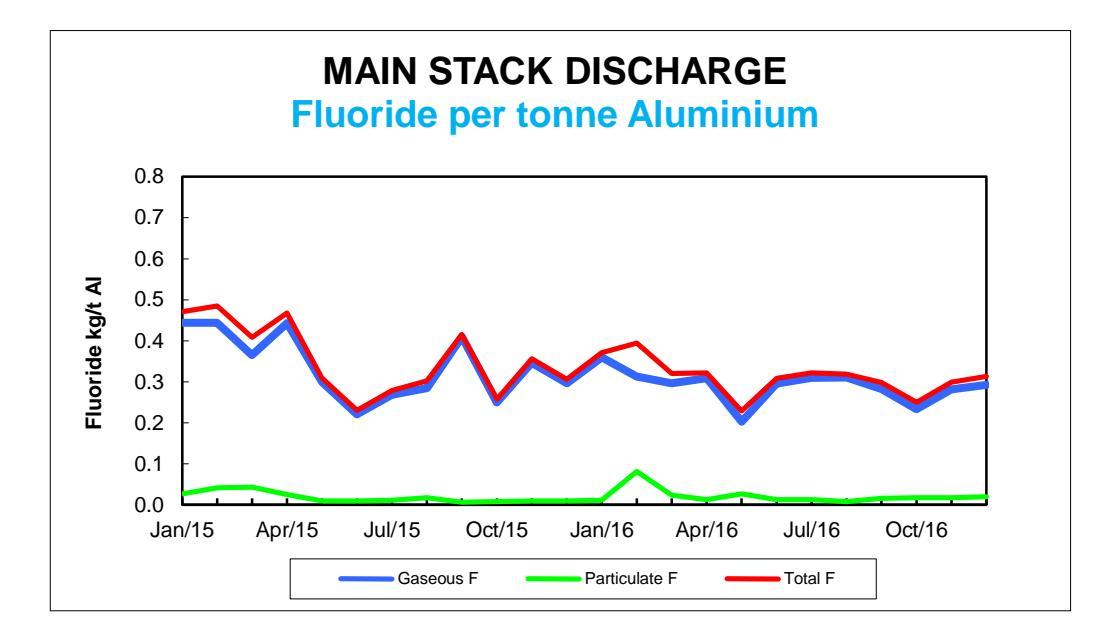
The following graph shows the monthly main stack fluoride per tonne aluminium discharge during 2015 and 2016.

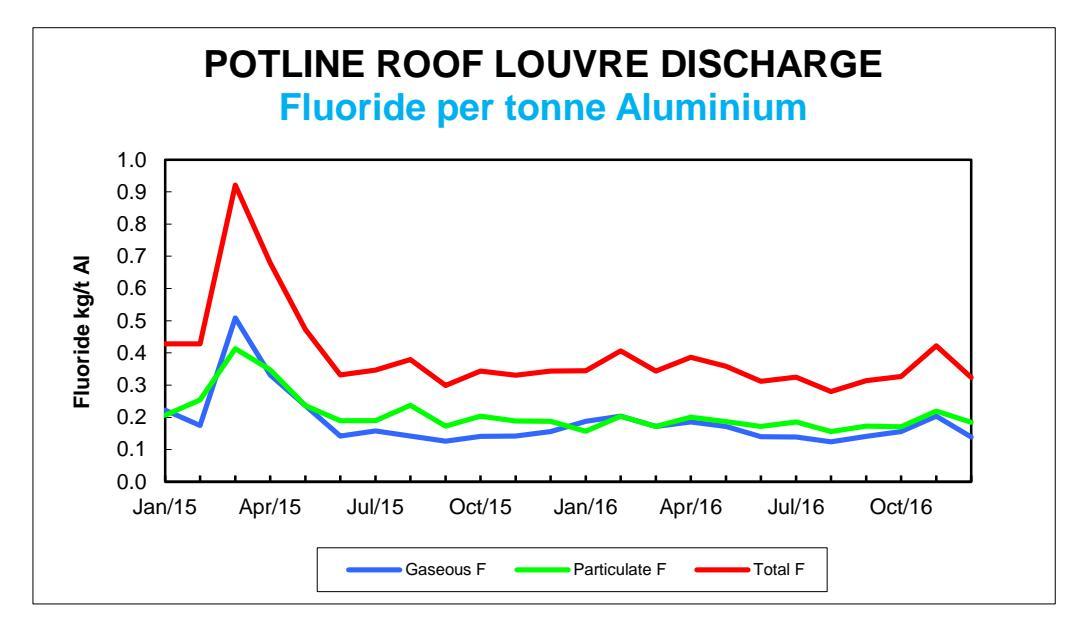
The following graph shows the average monthly Potline roof louvre fluoride per tonne aluminium discharge during 2015 and 2016.

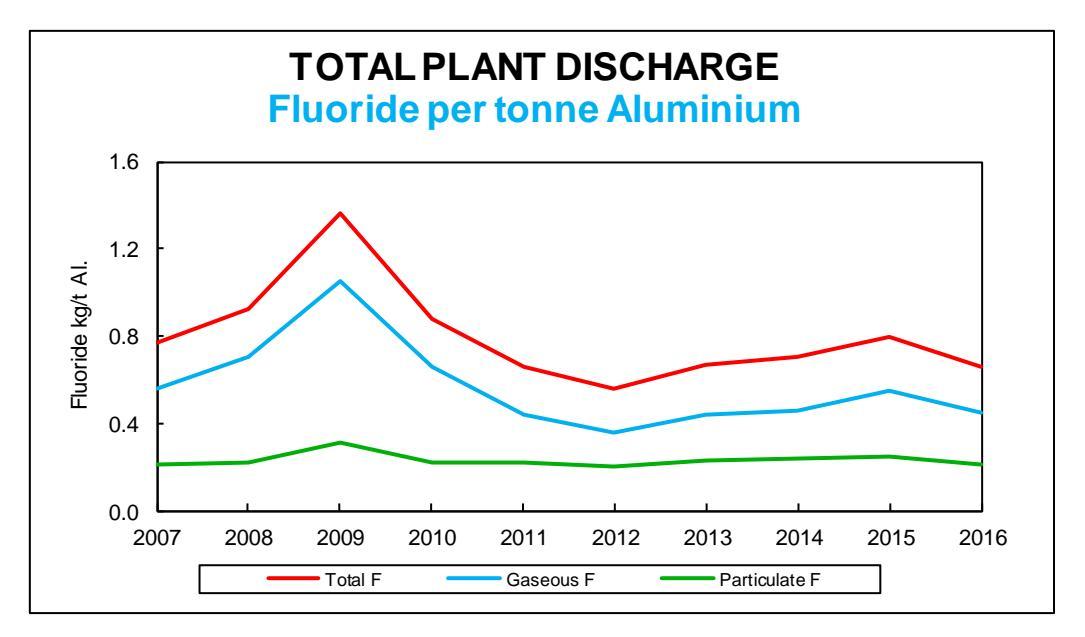
The following graph shows the average total plant fluoride per tonne aluminium for the last 10 years.

The annual total fluoride discharge rate from the plant for 2016 remains similar to previous years.

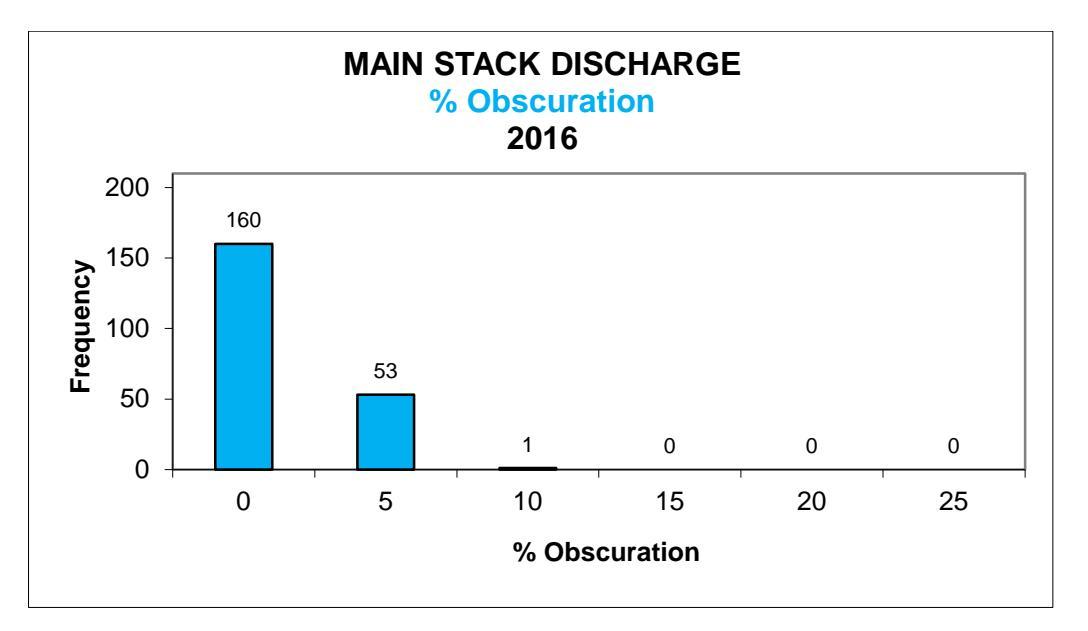
Main Stack smoke discharges were determined by visual observations using the standard Ringlemann chart. The following graph summarises the observations recorded during 2016.

During 2016 there was an increase in the frequency of observations in the 1 to 5% range, a decrease in the 10% range and no observations greater than 10%. The majority of the observations were 0%.

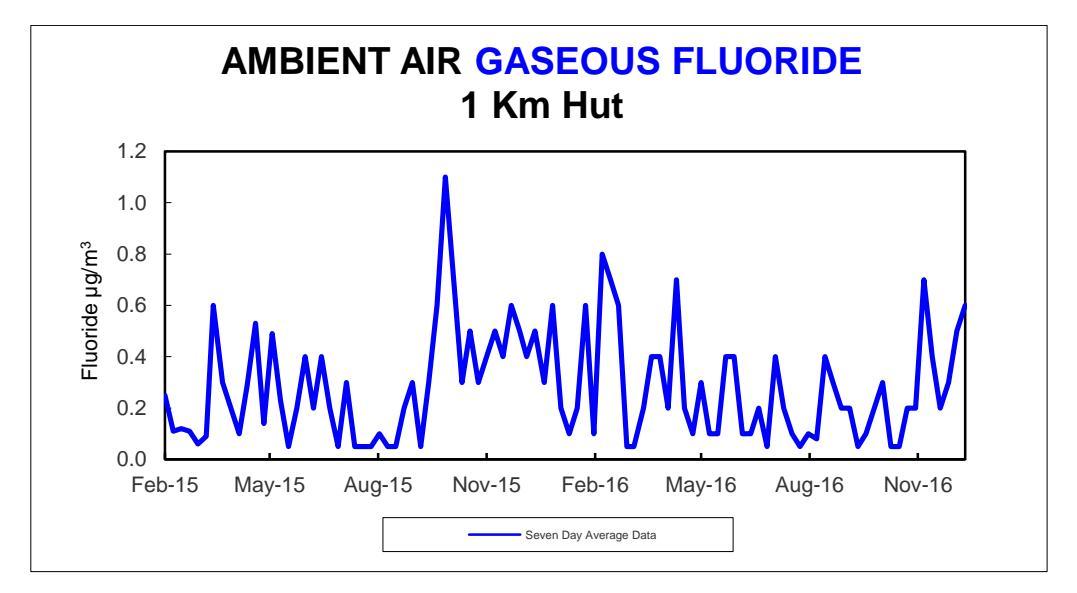
The following graph shows the seven-day average gaseous fluoride results for this site.

Note: Concentrations < 0.1 μ g/m³ are plotted as 0.05 μ g/m³

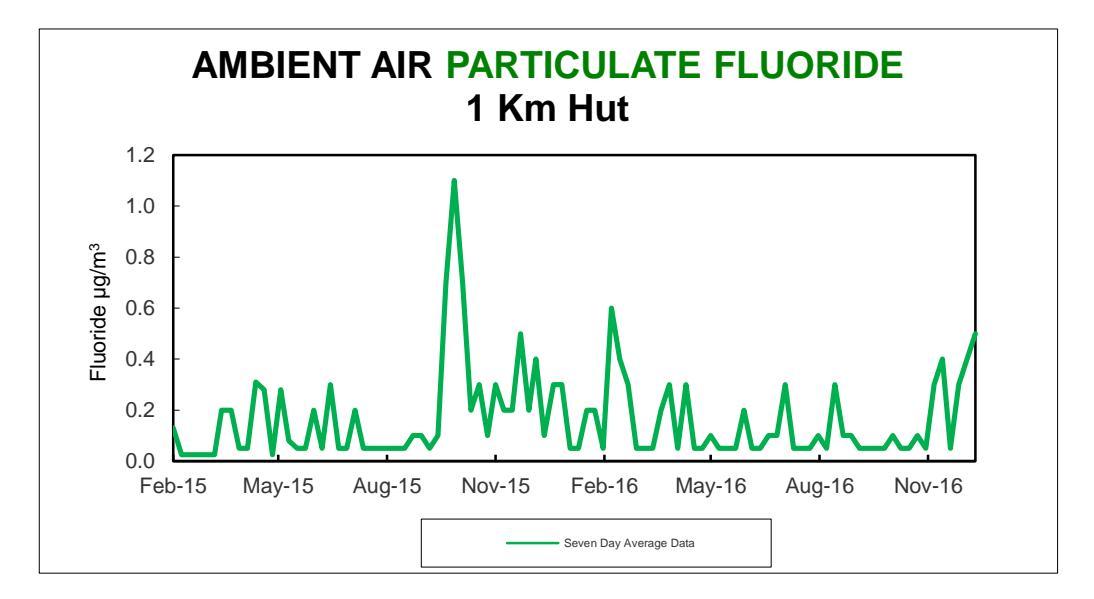
The following graph shows the seven-day average particulate fluoride results for this site.

Note: Concentrations < 0.1 μ g/m³ are plotted as 0.05 μ g/m³

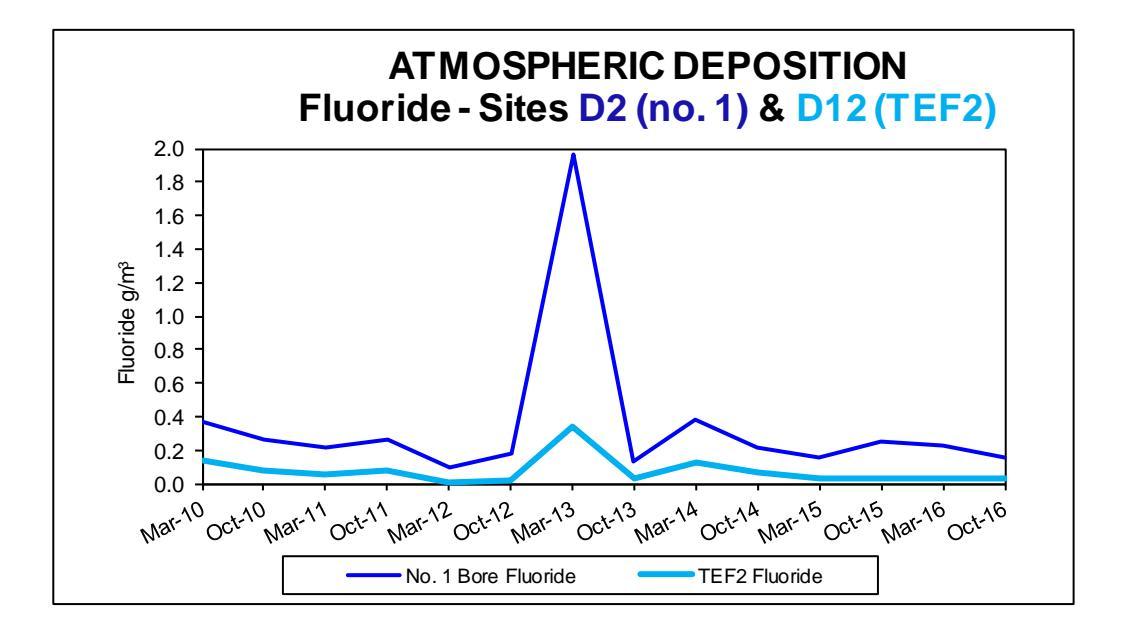
Site	Units	Mar-16	Oct-16
D2. (No1 Bore)	g/m ³	0.23	0.16
D12. (TEF2)	g/m ³	< 0.05	< 0.05

Fluoride levels at both sites are similar to previous years

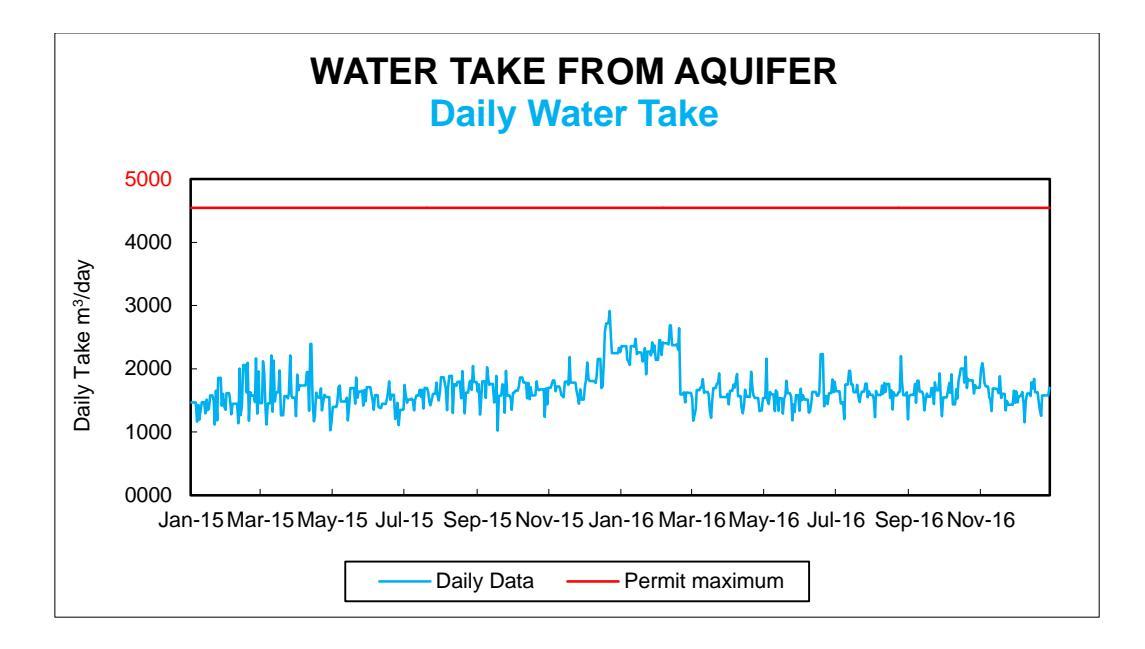
The total volume of water taken from the aquifer was recorded daily until early December 2012. Due to organisational restructuring the readings are no longer done in the weekends or public holidays. The practice now is to take the reading on the first available day and record the average. The data is displayed in the graph below.

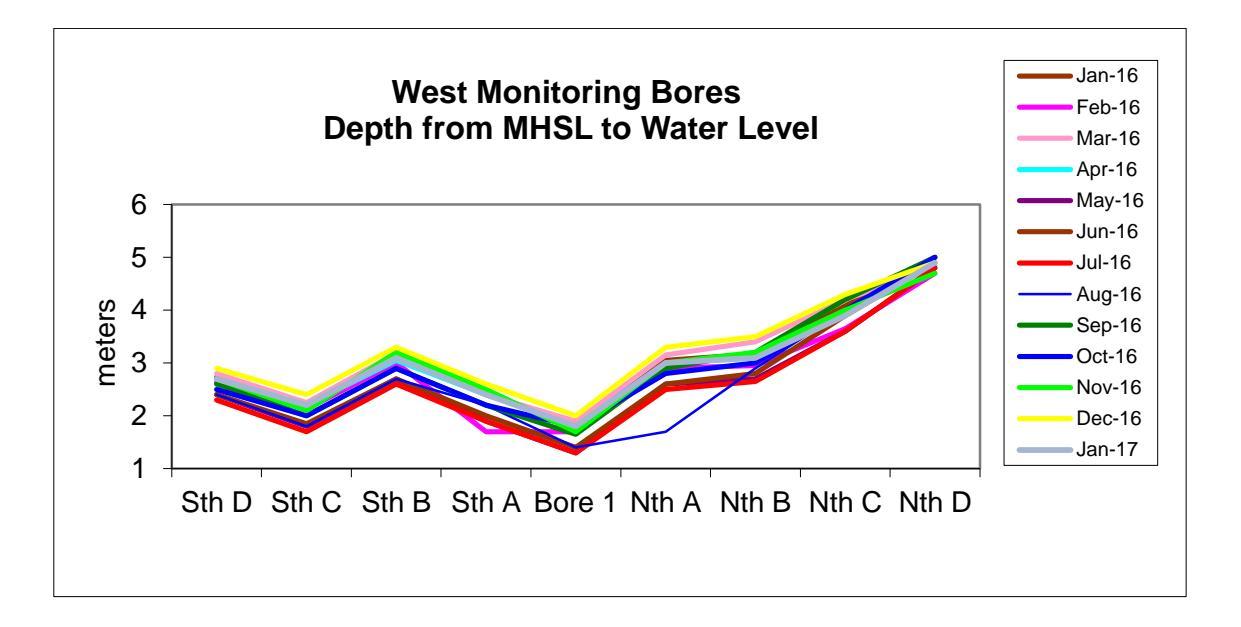
West Monitoring Bore Water Levels (from Mean High Sea Level in metres) <i>Total well depth in Italics</i>									
		So	uth		Boro 1	North			
Date	D	С	В	Α	DOIG	Α	В	С	D
	5.64	5.50	5.50	4.62	16.4	5.32	5.30	5.55	5.27
Jan-16	2.73	2.23	3.84	2.40	1.87	3.05	3.17	4.08	5.00
Feb-16	2.63	2.13	3.65	1.70	1.70	2.90	2.95	3.65	4.70
Mar-16	2.80	2.25	3.75	2.40	1.90	3.15	3.40	4.20	4.80
Apr-16	2.70	2.20	3.65	2.40	1.80	3.00	3.10	4.00	4.85
May-16	2.40	1.80	3.10	1.90	1.30	2.60	2.70	3.60	4.80
Jun-16	2.40	1.85	3.30	2.00	1.40	2.60	2.80	3.90	4.90
Jul-16	2.30	1.70	3.30	1.90	1.30	2.50	2.65	3.60	4.80
Aug-16	2.40	1.80	3.50	2.20	1.40	1.70	2.90	4.00	4.90
Sep-16	2.60	2.00	3.60	2.20	1.65	2.90	3.20	4.20	5.00
Oct-16	2.50	2.00	3.50	2.20	1.80	2.80	3.00	4.00	5.00
Nov-16	2.70	2.10	3.70	2.50	1.70	3.00	3.20	4.00	4.70
Dec-16	2.90	2.40	3.90	2.60	2.00	3.30	3.50	4.30	4.90

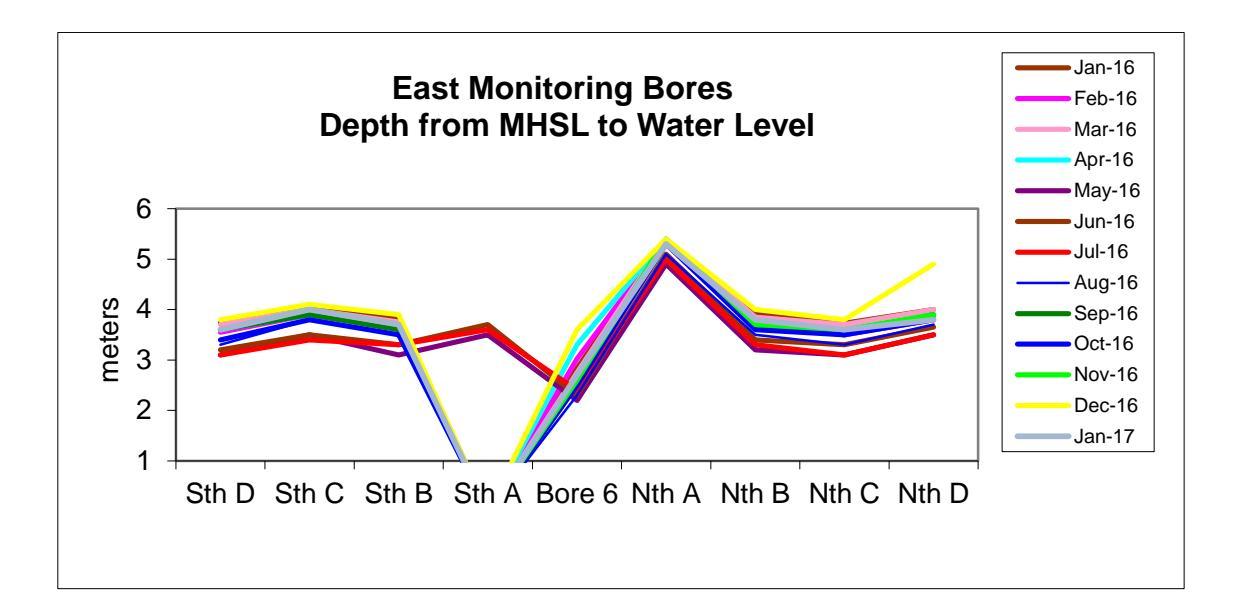
East Monitoring Bore Water Levels (from Mean High Sea Level in metres)									
Total well depth in Italics									
		Soι	ıth				Nor	th	
Date	D	С	В	Α	Bore 6	Α	В	С	D
	4.32	5.35	5.79	3.82	8.6	5.46	5.4	5.45	5.5
Jan-16	3.74	4.08	3.84	dry	2.83	5.38	3.93	3.73	4.00
Feb-16	3.55	3.90	3.65	dry	3.02	5.38	3.73	3.50	3.80
Mar-16	3.70	4.00	3.75	dry	2.75	5.40	3.85	3.70	4.00
Apr-16	3.60	3.90	3.65	dry	3.30	5.40	3.70	3.50	3.85
May-16	3.10	3.50	3.10	3.50	2.20	4.90	3.20	3.10	3.50
Jun-16	3.20	3.50	3.30	3.70	2.30	5.10	3.40	3.30	3.65
Jul-16	3.10	3.40	3.30	3.60	2.40	5.00	3.30	3.10	3.50
Aug-16	3.30	3.80	3.50	dry	2.30	5.10	3.50	3.30	3.70
Sep-16	3.60	3.90	3.60	dry	2.50	5.30	3.70	3.50	3.90
Oct-16	3.40	3.80	3.50	dry	2.50	5.30	3.60	3.50	3.80
Nov-16	3.60	4.00	3.70	dry	2.60	5.40	3.70	3.60	3.90
Dec-16	3.80	4.10	3.90	dry	3.60	5.40	4.00	3.80	4.90

Water levels in the monitoring bores have not changed significantly during 2016. Bore South A was dry for 9 of the 12 months as reflected in the graph above compared to 8 of the 12 months in 2015.

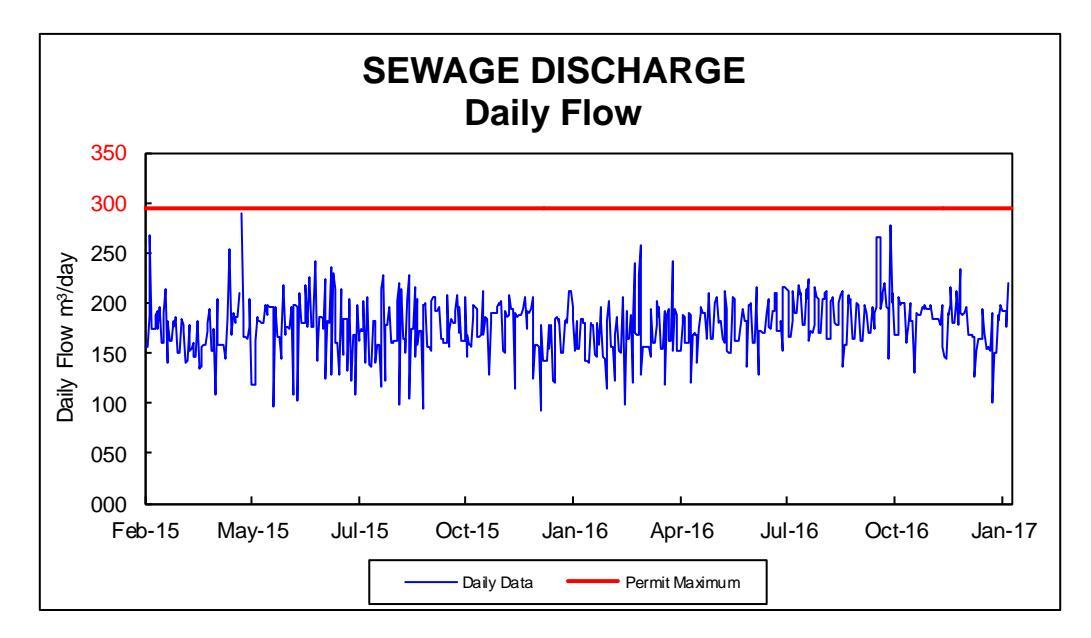
The following graph shows the daily sewage discharge flow during 2015 and 2016. The permit limit for daily flow is $295m^3/day$.
