New Zealand Aluminium Smelters Limited

Annual Environmental Monitoring Report 2016

Report to Environment Southland on consent monitoring and environmental effects of the Tiwai Aluminium Smelter for the year ending 31 December 2016

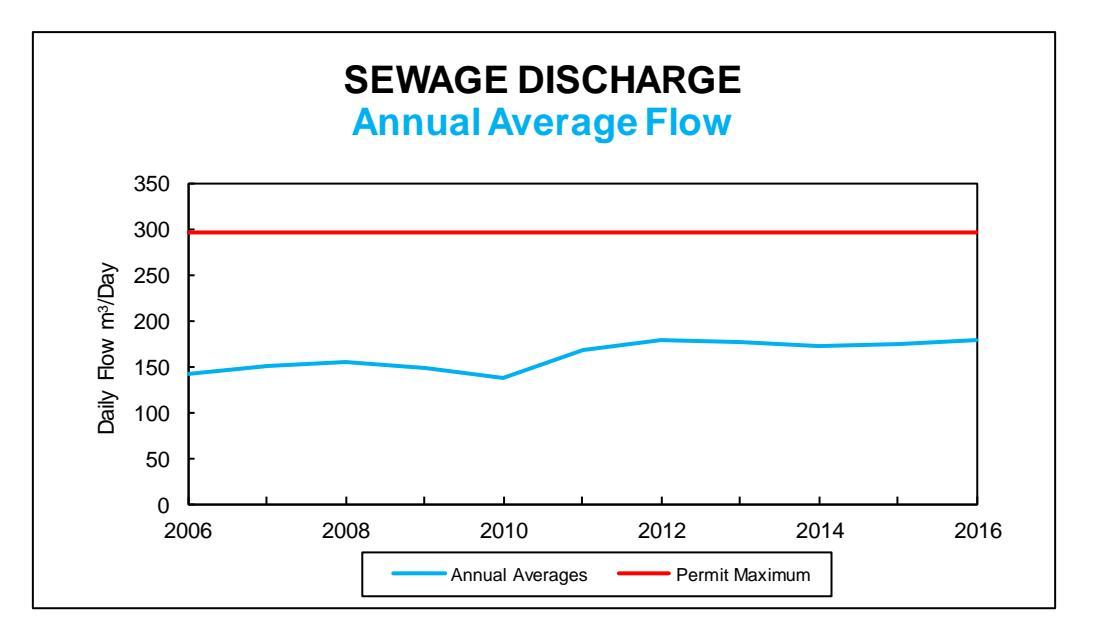
The following graph shows the annual average daily sewage discharge flow into the sewage treatment facility.

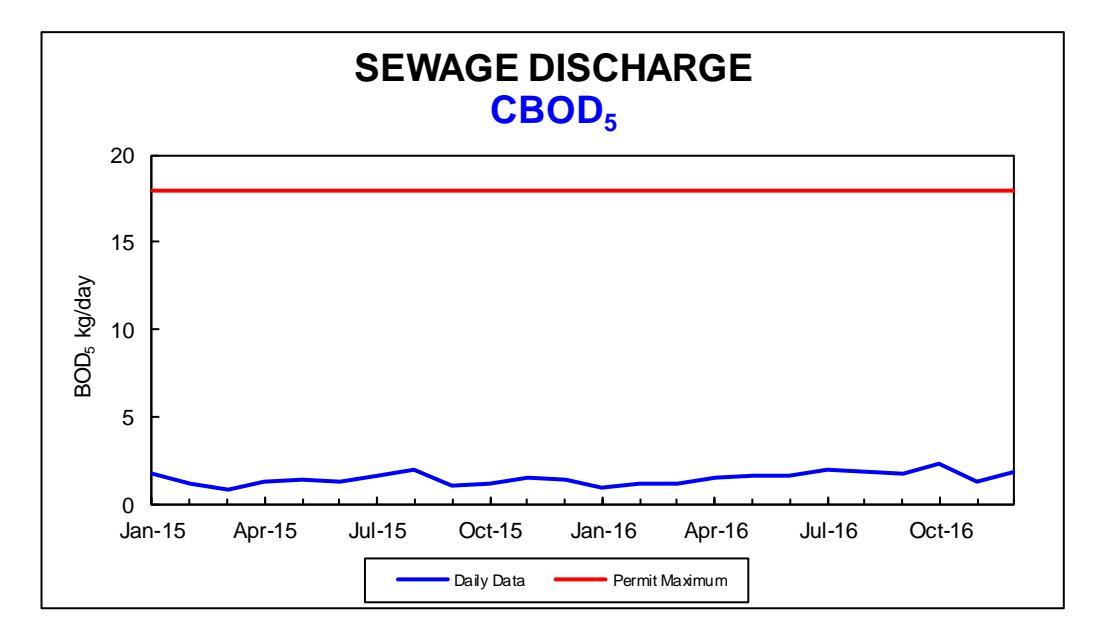
The following graph shows the monthly carbonaceous biochemical oxygen demand (CBOD₅) discharge from the sewage treatment plant during 2015 and 2016. The permit limit for CBOD₅ is 18kg/day.

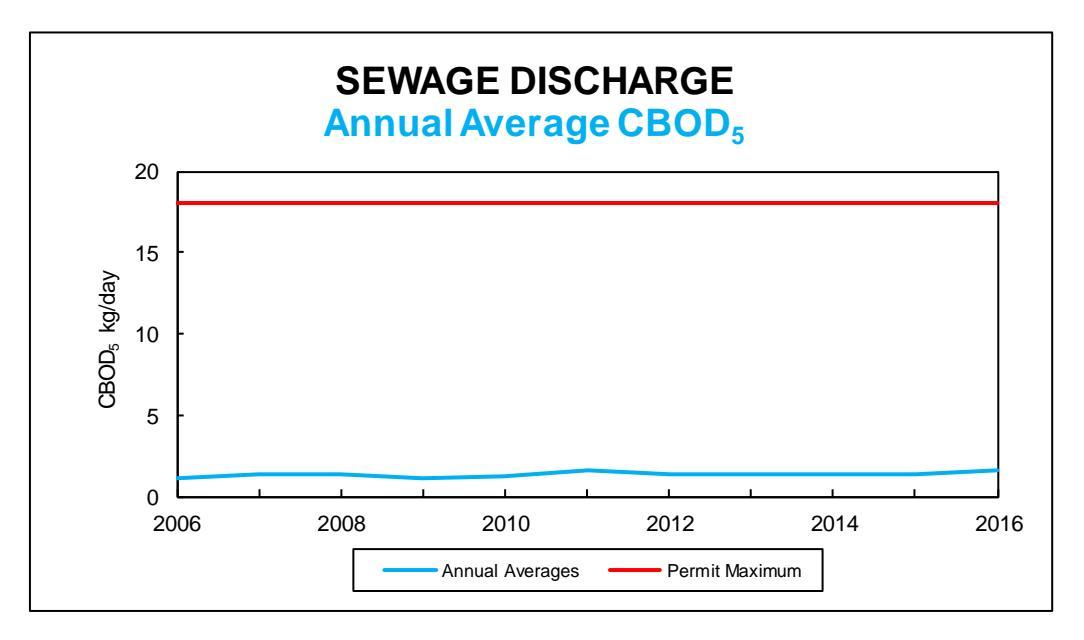
The following graph shows the annual average CBOD_5 discharge from the sewage treatment plant.

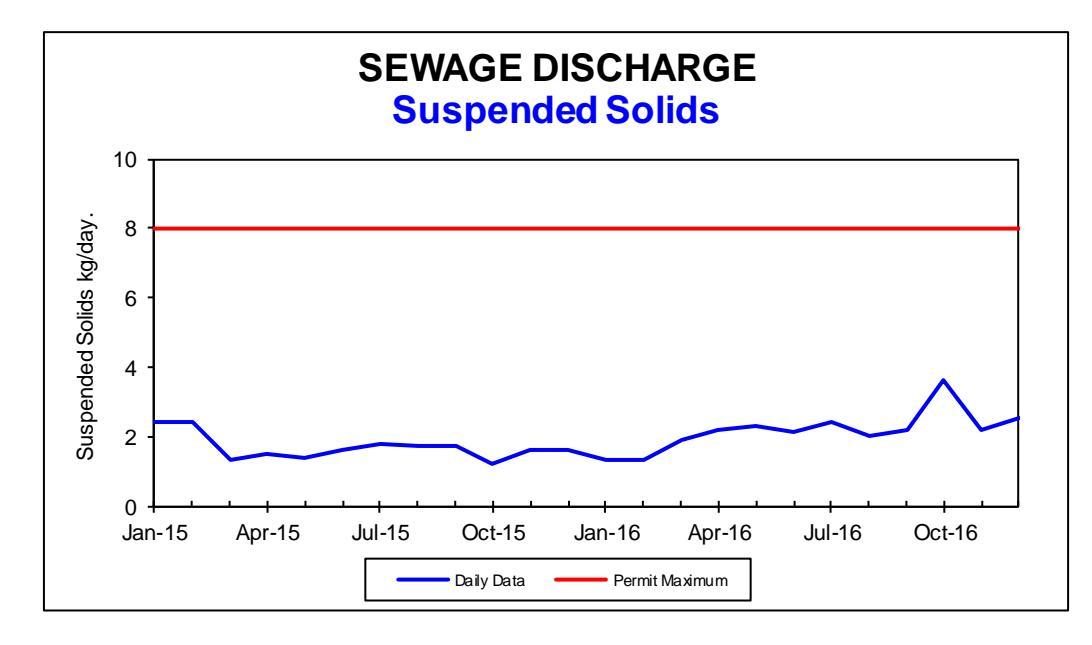
The following graph shows the monthly suspended solids in the discharge from the sewage treatment plant during 2015 and 2016. The permit limit for suspended solids is 8 kg/day.

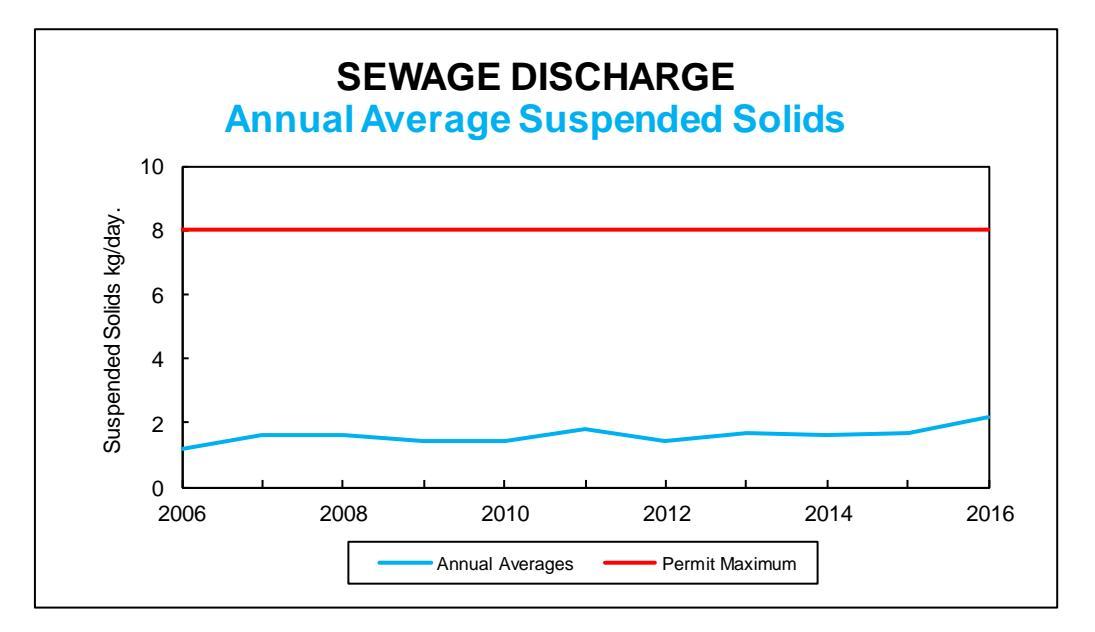
The following graph shows the annual average suspended solids discharge from the sewage treatment plant.

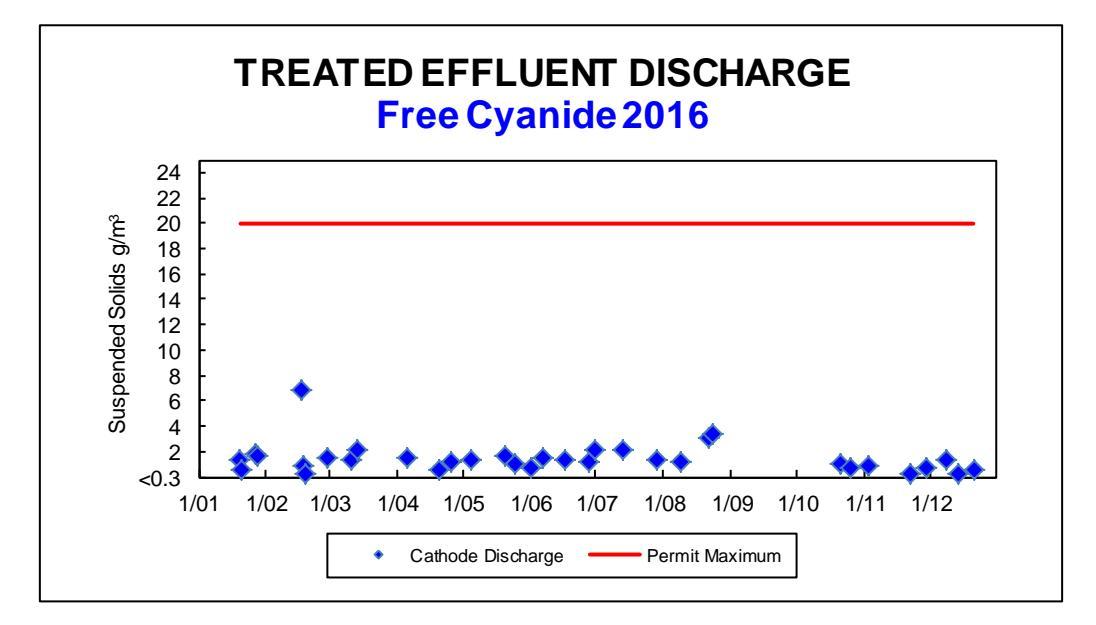
The following graph shows the free cyanide concentration of treated effluent discharged during 2016

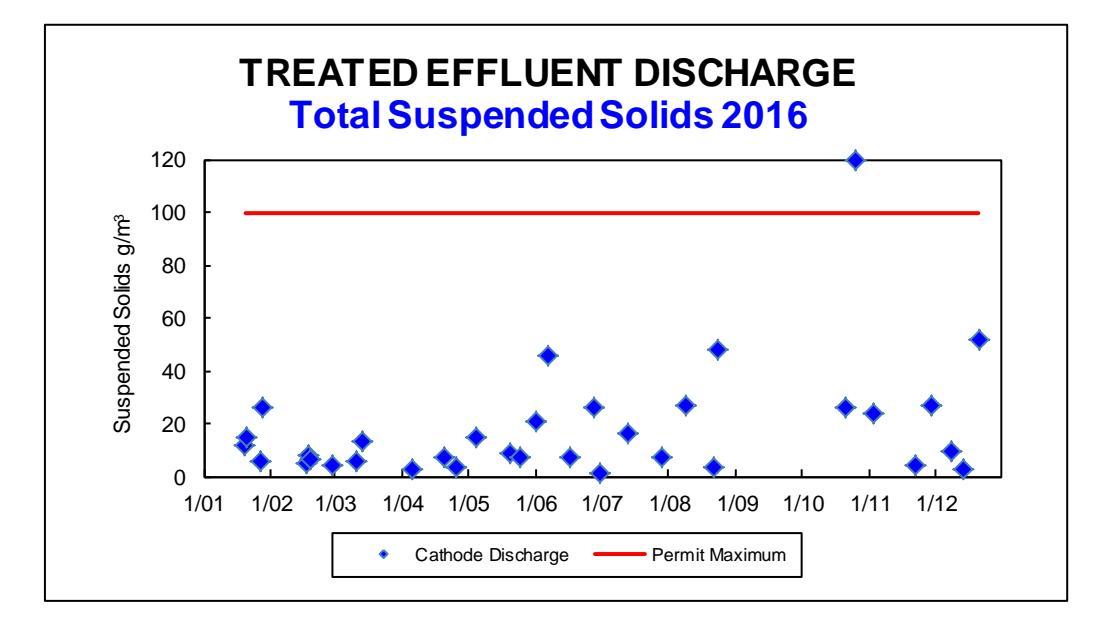
The following graph shows the total suspended solids concentration of treated effluent discharged during 2016.

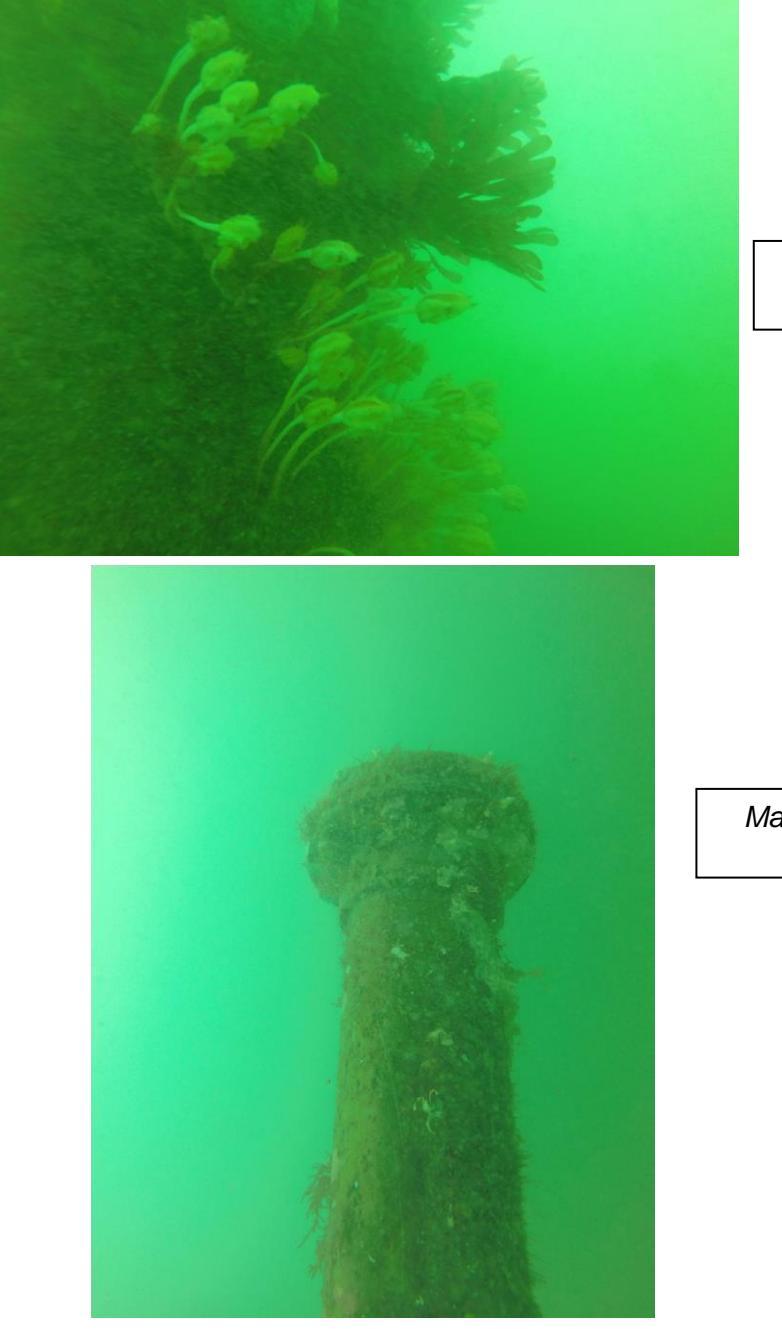
Out fall structure before cleaning

The Cathode Outfall Discharge Structure including the diffuser was inspected on 14th March. Overall the structure was found to be in good condition in an upright position on the seafloor as intended with parts having between 65-75% of their life remaining until replacement will be needed. Growth on the structure was found to be similar to other years. The structure was scraped clean making sure to leave any small snails in place. The snails seem to stop the sea tulips attaching themselves to the structure. All discharge tubes were cleaned of growth and blockages removed.

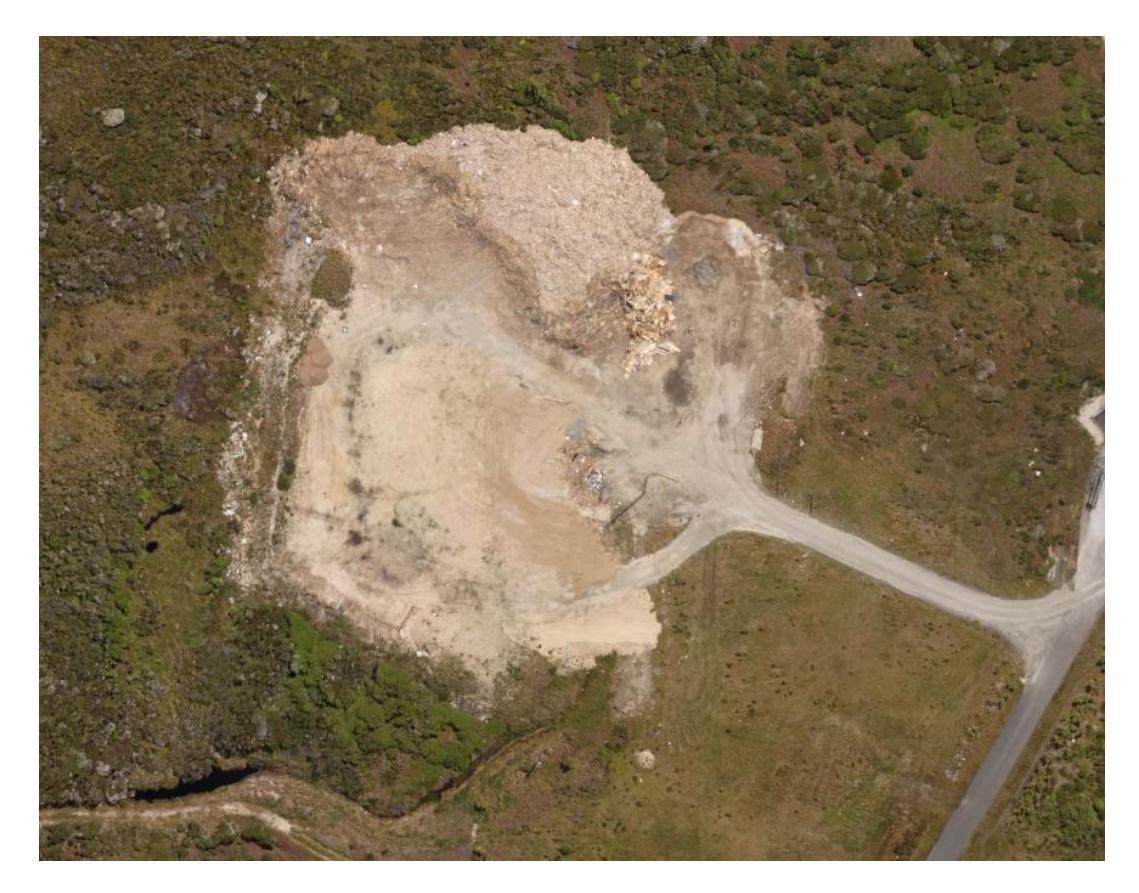
In November 2016 the waste wood pile was chipped by external contractor to reduce the volume. Staff and contractors were allowed to remove waste wood from site for firewood.

General waste area with wood pile chipped

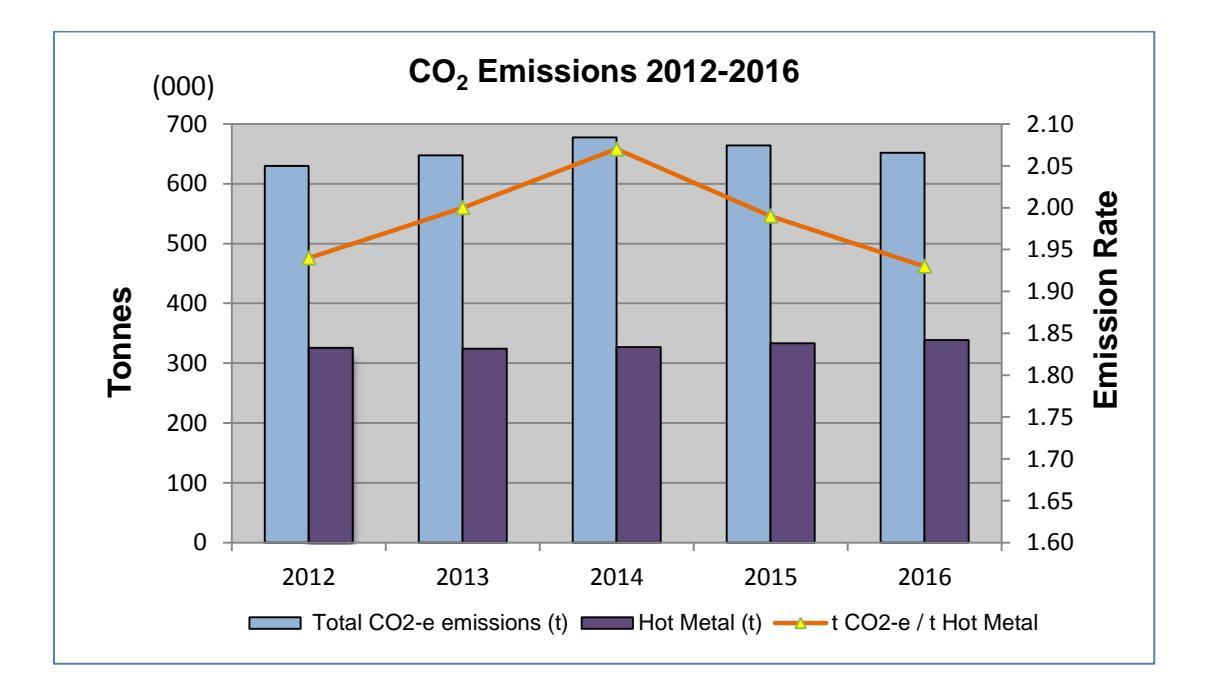
The total calculated carbon dioxide equivalent (CO₂-e) discharge from NZAS during the year ending 31 December 2016 was 651,840 tonnes. This was 2% less CO₂-e than last year and with metal production increased by 5,340 tonnes. The average emission rate in 2016 was 1.93 t CO₂-e / per tonne of aluminium produced, which is the best result in the last 5 years.

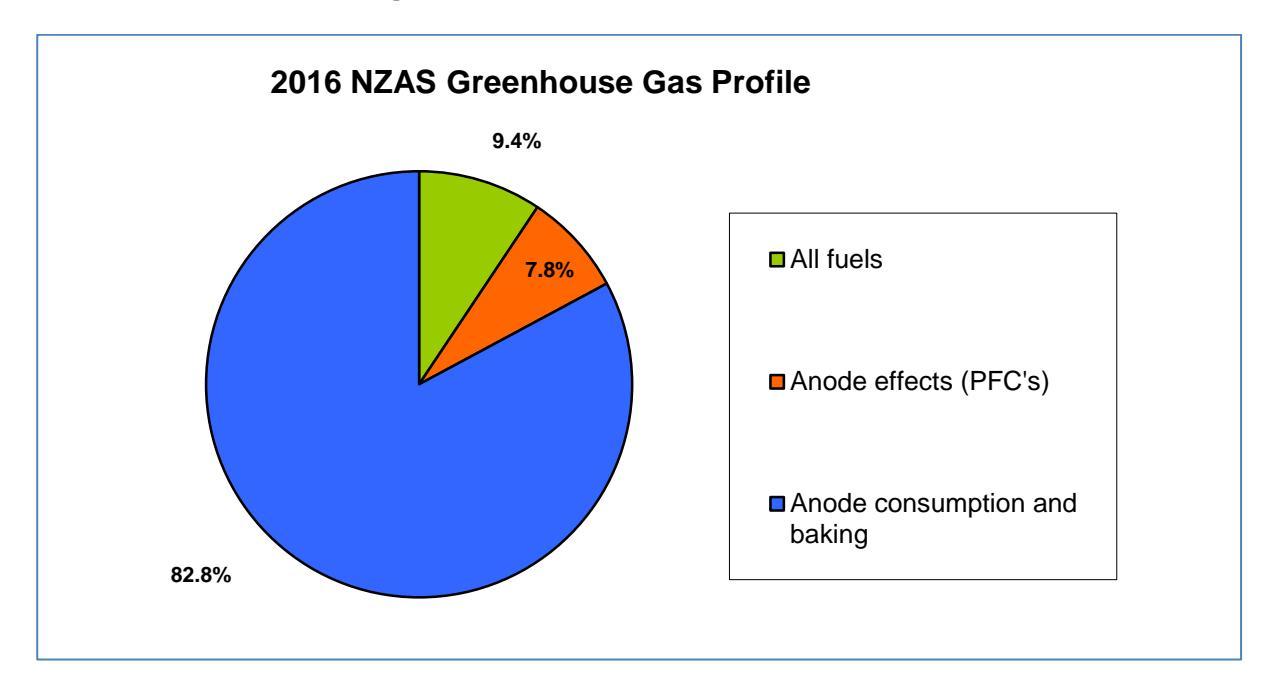
The total calculated CO_2 equivalents are emitted from carbon consumption (anodes), perfluorocarbons generation (PFCs) and fuel usage. The contribution from PFCs and fuels decreased on 2015 values due to a fuel efficiency project in the baking furnaces and better process stability in the Reduction Lines. The percentage distribution is displayed on the next page.
