NEW ZEALAND NZAS ALUMINIUM SMELTERS LIMITED

REPORT TO THE INTERDEPARTMENTAL COMMITTEE ON ENVIRONMENTAL EFFECTS OF THE TIWAI ALUMINIUM SMELTER FOR THE YEAR ENDED 31 DECEMBER 1991

MEETING AT TIWAI 12th JUNE, 1992

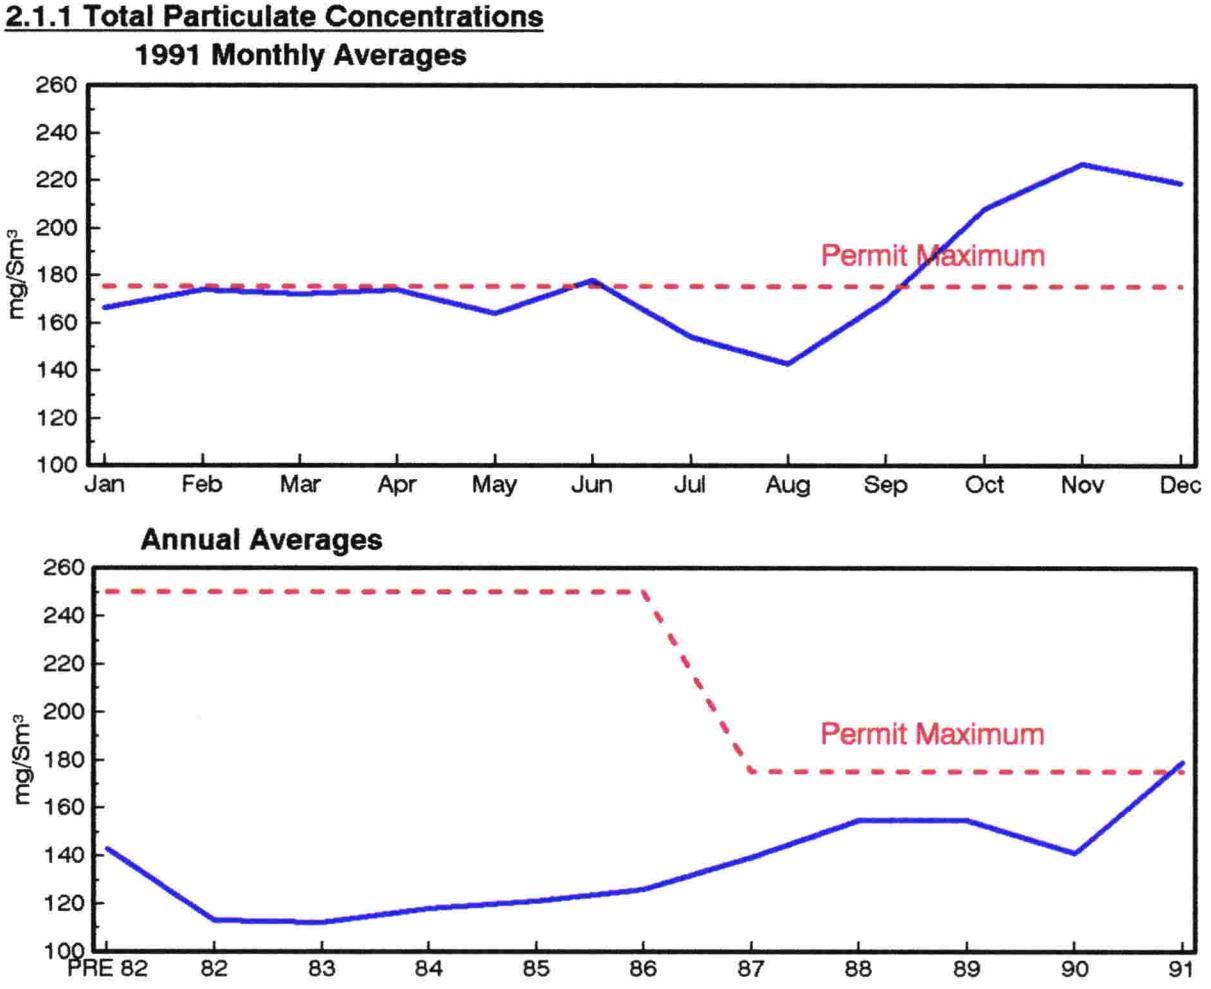
The 1991 average stack total particulate concentration of 179 mg/Sm³ was significantly higher than the 1990 average of 141 mg/Sm³ and marginally exceeded the Permit Condition maximum. The concentrations were constant during the first 6 months and decreased in July and August when the alumina injection system was not operated. The concentration increased in September when the alumina injection system was restarted but continued to increase above the previous operating concentrations.

Accelerated wear of the paraclones in the Lines 2B, 3A and 3B multicyclones was identified as the cause. A paraclone replacement programme was initiated but more wear was detected than was originally indicated. The replacement programme will be completed by mid 1992, and paraclones will be regularly replaced in future to prevent a reoccurance.

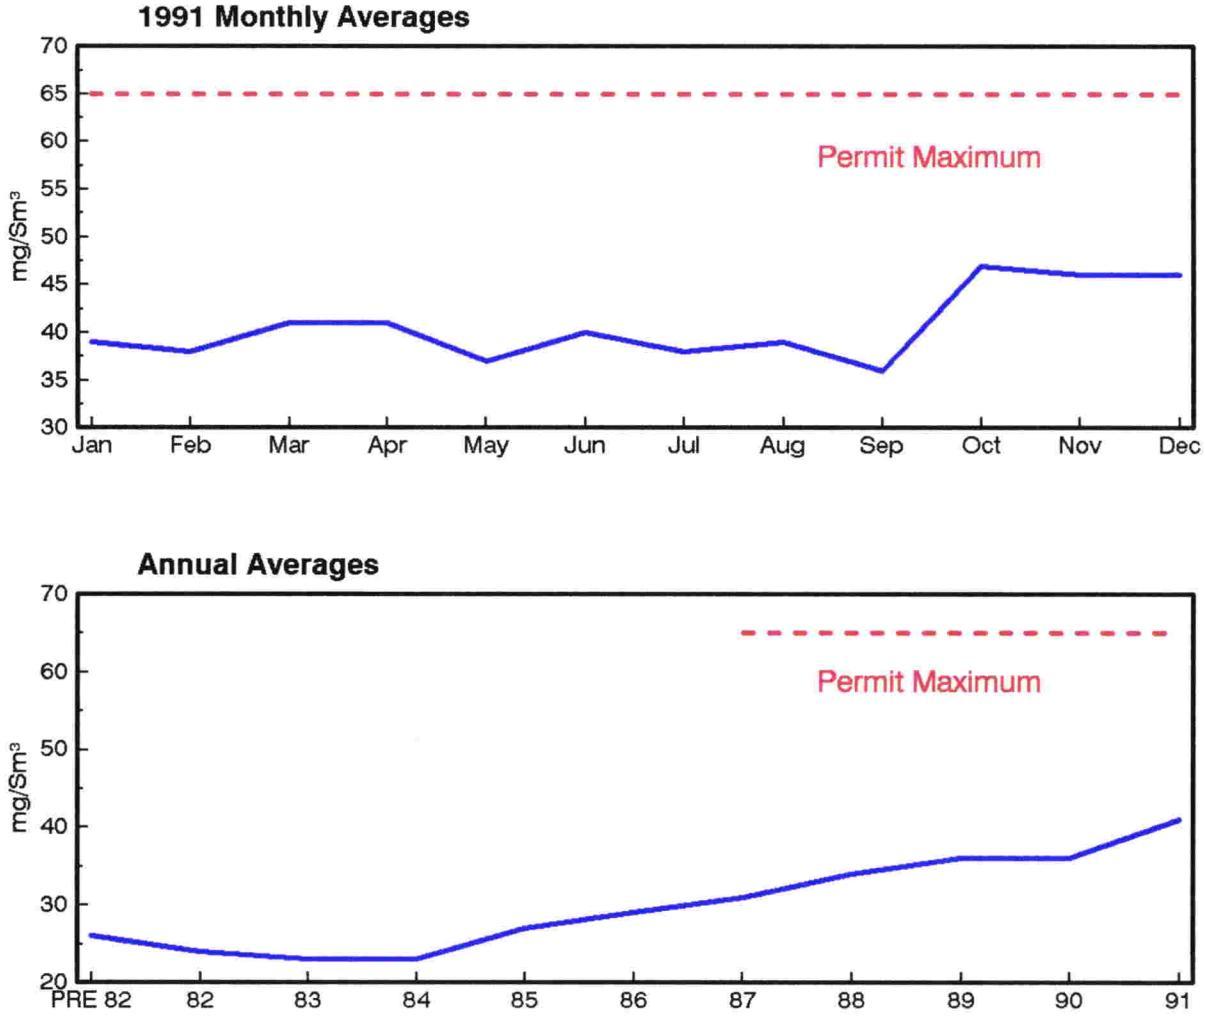
The 1991 average stack particulate fluoride concentration was 41 mg/Sm³ compared to 37 mg/Sm³ in 1990. This increase was also due to the accelerated wear to the paraclones in the Lines 2B, 3A and 3B multicyclones.

The annual average concentrations have increased in past years as a result of process optimisation activities. Additional comment is made in Section 2.1.3.

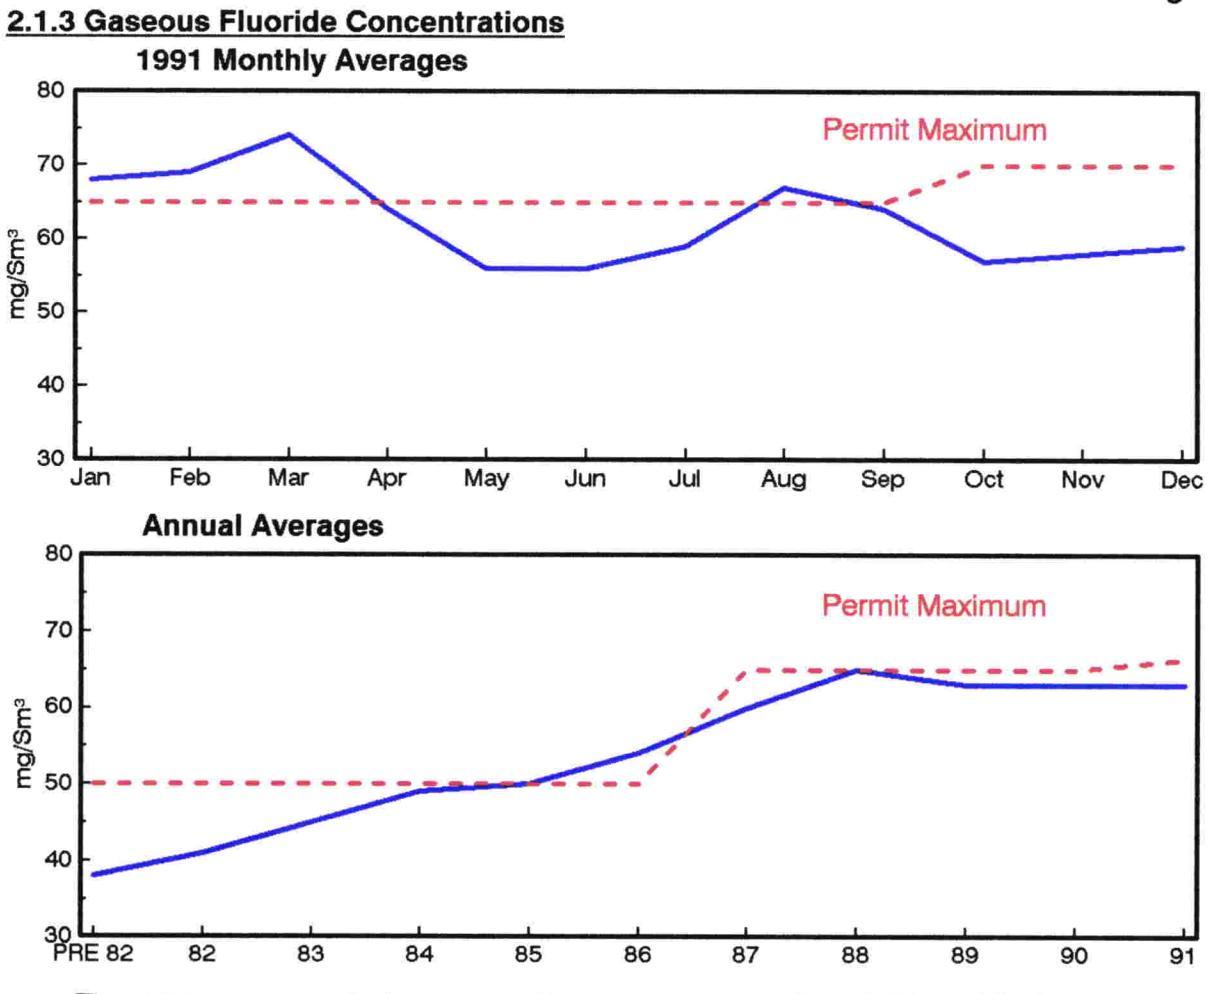
The 1991 average stack gaseous fluoride concentration of 63 mg/Sm³ was similar to the 1990 average concentration of 62 mg/Sm³. The alumina injection system on Lines 2B, 3A and 3B was improved during 1991 and the benefits are indicated by the lower concentrations during the spring and early summer.

The cumulative effect of the many changes to the aluminium reduction process parameters and operations since the mid 1980s has resulted in an overall increase in fluoride emissions. A Process Improvement Team and the Atmospheric Emissions Control Project MRU have, and are continuing to investigate the mechanisms causing fluoride generation. As a result some process operating improvements have been made to maintain the stack gaseous fluoride concentrations within the Permit Conditions.

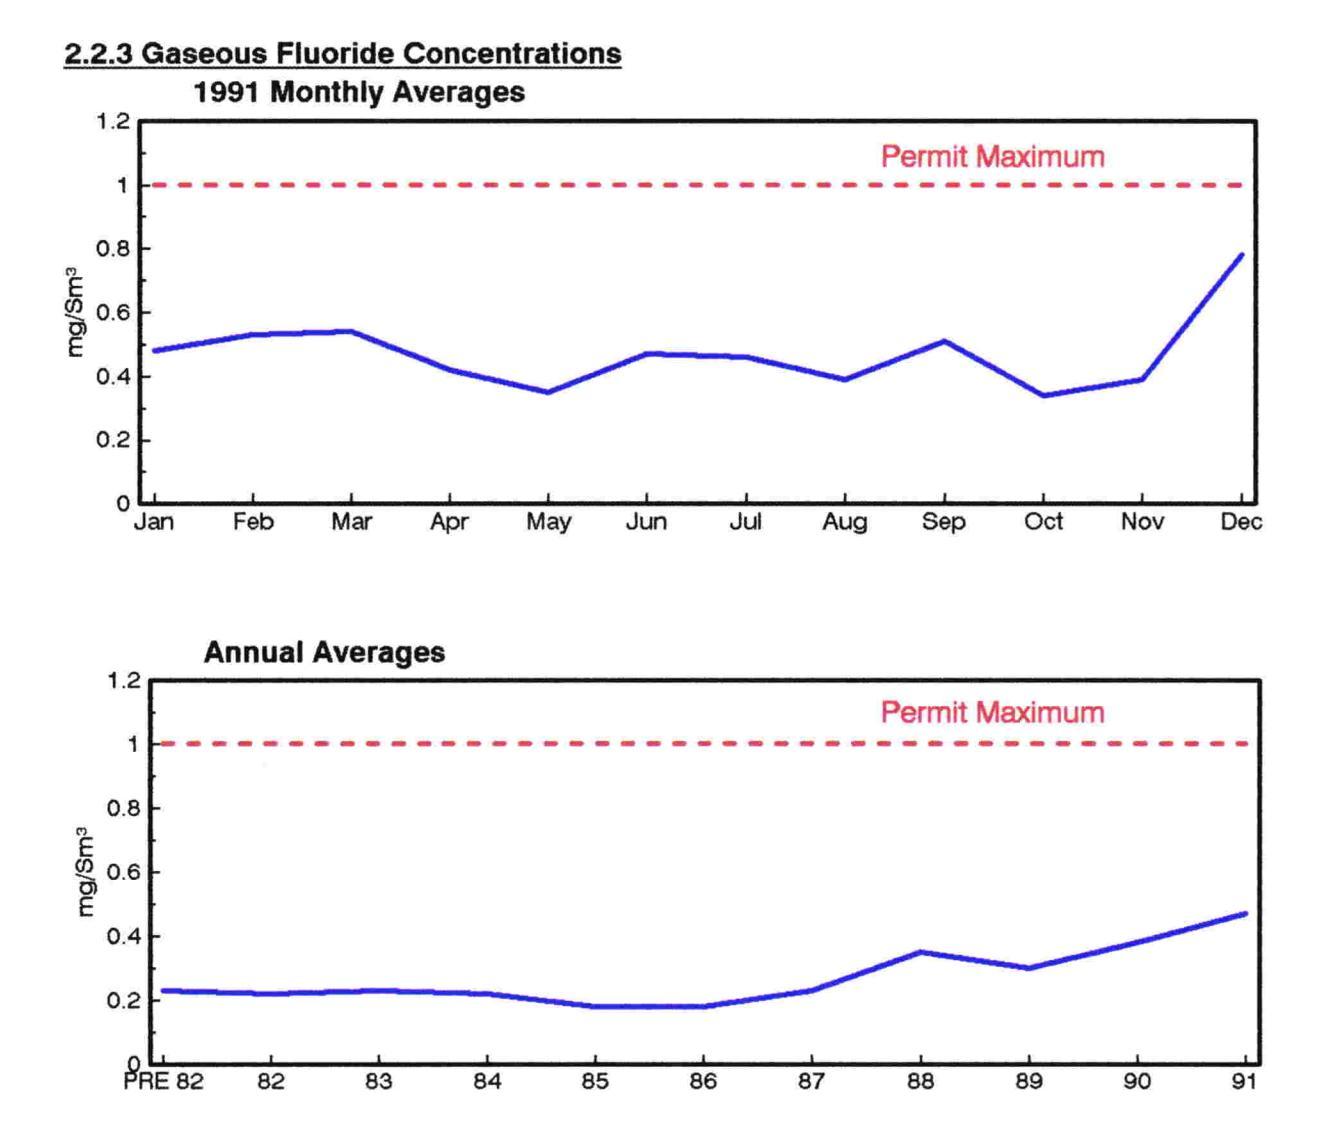
The 1991 average Potroom roof louvre gaseous fluoride concentration of 0.47 mg/Sm³ was an increase on the 1990 average concentration of 0.38 mg/Sm³. An abnormally high concentration was measured in December with no absolute cause being established.

The annual average concentrations have been increasing as a result of the changes to the aluminium reduction process parameters and operations. (Section 2.1.3.)

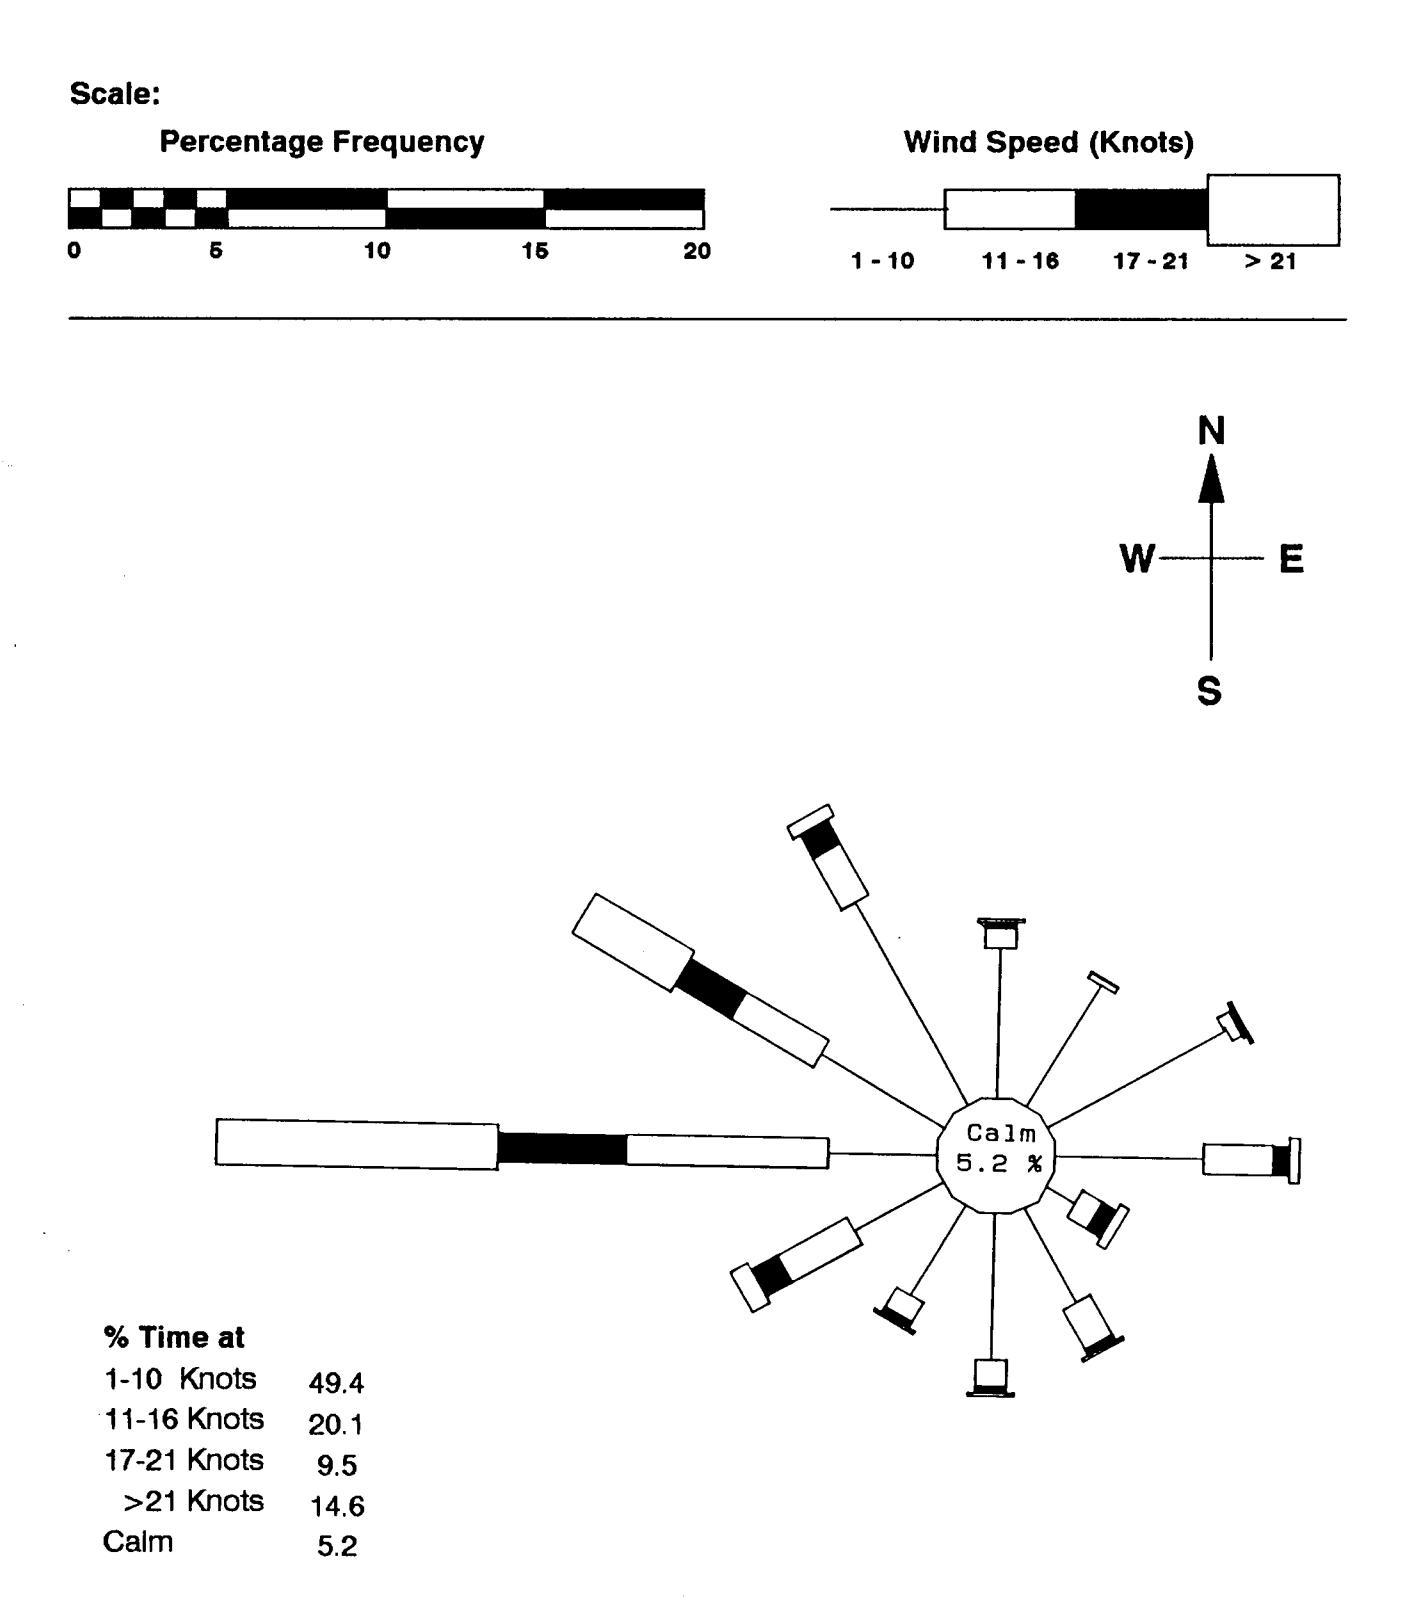
TIWAI POINT MEAN WIND FREQUENCY (%) OF SURFACE WIND DIRECTIONS FOR THE YEAR 1991

The mean wind frequency diagram shown on the following page indicates the typical Tiwai wind pattern with the predominant westerly wind components. There were less south-westerly and more north-westerly winds in 1991 when compared to the previous year.

Unfortunately only 10 months wind data are available from the Tiwai meteorological station for 1991 due to equipment failures. No wind data is available for June and December.

January and February were characterised by a high frequency of strong westerly winds. March and April were relatively calm. The strong westerlies prevailed in May but July and August were relatively calm. The strong westerlies returned in September and October but were of less strength in November.

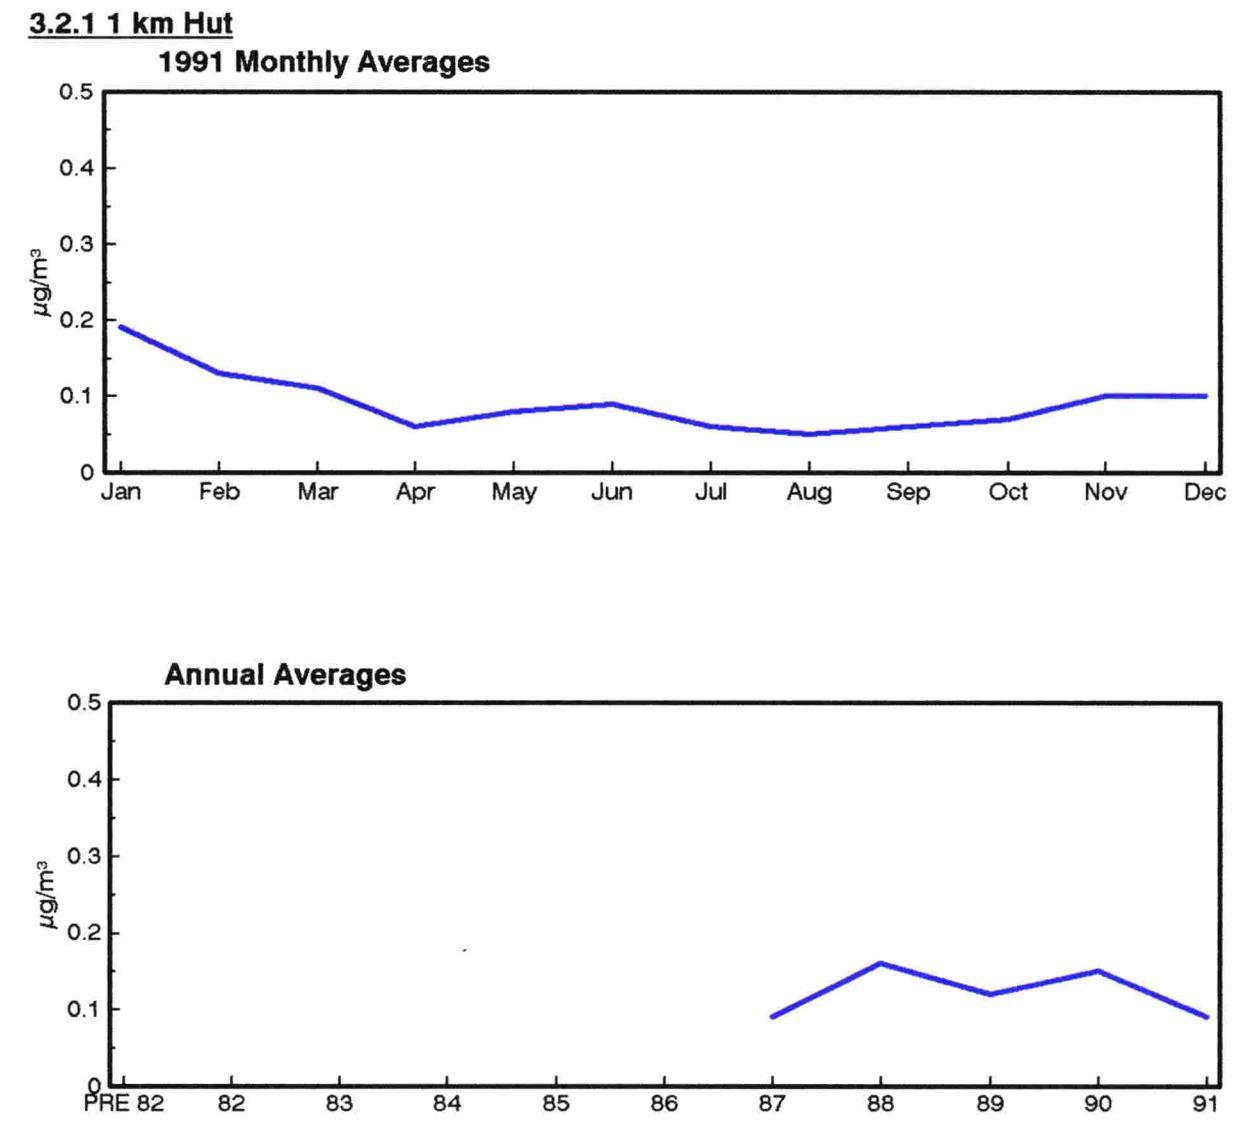
The 1991 mean gaseous fluoride concentration at the 1km hut was 0.08 μ g/m3, and lower than the 1990 average of 0.14 μ g/m³. This site was introduced in 1987 as part of the project to incorporate computer based predictive dispersion modelling into the NZAS monitoring programme. The site was chosen so that the fluoride concentration was high enough to be measured by a real time continuous fluoride analyser. This will allow validation of the modelling predictions. The status of this project is that an automatic meteorological station was commissioned in 1990 and currently NZAS meteorological and emission data is being uploaded into the Bouyant Line Plume (BLP) model by our Brisbane-based consultant.

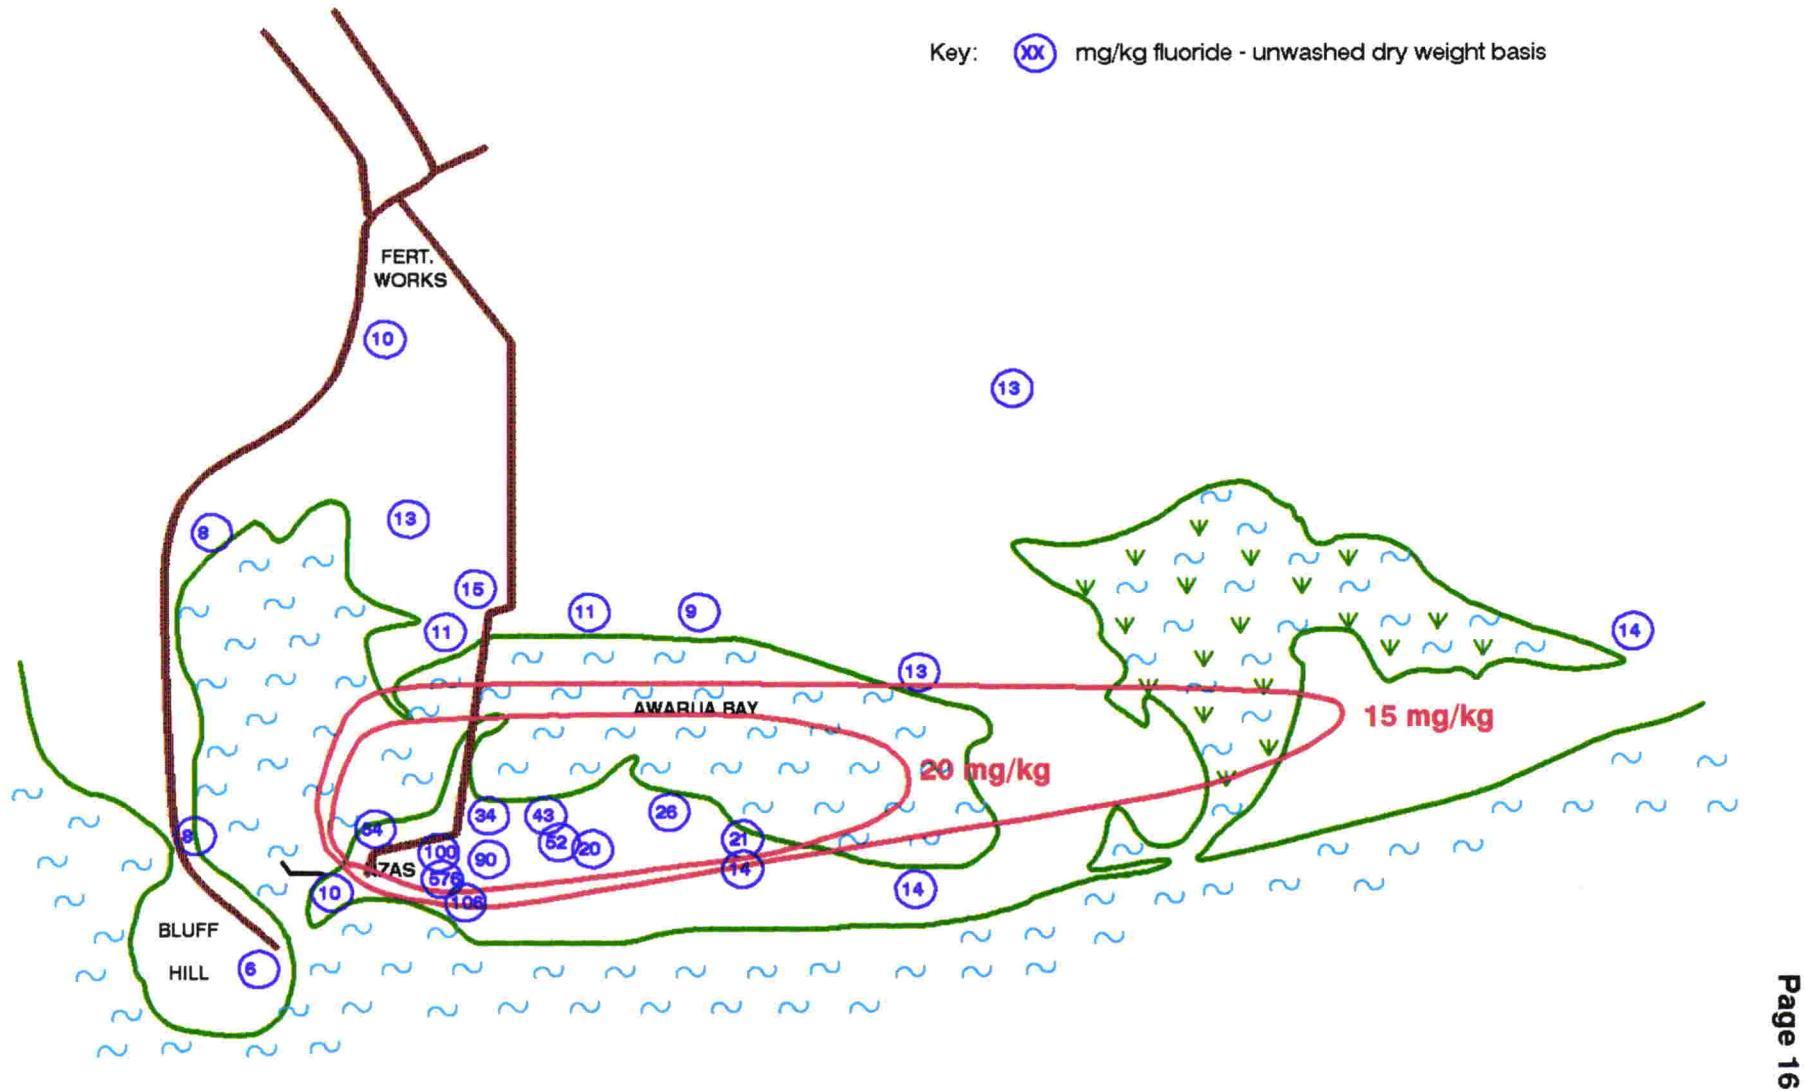
UNGRAZED GRASS FLUORIDE CONCENTRATIONS

The ungrazed grasses 1991 mean concentrations are shown in the map on the next page. Comparison with the 1990 mean concentrations indicates similar concentrations to the east but lower concentrations to the north and west.

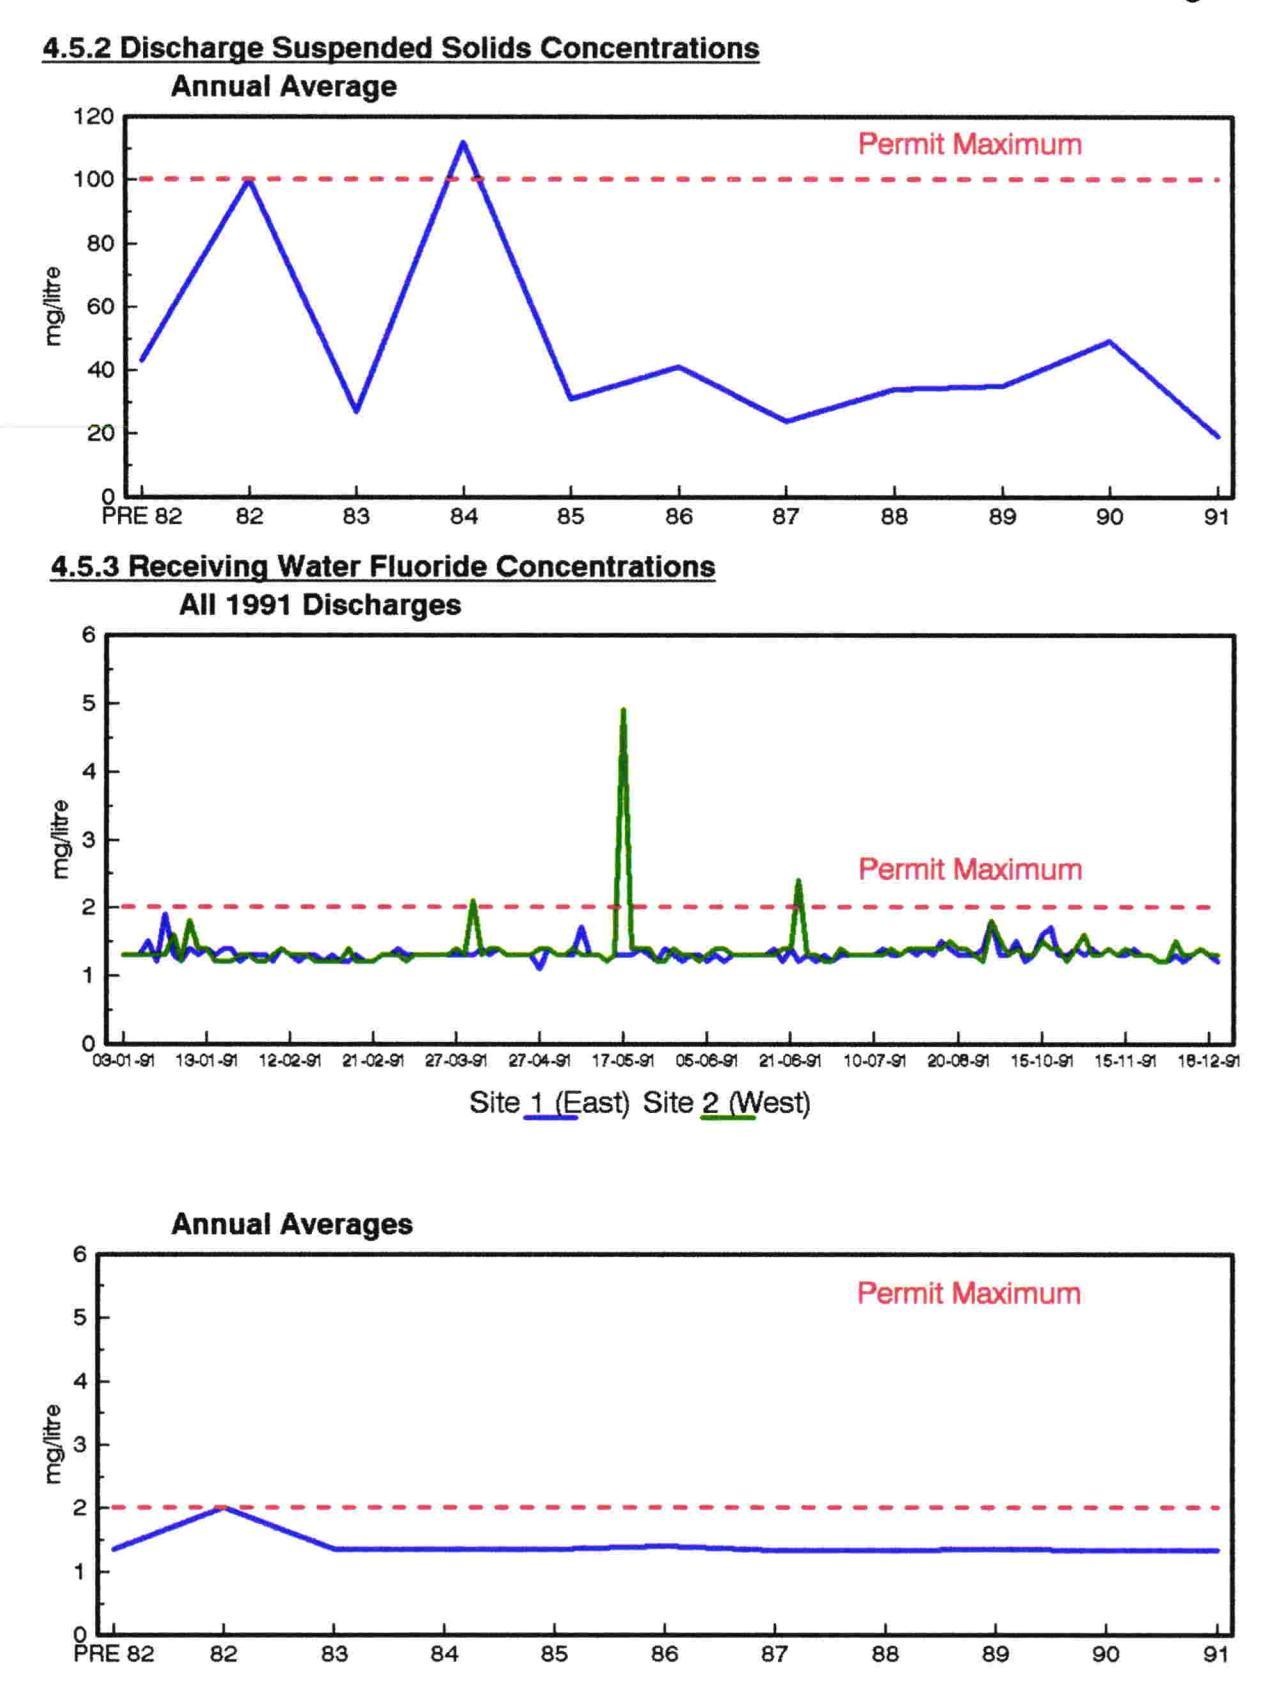
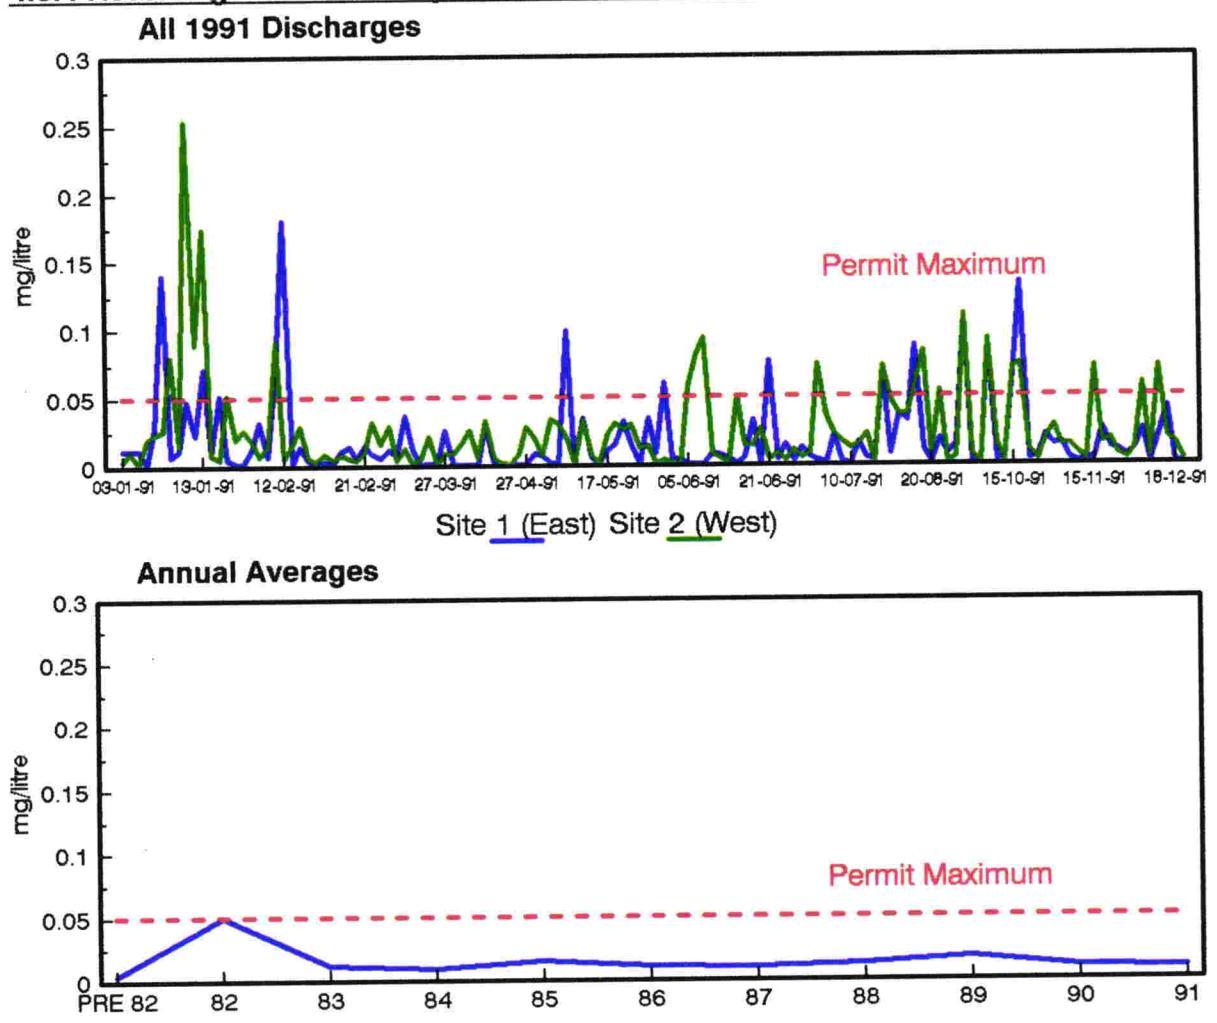
4.5.4 Receiving Water Total Cyanide Concentrations

Occasional high discharge suspended solids concentrations occurred in 1991 despite the use of flocculants and a field test to assess the quality before discharge. On most discharges the concentrations were very low.

No trends were evident in the discharge free cyanide concentrations which remained low.

Occasional high receiving water fluoride and intermittent high total cyanide concentrations occurred. A diffuser was installed on the outfall pipe in September but broke away later in the year. It was modified and reinstated in early 1992.

Past actions of changing the time of discharge and installing the diffuser have not eliminated the high receiving water concentrations. A Process Improvement Team was established to recommend options for eliminating the high concentrations. As a result of this team's work, two groups of consultants have been engaged to establish the ground and seawater movements near the spent cathode storage area.
